**REPUBLIC OF BULGARIA**  
**NATIONAL AIR, MARITIME AND RAILWAY TRANSPORT, ACCIDENTS**  
**INVESTIGATION BOARD (NAMRTAIB)**

**FINAL REPORT**

**Investigation of railway accident – fire in locomotive № 91520043309-1, serviced fast train  
№8632 between the stations Svoboda – Tchyrpan on 25.08.2024**

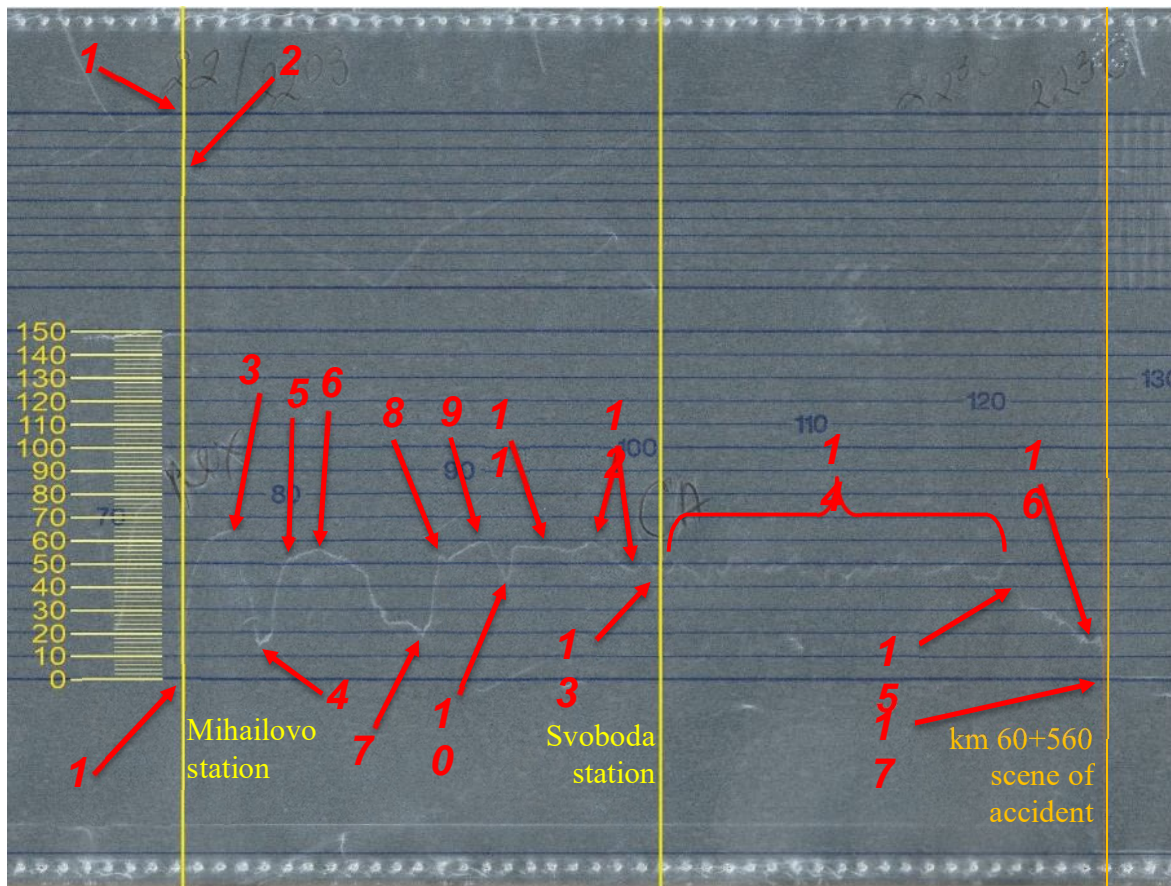
**Fig. 4.4. Speedometer tape of locomotive № 91520043309-1 from Mihaylovo station at km 60+560**

It is necessary to note that the registrations on the tape during the movement of the train before the accident site are faint, which is due to the increase in temperature in the control cabin 1 after the ignition of the locomotive and the late removal of the speedometer tape from the recording speedometer. This significantly complicated the analysis of the train's movement.

FT No. 8632, led by locomotive No. 91520043309-1, arrived at Mihaylovo station at 22:00 p.m. (Fig. 4.4, pos. 1). It stayed for three minutes and departed at 22:03 p.m. (Fig. 4.4, pos. 2). It accelerated to 64 km/h, travelled about 1250 meters in 1 minute and 30 seconds (Fig. 4.4, pos. 3), after which the locomotive driver held it with the automatic train brake and the speed decreased to 15 km/h for about 500 meters (Fig. 4.4, pos. 4). Immediately after that, a new increase in speed began, initially steeper to 51 km/h (Fig. 4.4, pos. 5), and then more smoothly to 56 km/h, with the train traveling another about 1400 meters in 2 minutes (Fig. 4.4, pos. 6).

That was followed by a new speed reduction to 20 km/h (Fig. 4.4, pos. 7) and a new increase, initially steep with a peak at 54 km/h (Fig. 4.4, pos. 8), with a reduction to 50 km/h and a subsequent smoother increase to 60 km/h (Fig. 4.4, pos. 9). The speed reduction in that interval was carried out without using the automatic train brake – only by the natural resistance of the train movement.

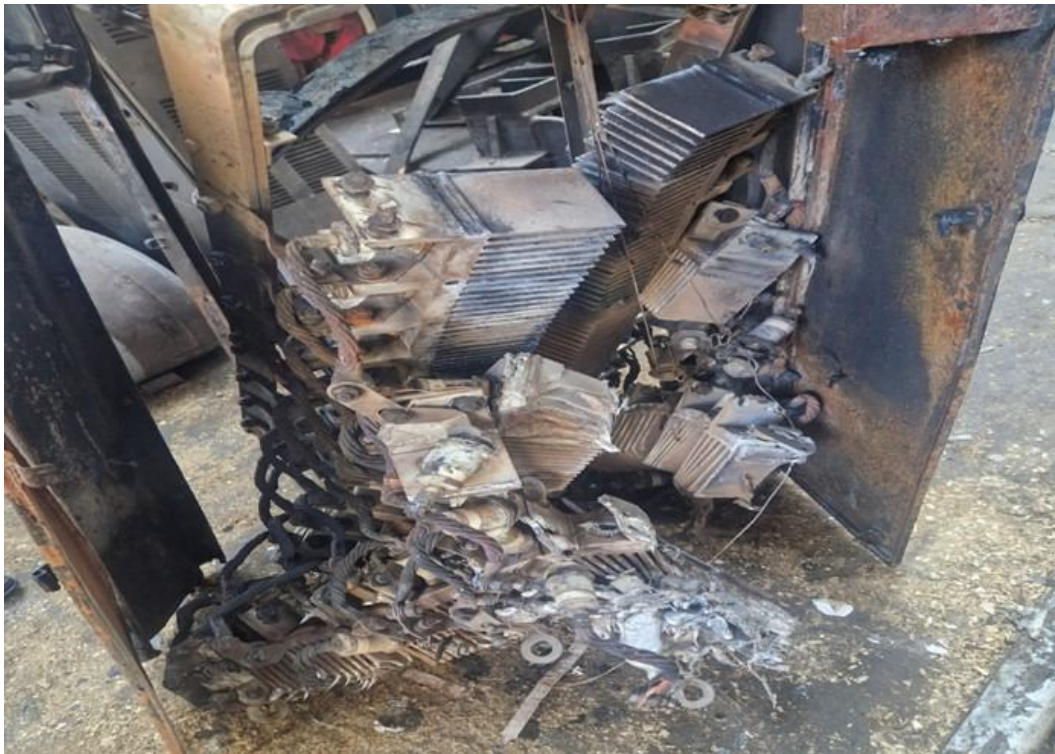
**Fig. 4.5. View to the second rectifier block 022 and 221**

When dismantling the second rectifier block 022, melted cooling elements of the diodes of the rectifier group were found, as well as destroyed auxiliary rectifiers 221 of the fans 232, 233 and the compressor 235 (Fig. 4.6 and 4.7).

Inspection of auxiliary rectifier 221, powering the compressor motor and fan motor – the coolers were burnt and melted. Most likely, the temperature was highest there. It was very likely that the fire started from rectifier 221 due to prolonged operation of the second compressor motor.

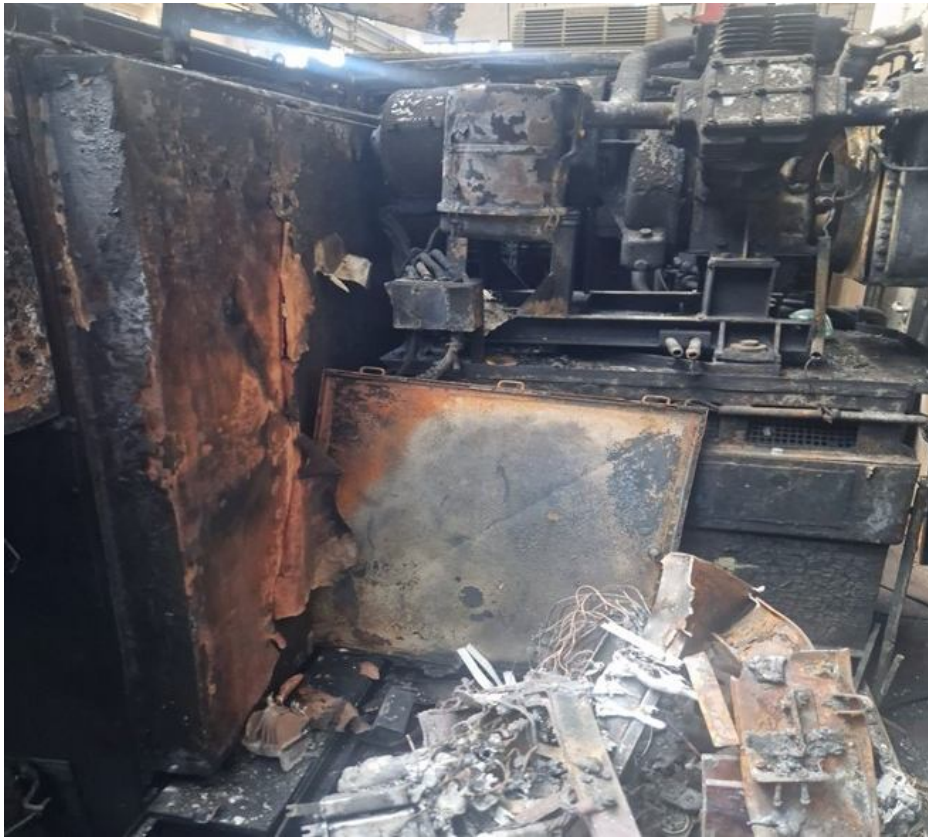
**Fig. 4.6. View of the burned rectifier 022 and 221**

The location of the power auxiliary unit 221 is in the lower part of the rectifier power unit 022. It cools after the power unit 022 cools down. The R-C groups of the power and auxiliary units 022 and 221 are for protection against external and internal overvoltage. It was found that the capacitors in the R-C groups are made of liquid electrolyte (Fig. 4.8). Because of the increased temperature, it expanded and caused the capacitor to explode. The hot electrolyte falls on the heated surfaces of the rectifier diodes and on the power block of the auxiliary rectifier. That caused a fire in the rectifier. Initially, the fire occurred with thick, impenetrable dense smoke due to the lack of oxygen.

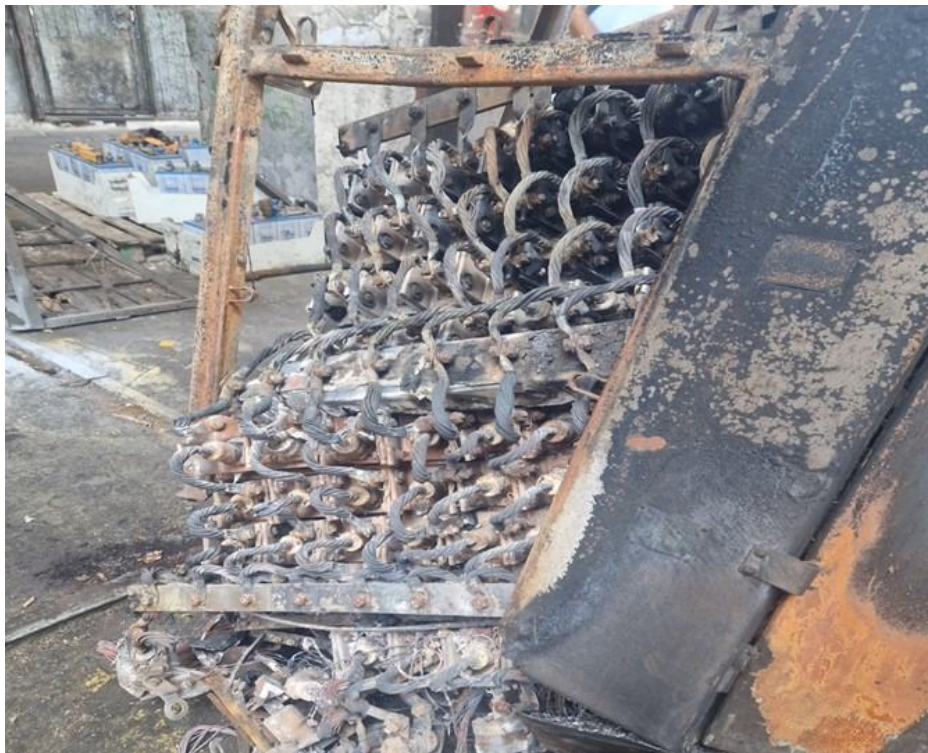
**Fig. 4.7. View of the first rectifier 020**

Dismantled first rectifier group 020. It can be seen that the burning and melting of the coolers was significantly less. That compressor motor may have been loaded less. It is assumed that it was not used during the train's movement (Fig. 4.7).

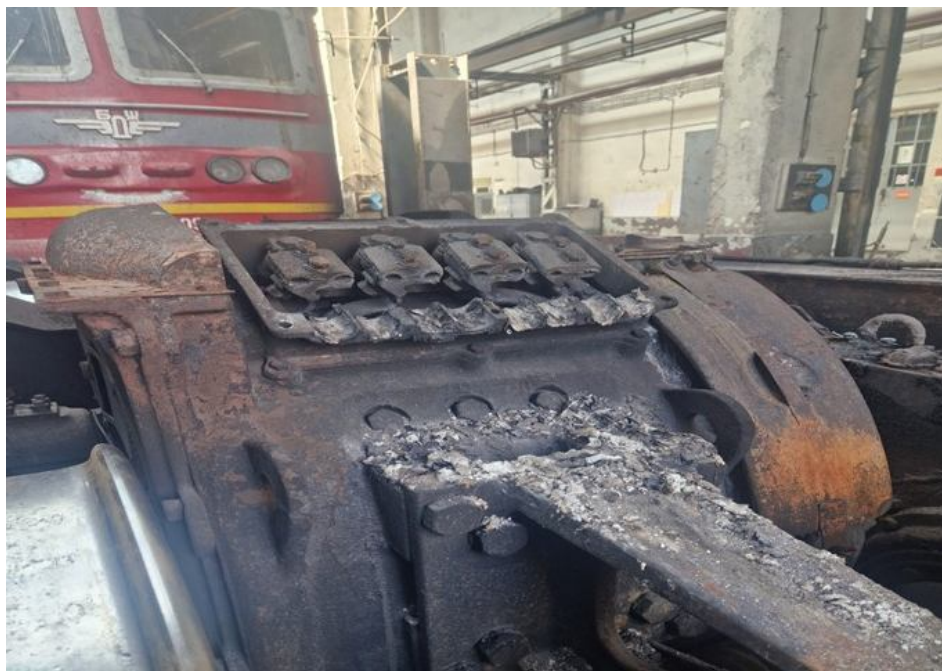
**Fig. 4.9. View of second traction motor**

When the door to the passageway was opened, oxygen access was provided and a flame appeared. The damage was extensive to the rectifier groups, horizontal engine fans and traction motors (Fig. 4.9 and 4.10) due to the lack of adequate actions by the Fire and Rescue Service (the initial extinguishing began by pouring water on the locomotive body), as well as the failure of the locomotive's fire extinguishing system.

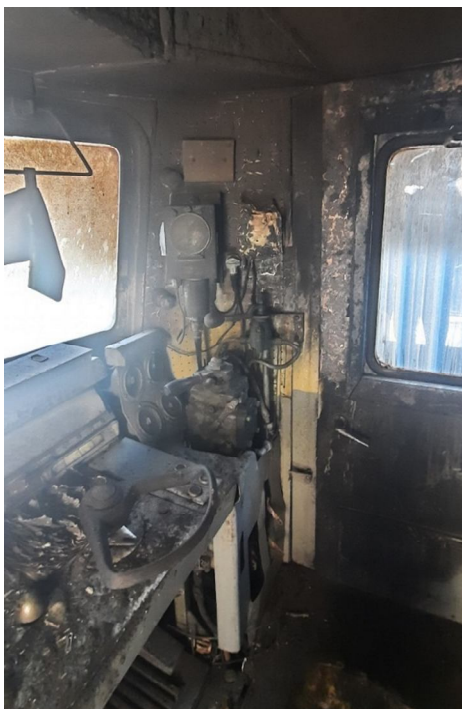
**Fig. 4.11. Condition of the control cabin № 1 after the fire**

The commission inspected the two control cabins and found that they were smoky, with the temperature in the first control cabin being high, heating up the recording speedometer and to some extent damaging the recordings on the locomotive's speedometer tape (Fig. 4.11, 4.12).

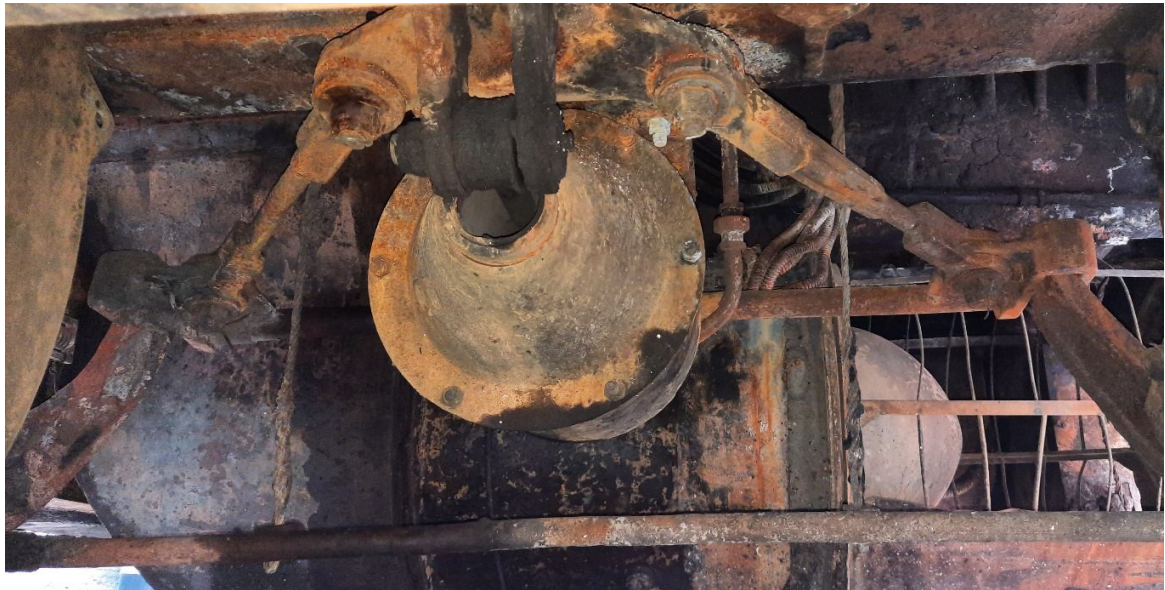
**Fig. 4.13. Condition of the elements under the locomotive frame after the fire**

The commission inspected the engine compartment, as well as the elements located under the locomotive frame, and found burnt power cables of the traction motors, under-basket horizontal fans, part of the bogie frames, brake cylinders, the lever brake system and other elements, all of which were a result of the high temperature during the expansion of the fire (Fig. 4.13, 4.14, 4.15).
