REPUBLIC OF BULGARIA
NATIONAL AIR, MARITIME AND RAILWAY TRANSPORT, ACCIDENTS
INVESTIGATION BOARD (NAMRTAIB)

FINAL REPORT

**Investigation of accident - Collision of shunting train with locomotive No98520055057-4 in
the last coach of fast train No 1621 in Sofia station on 28.05.2024**

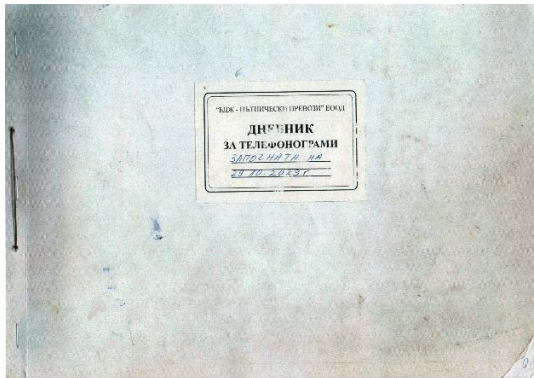
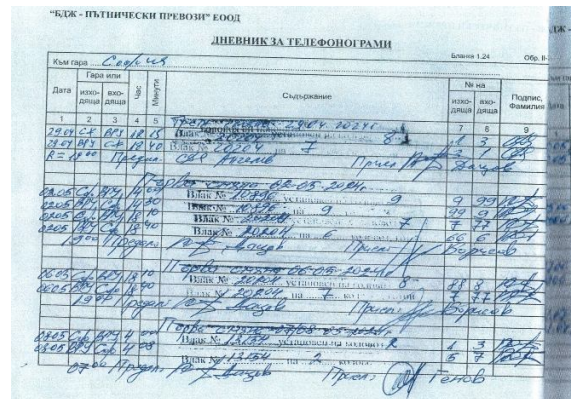
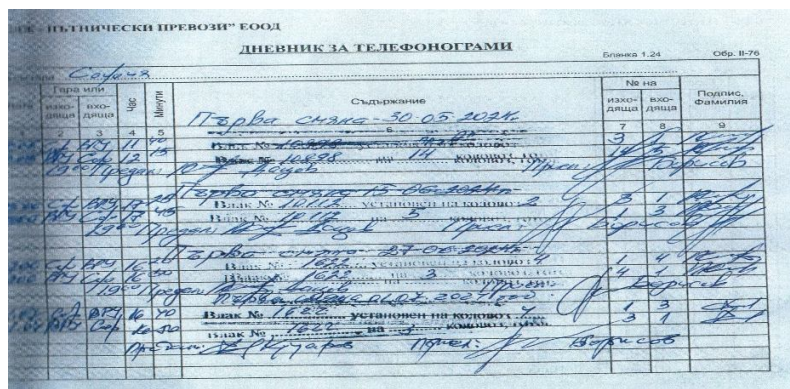
Fig. 3.8. Logbook for telephone grammes of the wagon-inspection section in Sofia station

Fig. 3.9. Logbook for telephone grammes of the wagon-inspection section in Sofia station

Fig. 3.10. Logbook for telephone grammes of the wagon-inspection section in Sofia station

- On 28.05.2024, no registered record of exchange of telephone messages between the TMWI and the duty traffic controller was found in the logbook II-76, Fig. 3.8, 3.9 and 3.10;

- Recommendation 2 proposes that the personnel involved in ensuring train movement and shunting work of the SE NRIC, as well as the personnel involved in performing shunting work of BDZ PP EOOD, performing their duties at Sofia Station, be re-equipped with mobile terminals for using the existing GSM-R radio connection in order to carry out a permanent objective recording of the conversations;

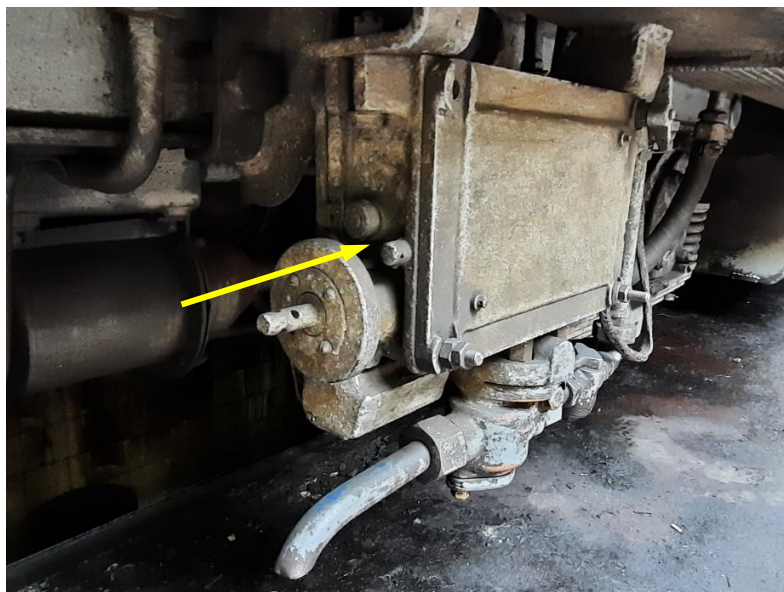
Fig. 3.11. Vigilance device of locomotive № 98520055057-4 – unsealed

Locomotive № 98520055057-4 was not technically sound (unsealed non-working vigilance device – evident from the testimonies of the locomotive driver) (fig. 3.11).

- Shunting locomotive No. 98520055057-4 on the 2nd shunting at Sofia station, operated with an inoperative insulated vigilance device;
- Untimely removal of the failure that occurred on switch No. 90 in the interval from 14:30 p.m. to 16:00 p.m., led to a violation of the TOS and Plan sample II-24;

- Recommendation 4 proposes that BDZ PP EOOD, until the introduction of the route-computer interlocking at Sofia Station into regular operation, turn on and seal the devices for monitoring the vigilance of the shunting locomotives;

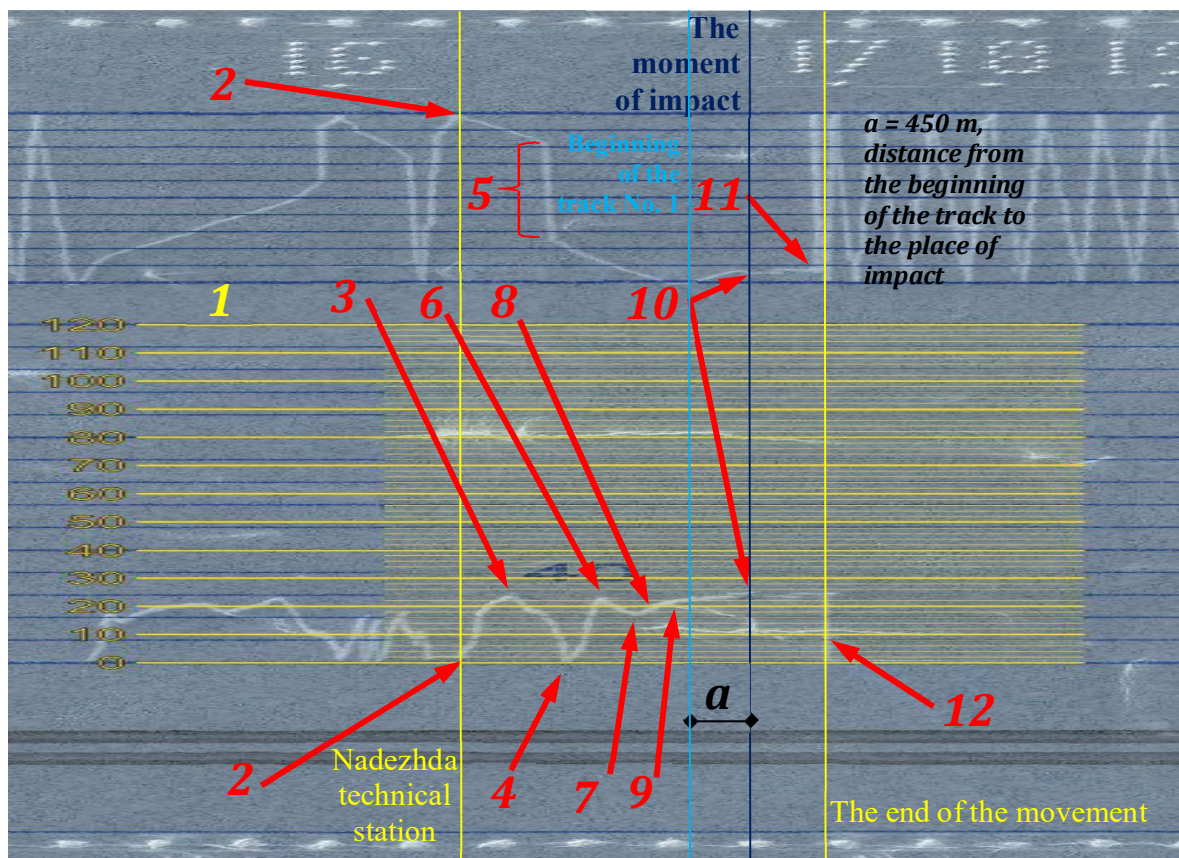
Fig. 4.4. Part of the speedometer tape of locomotive № 98520055057-4 with additional indications for facilitating the analysis

The locomotive departed from the Nadezhda Technical Station at 16:20:00 p.m. (Fig. 4.4, pos.

2), accelerated and its speed reached 24-25 km/h (Fig. 4.4, pos. 3), after which it immediately began to decrease: initially at a higher rate to about 19 km/h, then more smoothly to 15 km/h and again at a higher rate until a complete stop at 16:21:40 p.m. (Fig. 4.4, pos. 4), i.e. the train moved for 1 minute and 30 seconds, during which time it travelled about 660 meters. Apparently, the locomotive driver held it with the automatic train brake, which contributed to a faster establishment of the shunting train. The train stopped from 16:21:40 to 16:27:30 p.m. for 6 minutes and 50 seconds (Fig. 4.4, pos. 5).

From that moment, for a few millimeters of the speedometer tape, the recorders did not correctly register the speed and time caused by the collision of the locomotive on the stationary FT No. 1621. The registration of speed and time was restored after the action of the forces caused by the collision had passed (Fig. 4, pos. 10). That happened at 16:30:50 p.m. (Fig. 4.4, pos. 11), and the speed with a strictly vertical line indicated a decrease from 24 to 0 km/h (Fig. 4.4, pos. 12).
