NIB'S NETWORK 2024

NIB FINAL REPORTS
BETWEEN OCTOBER 2023-
SEPTEMBER 2024

THE SUMMARY OF FOUR
DIFFERENT ACCIDENTS

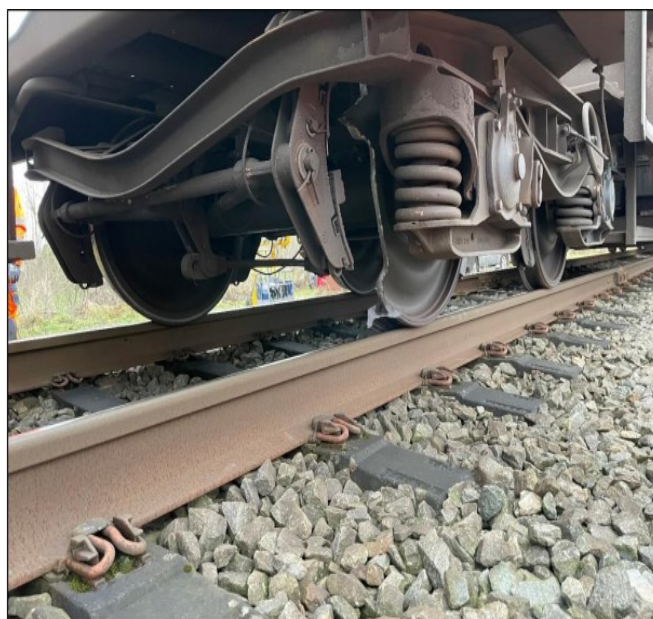
WHEEL FAILURE ON FREIGHT WAGON AT EJBY

Shortly before freight train 42702 was about to pass Ejby Station, part of a wheel on one of the wagons fractured. The train was brought to a stand in Ejby and subsequent investigation revealed that around 40% of the circumference of the wheel in question was missing. The incident did not lead to any derailment and the damage was limited to the vehicle's wheel, brakes, bogie and wagon floor. AIB concluded that, under slightly different circumstances, the incident could have led to a serious accident and therefore decided to instigate an investigation into the incident. The investigation, which was conducted in collaboration with the parties involved, has revealed safety deficiencies in the maintenance system underlying the wagon concerned. Special stricter safety requirements concerning the minimum dimensions of the wheel type involved had not been complied with, and the monitoring and checks carried out by the entities in charge of maintenance were not sufficient to identify this. Vehicle inspections during day-to-day operations and repairs carried out by the mobile repair service were also unable to identify one or more cracks which had developed in the wheel before the failure occurred while the train was travelling at a speed of 99 km/h near Ejby.

The investigation revealed that a wheel of type BA004 was deformed and developed cracks as a result of one or more thermal overload events. Despite this, the visible sign of thermal overload (burnt paint in the transition zone between wheel plate and wheel rim) was significantly below the limit where a closer examination of the wheel should be carried out. AIB has transferred this knowledge to the working group "JNS Broken Wheels", where, by agreement, it will be included in the group's further work with safety-promoting measures.

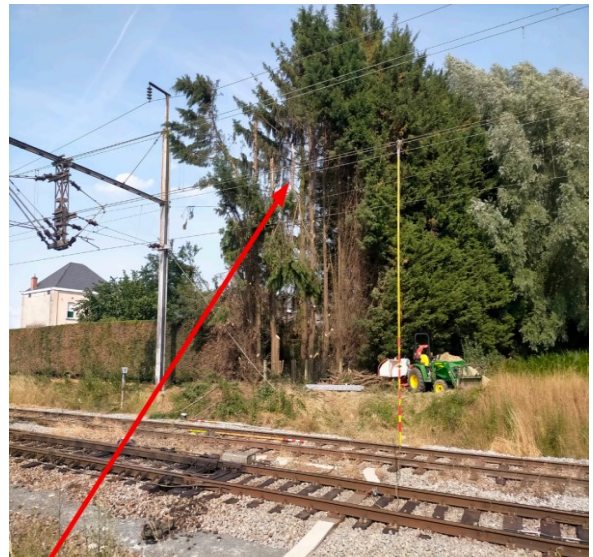
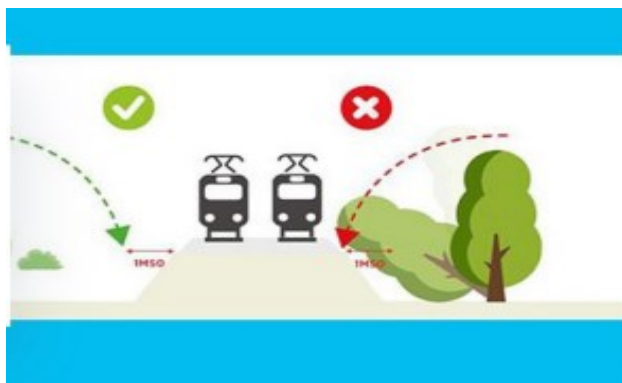
DEATH BY ELECTROCUTION OF A PRIVATE TREE PRUNER

On July 10, a tree pruner was electrocuted while working near a railway line in Quévy. The accident occurred when the upper part of a tree he cut fell onto a feeder powered by a 25 kV line, creating an electric arc that caused his death.

Prior to the accident, the tree's owner had informed Infrabel about the dangerous proximity of the trees to the railway catenary. Infrabel had scheduled a power shutdown for July 20, 2023, for the pruning work, but the pruner began the job on July 10 without notifying Infrabel. During the work, a branch likely came too close to an energized wire, causing damage to the railway infrastructure and triggering a circuit breaker. Infrabel agents arrived at the scene, halted the pruning work, and inspected the site. Despite their presence, a tree top later made contact with the feeder, leading to the fatal electrocution of the pruner.

The investigation revealed failures in communication and coordination between the pruner, the property owner, and Infrabel. While safety measures were implemented, the pruner may have mistakenly believed the area was de-energized. It was also determined that the risks related to falling tree sections were not adequately managed. The report highlighted the need for better awareness of safety risks when working near high-voltage power lines and recommended improved communication and preventive measures for similar situations in the future.

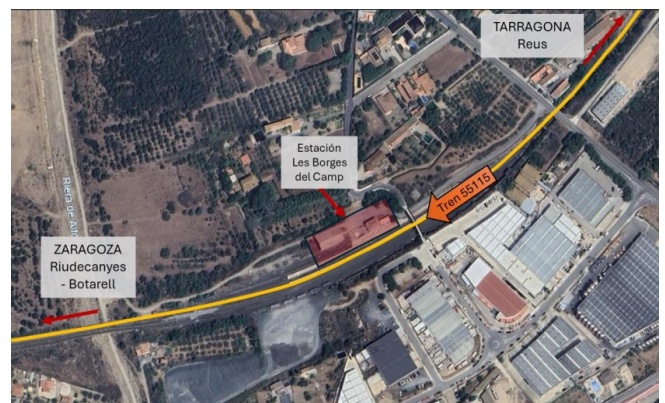
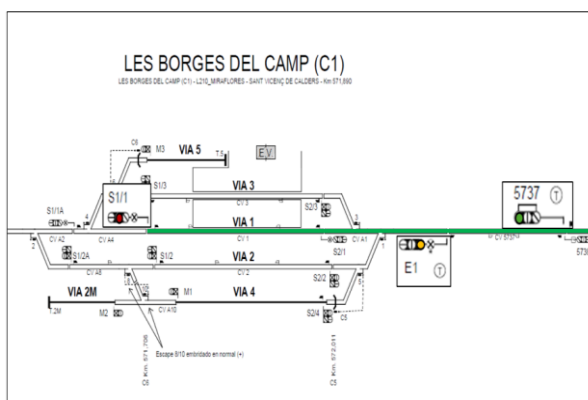
SIGNALING FAILURE IN LES BORGES DEL CAMP (TARRAGONA)

On May 18, at 19:00, RENFE Mercancías train 55115 approached the Borges del Camp station, where it was directed to track 1 and notified that the level crossing at kilometer 567+603 was unprotected. Upon seeing that the signal sequence was incorrect and there was insufficient braking distance between the entry (E1) and exit (S1/1) signals, the driver activated the emergency brake. An investigation confirmed the signals did not match the current Series A Directive.

A February 27, 2023, update that centralized the Reus-Mora Blockages in various stations introduced a software fault that caused incorrect signaling sequences. Fortunately, no injuries or fatalities occurred.

The incident's causal factors were incorrect software assumptions and the failure to verify them. Contributing factors included the lack of necessary testing and poor project boundary definition.

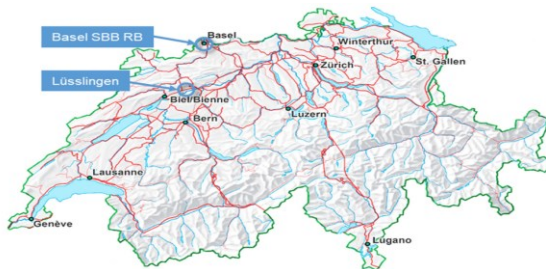
On October 19, at 21:02, a technical inspector at Basel SBB RB marshalling yard discovered liquid dripping and evaporating from the front of a tank wagon filled with hydrochloric acid. While inspecting the leak, the inspector inhaled the fumes and sustained injuries. Emergency services were promptly called to contain the leak, safely removing the hazardous substance from the wagon.

In both cases, the leaking hydrochloric acid posed serious risks, but quick action prevented further harm. The leaks were attributed to failures in the internal protective lining of the wagons, which had not been detected during mandatory inspections by various testing centers.

The tank wagons involved were operated by Ermewa and inspected by several international companies, including Bureau Veritas and Technická Inšpekcia. Despite these inspections, defects in the manufacture of the protective linings went unnoticed, leading to the dangerous leaks.

These incidents highlight the importance of stricter controls and inspections to ensure the safety of hazardous materials transported by rail. While no fatalities occurred, the injuries sustained and potential environmental risks underline the need for improvements in tank wagon safety standards.

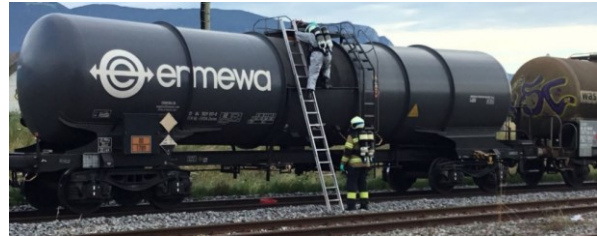
A similar incident occurred on July at 07:36, when a train driver spotted blue steam emitting from a train being shunted from Solothurn to Arch. After stopping the train in Lüsslingen, the driver identified a small leak in the wall of a tank wagon, also filled with hydrochloric acid. Once again, emergency teams managed to contain the situation, removing the acid from the wagon.
