STATE COMMISSION ON RAILWAY ACCIDENT INVESTIGATION
Ministry of Interior and Administration

REPORT No. PKBWK 01/2025

**on the investigation of a serious railway accident occurring on
10 January 2024 at 7:58 AM
on the Rogoźno Wielkopolskie-Budzyń section, track No. 1, km
56.055, of railway line No. 354, Poznań Główny POD-Piła Główna,
level crossing of category D
area of infrastructure operator PKP PLK S.A. Maintenance-of-Way Department in
Poznań**

WARSAW, 3 January 2025

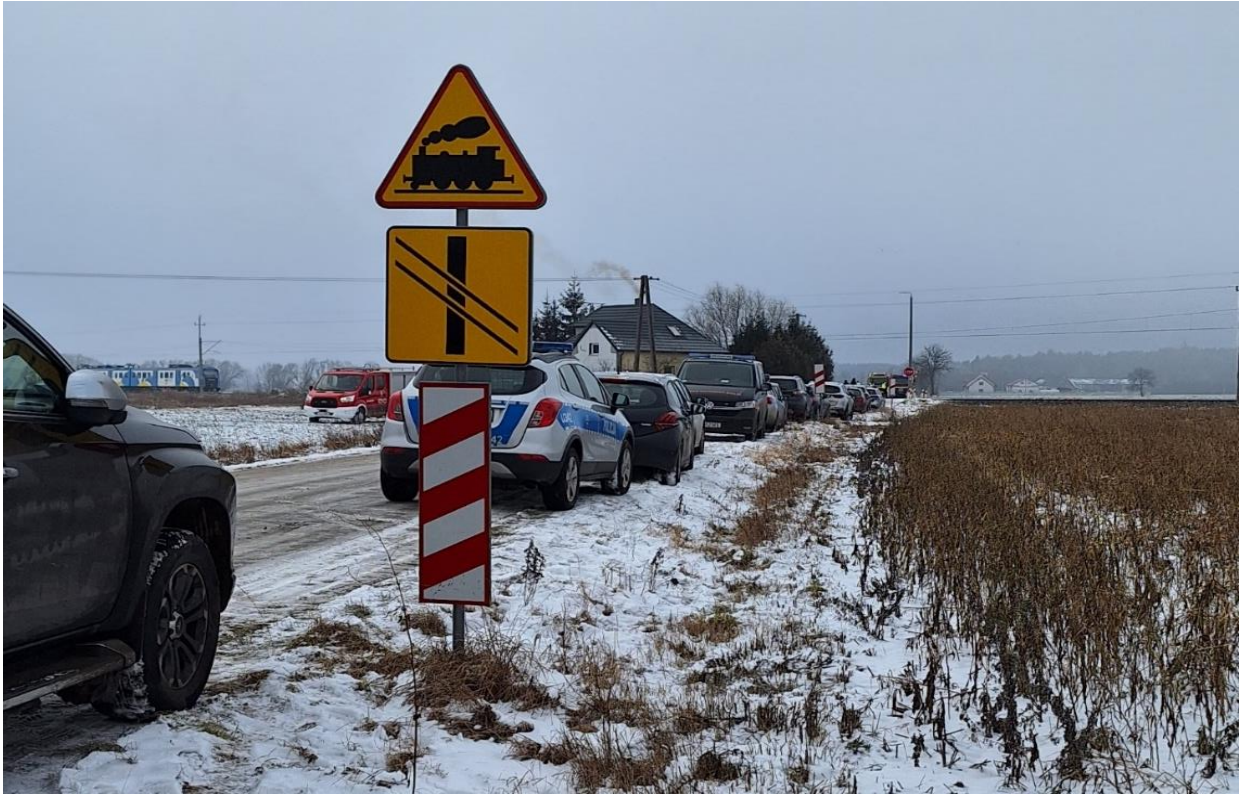
Photo 3 – Marking of the road leading to the crossing (source: PKBWK)

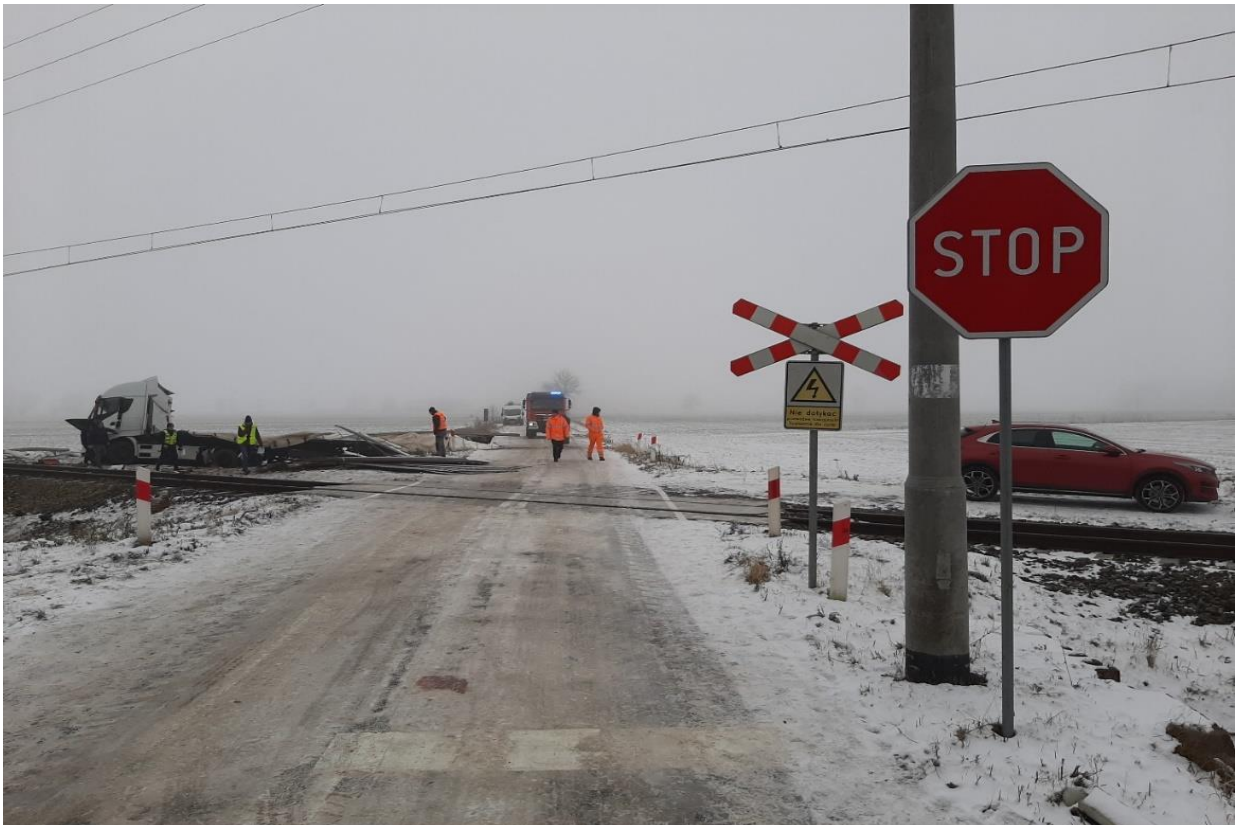
Photo 4 – View of the crossing from the direction of travel of the road vehicle (source: PKBWK)

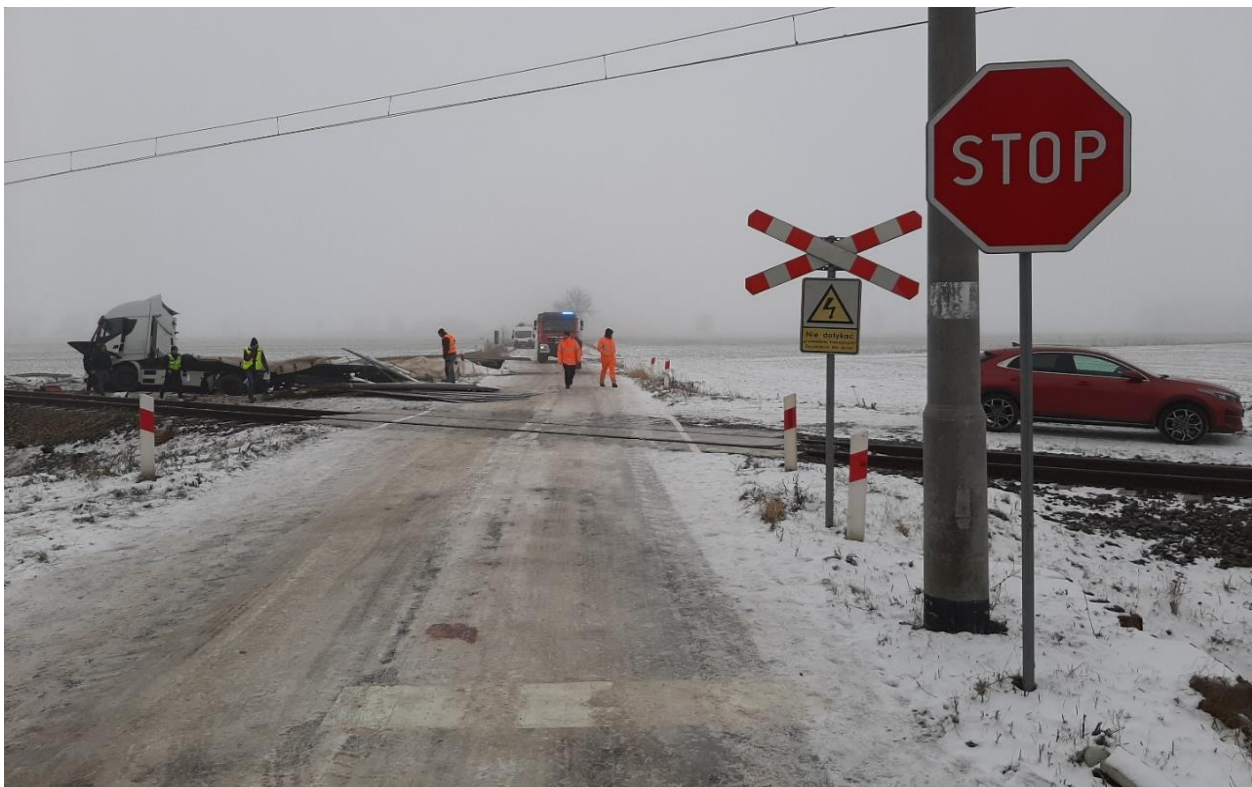
The approach road to the crossing from the direction of the moving road vehicle rises along a distance of 25 m

and has a slope of 2.3%. The angle of intersection between the railway line and the road is 53°.

Photo 5 – View of the crossing from the direction of travel of the road vehicle (source: PKBWK)

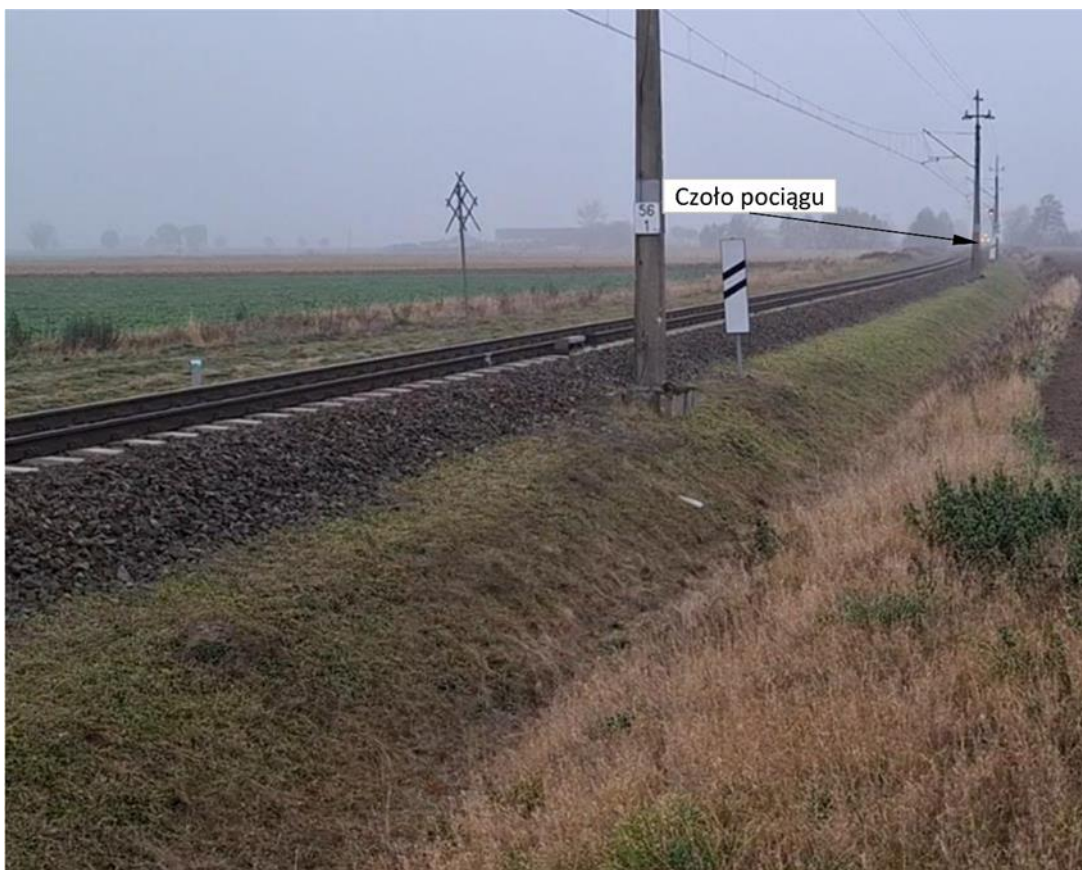
Photo 9 – Visibility of the train front from the pedestrian’s position (source: GDPWK)
