## FINAL REPORT ON ACCIDENT INVESTIGATION

Accident type: Derailment

Train No: 52770

Location: Municipality of Knjaževac,  
open railway line between Svrljig and Knjaževac stations

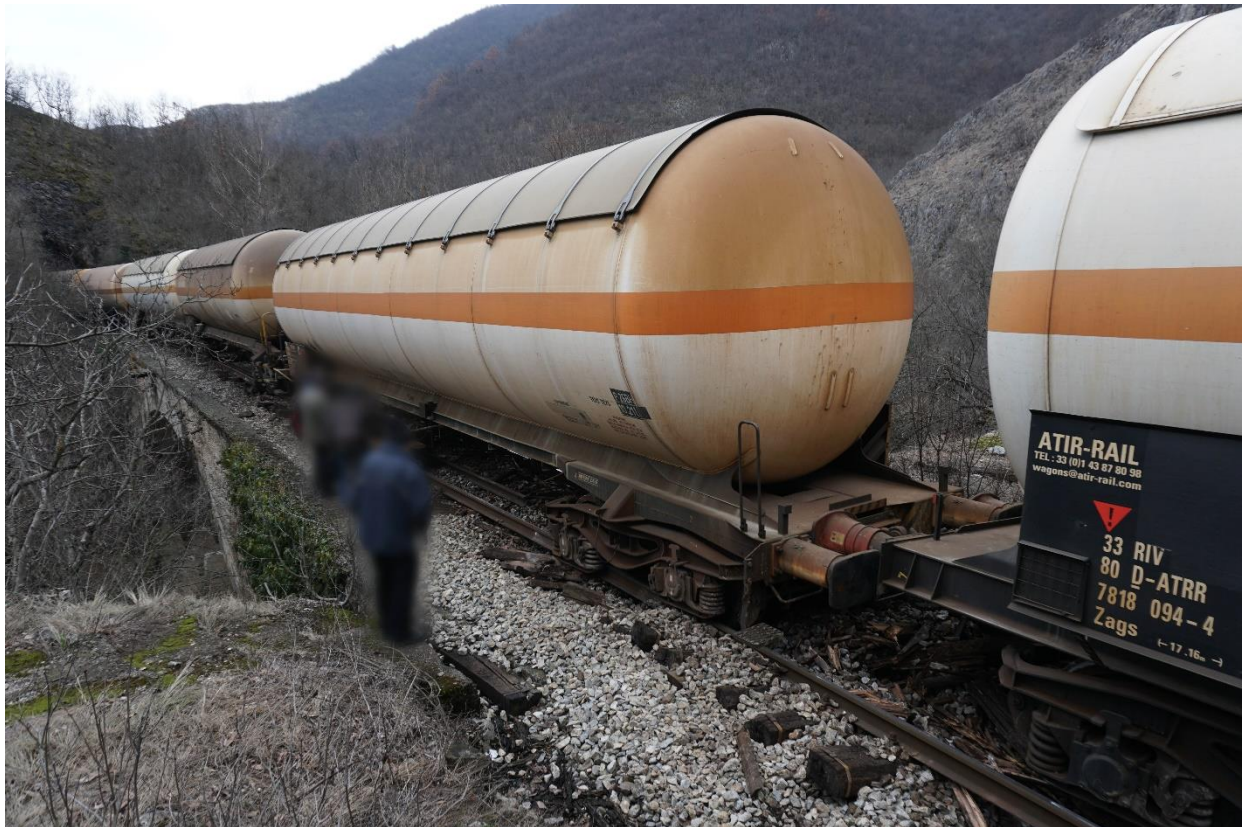
The appearance of the accident site (concrete bridge between the tunnel No. 21 and tunnel No.22) is shown in Fig. No. 2.1.2.1.

**Figure 2.1.2.1:** Appearance of the derailment of the train No. 52770 site

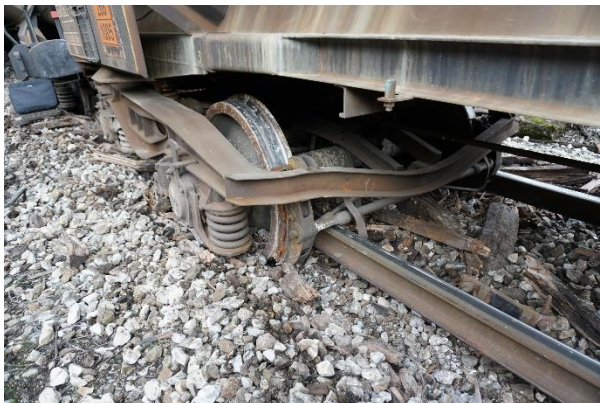
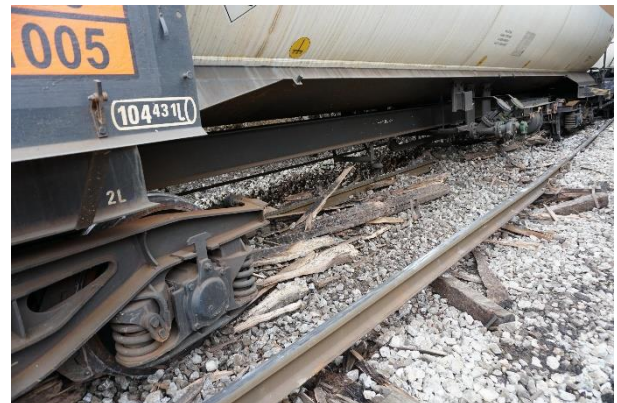
**Figure 3.4.4.1:** Appearance of the parts of derailed wagons

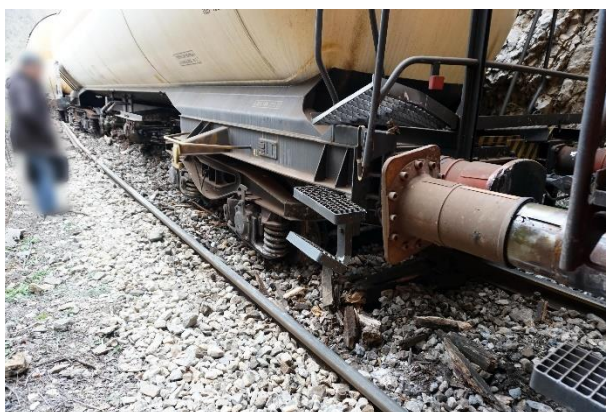
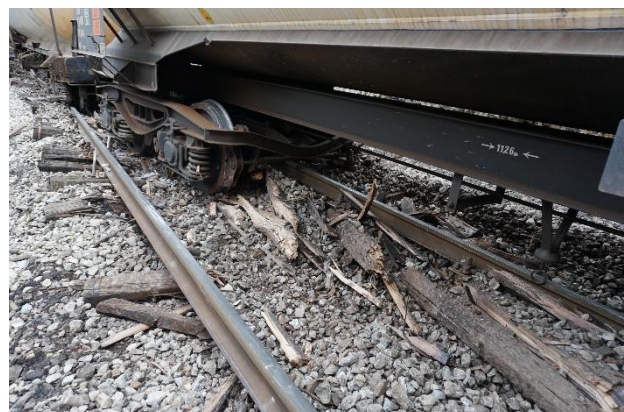
**Figure 3.4.4.2:** Appearance of the parts of derailed wagons

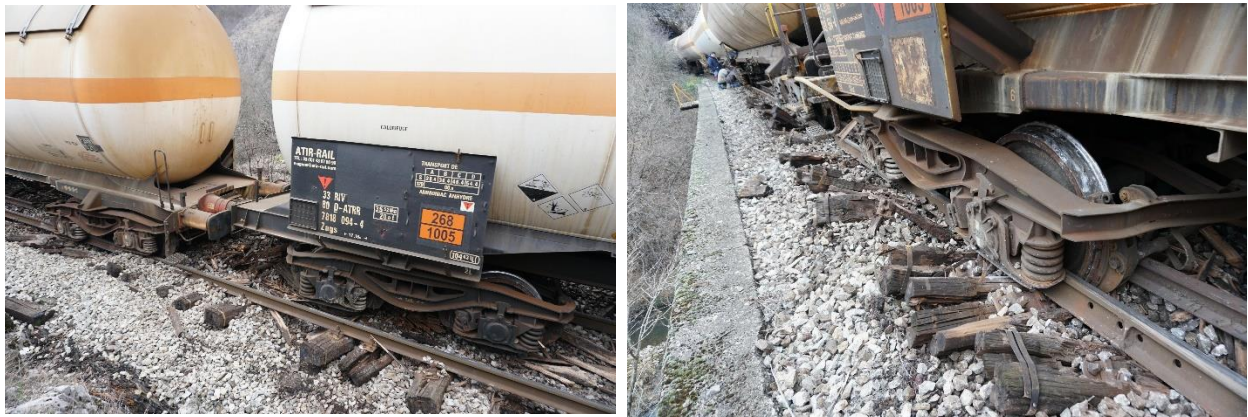
**Figure 3.4.4.3:** Appearance of the parts of derailed wagons

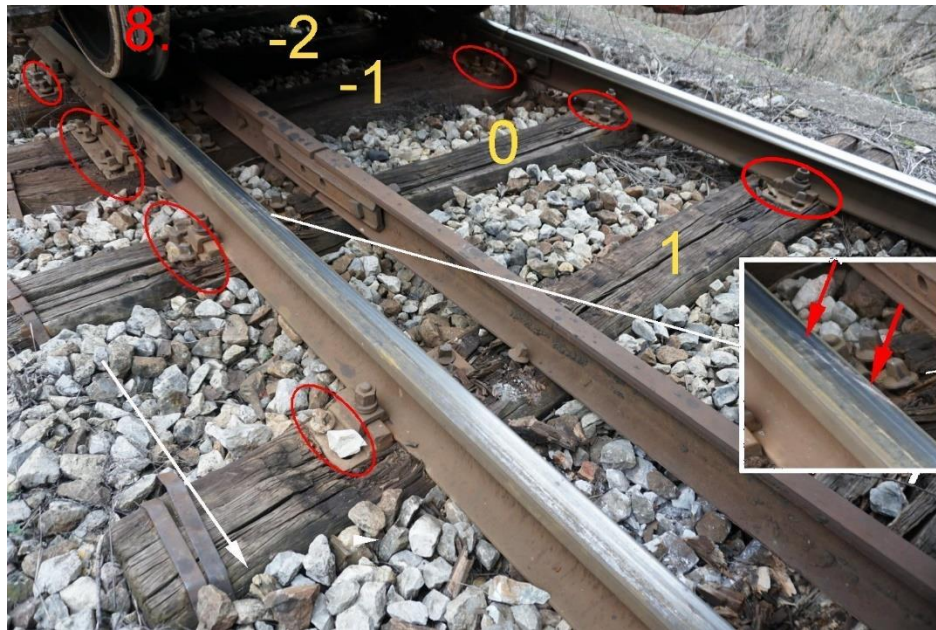
A detailed inspection of the track in the accident zone was carried out to find the first traces of derailment. In Figure 4.2.1.1, the location at km 55+252 is shown, where the first trace of wheel

slippage across the head of the inner rail, in the direction of entry into the track, was observed at rail “0”. This trace is shown in greater detail in the enlarged portion of Figure 4.2.1.1.

**Figure 4.2.1.1:** The first trace of wheel entry into the track and the condition of the sleepers and fastening equipment

The illustration of the condition of the sleepers and fastening equipment in the derailment zone can be seen in Figures 4.2.1.1, 4.2.1.3, and 4.2.1.4. The sleepers have cracked and are rotting in the area of the fastening hardware, both in front and behind sleeper 0. Some fastening hardware is missing, and the screw bolts (tirphons) along the series of sleepers in the derailment zone are loose.

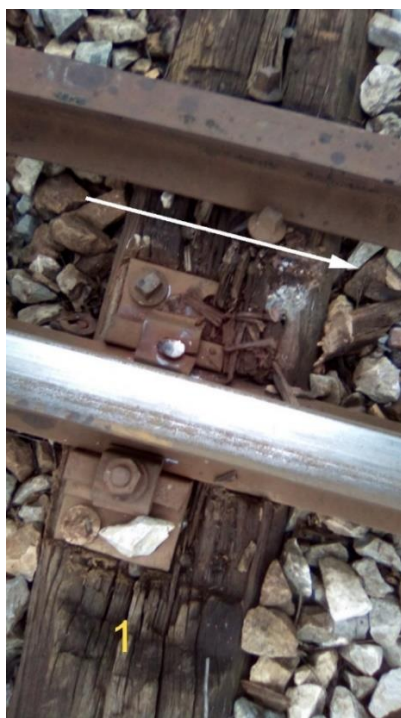
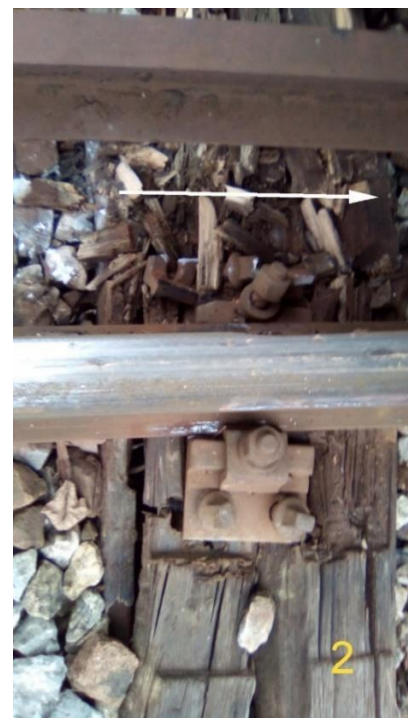
**Figure 4.2.1.2:** First traces of damages from the entered wheel on the inner rail

Figure 4.2.1.2 a) shows the trace on the bolt where the wheel, upon entering the track, detached the nut from the fastening equipment of sleeper 1. Figure 4.2.1.2 b) shows the fastening equipment on the inner side of the inner rail, which was broken and torn out of sleeper 2 by the impact of the derailed wheel. Similar traces can be found on the fastening hardware of the following sleepers.

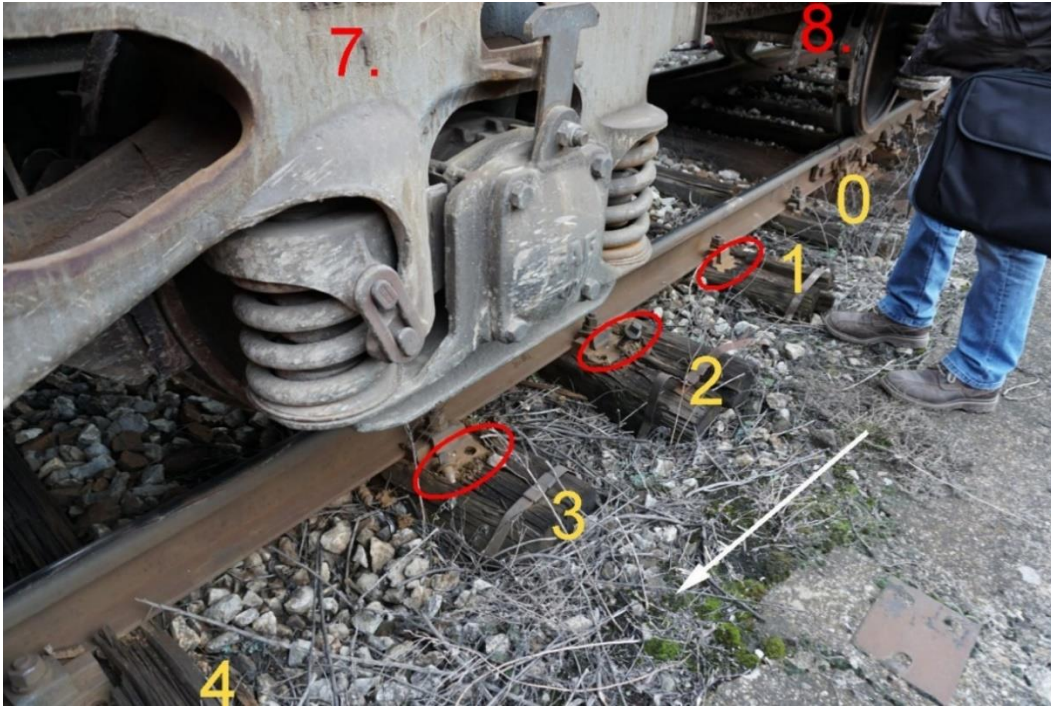
**Figure 4.2.1.3:** Derailed zone from the outside curvature side

On the outer rail, between the zero and third sleeper, there are no signs of the wheel climbing onto the rail. In Figure 4.2.1.3, the first traces of the wheel flange movement on the rail can be seen, starting from sleeper 3, approximately 2.1 meters after the inner wheel entered the track.

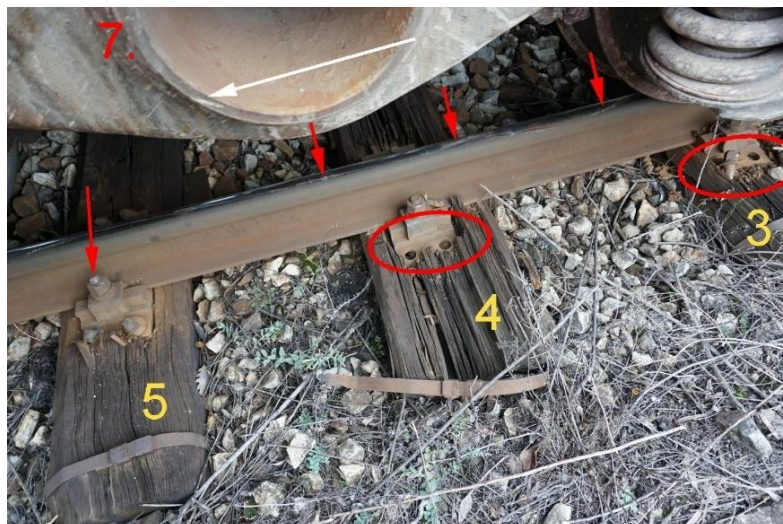
**Figure 4.2.1.4:** Signs of the wheel climbing onto the rail and derailment on the outer side

On the bolt of the fastening equipment, on the outer side of sleeper 5, the first damage from the sliding of the outer wheel is visible.

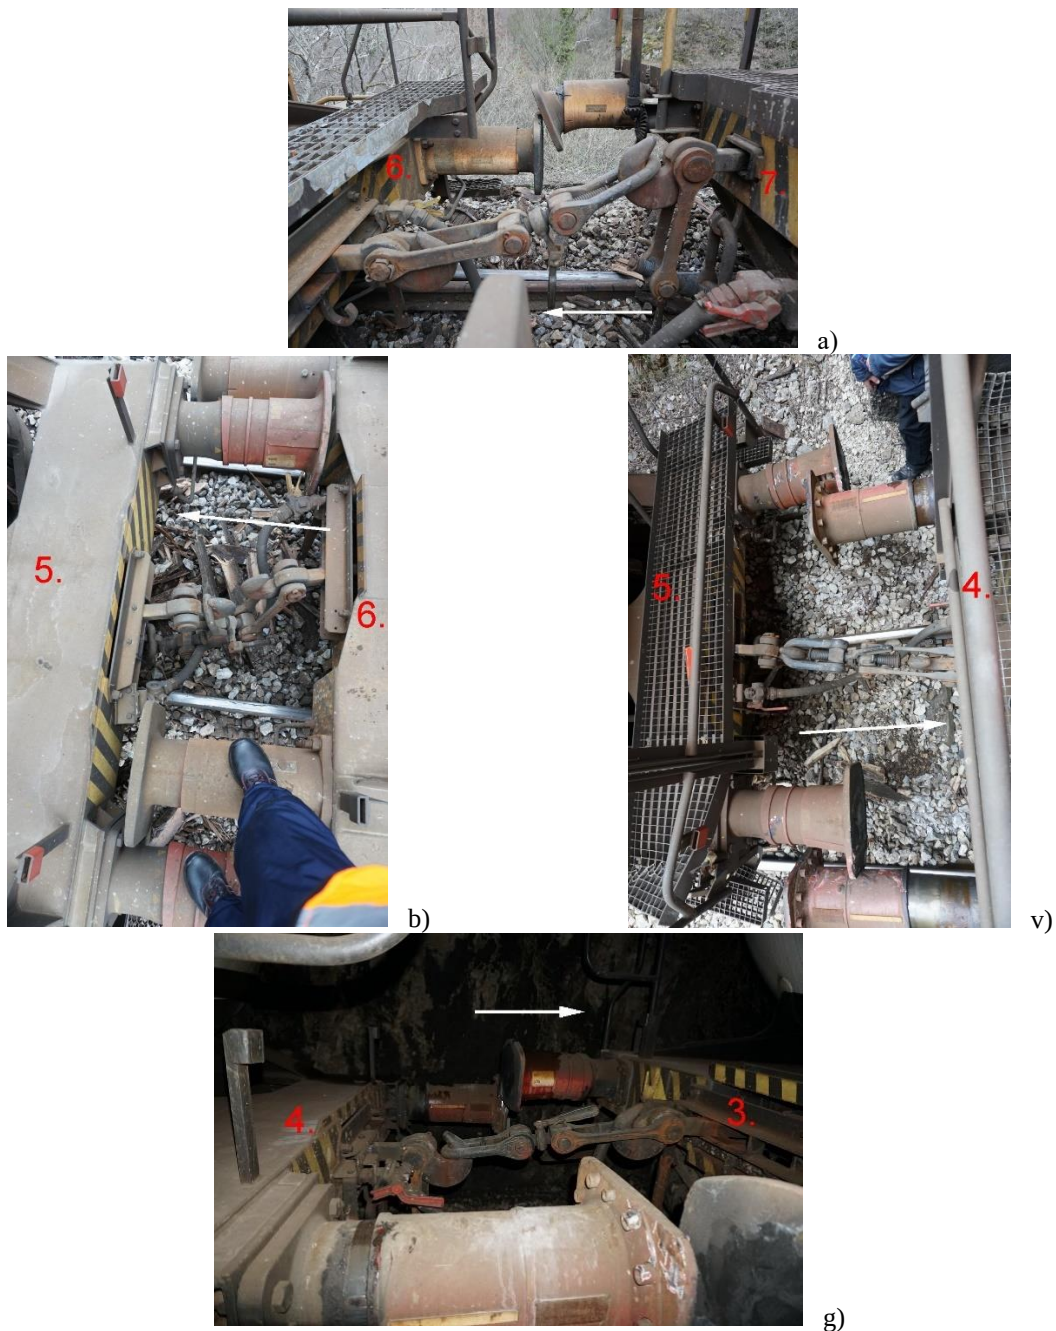
Figure 4.2.1.5 shows the condition of the buffers on the derailed wagons. The deformation of the front right buffer of the seventh wagon (Figure 4.2.1.5.a) indicates that this car hit the sixth car with great force. The relationship of the buffers between the sixth and fifth wagons (Figure 4.2.1.5.b) shows that the sixth wagon overtook the fifth during the accident. Similarly, Figure 4.2.1.5.c shows that the fifth wagon overtook the fourth wagon. Figure 4.2.1.5.d shows that the front left buffer of the fourth wagon was pushed under the buffer of the third wagon.

**Figure 4.2.1.5.:** Relationship of the buffers of the derailed wagons

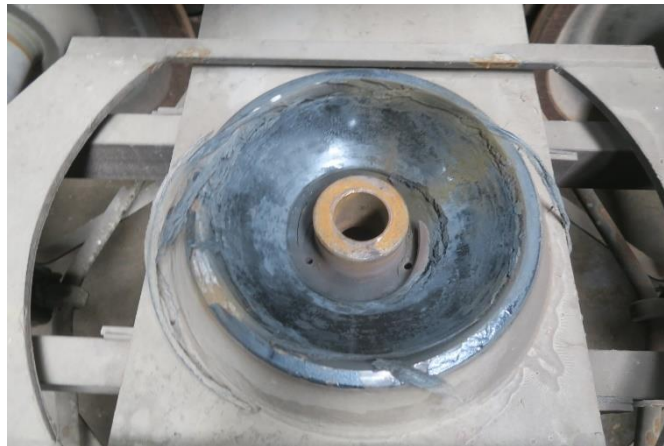
Upon inspection of the center bowls and side bearers, it was found that on the bogie at housings 7 and 8 of wagon No.33 87 7814 136-0, there were cracked and partially broken sections at the upper and lower ends of the bogie bowl insert. No signs of friction between metal parts were observed on either the upper or lower bogie bowls (see images 4.2.6.1 and 4.2.6.2.), which means that the insert was still functional and could not have influenced the accident. At the time of the accident, the car was within the last month before its next scheduled overhaul.

**Figure 4.2.6.1:** The condition of the lower center bowl on wagon No. 33 87 7814 136-0 at housings 7 and 8

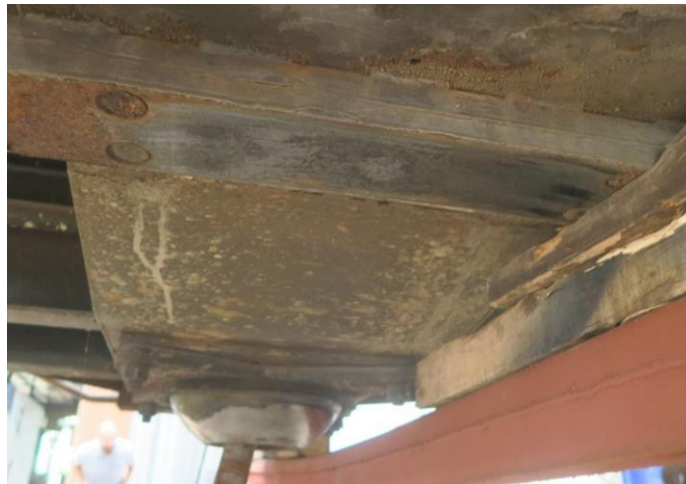
**Figure 4.2.6.2:** The condition of the upper center bowl and side bearers on wagon No. 33 87 7814 136-0 at housing 7 and 8

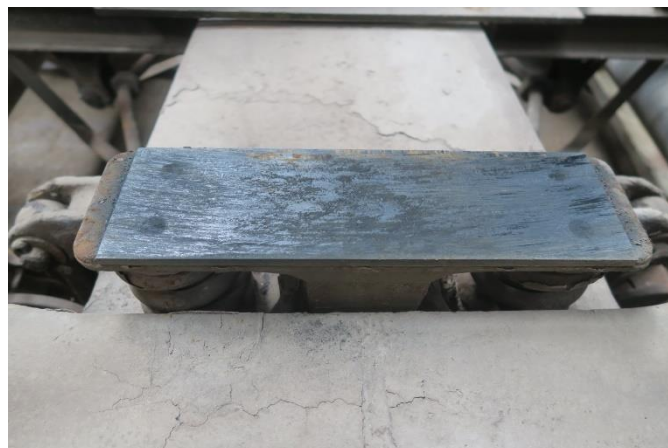
**Figure 4.2.6.3:** Lower side bearers of the wagon No. 33 87 7814 136-0 at housing 7

All inspected inserts of the lower side bearers were found to be within the permissible wear limits (example shown in image 4.2.6.3.). There were no signs of wear or defects on the upper or lower side bearers that could have had an impact on the accident or its consequences.

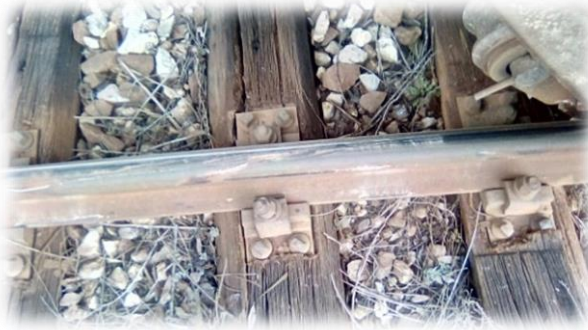
**Figure 4.2.8.5:** Appearance of the pockets of rotten sleepers

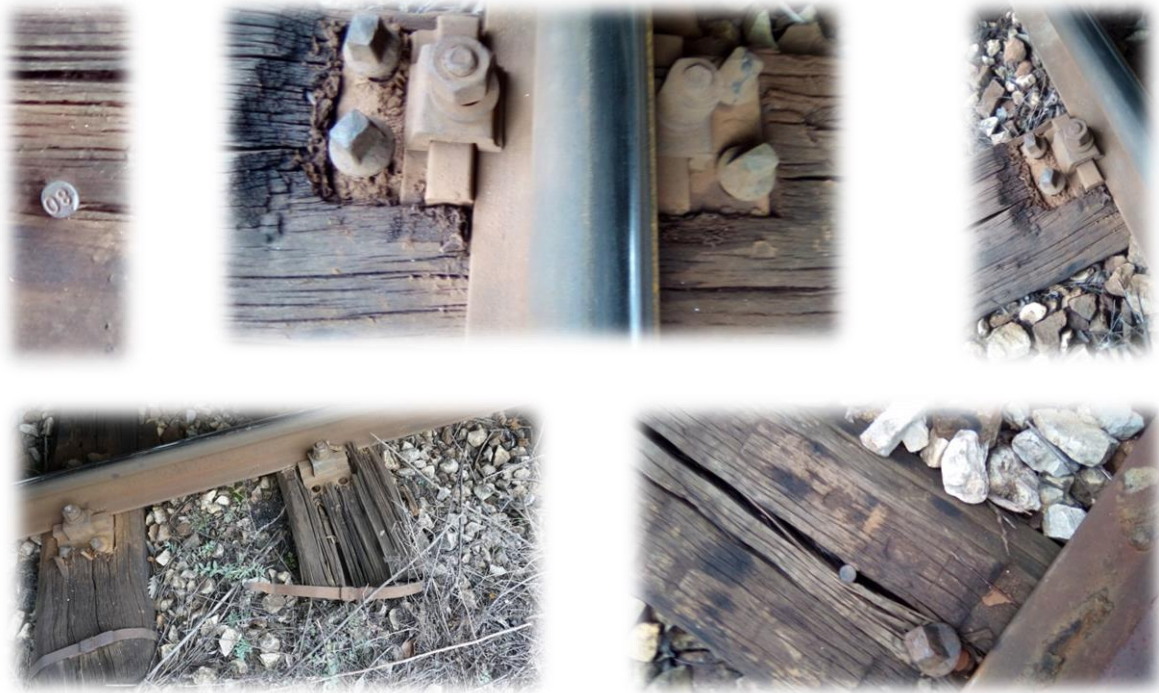
The condition of the sleepers and fastening devices in the derailment zone is illustrated in images 4.2.10.3, 4.2.10.4, 4.2.10.5, and 4.2.10.6.

**Figure 4.2.10.3:** Local decay beneath the rail support and longitudinal cracks in the sleeper.

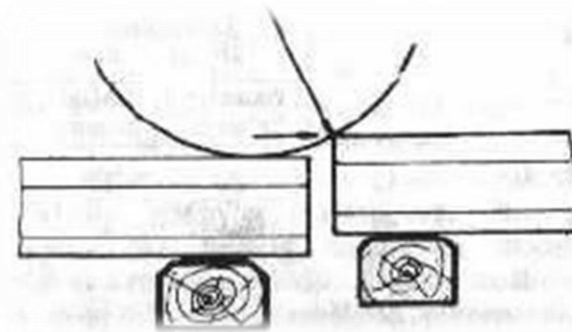
**Figure 4.2.10.6:** Influence of the wheel on the rail joint
