STATE COMMISSION ON RAILWAY ACCIDENT INVESTIGATION
Ministry of Interior and Administration

REPORT No. PKBWK 01/2025

**on the investigation of a serious railway accident occurring on
10 January 2024 at 7:58 AM
on the Rogoźno Wielkopolskie-Budzyń section, track No. 1, km
56.055, of railway line No. 354, Poznań Główny POD-Piła Główna,
level crossing of category D
area of infrastructure operator PKP PLK S.A. Maintenance-of-Way Department in
Poznań**

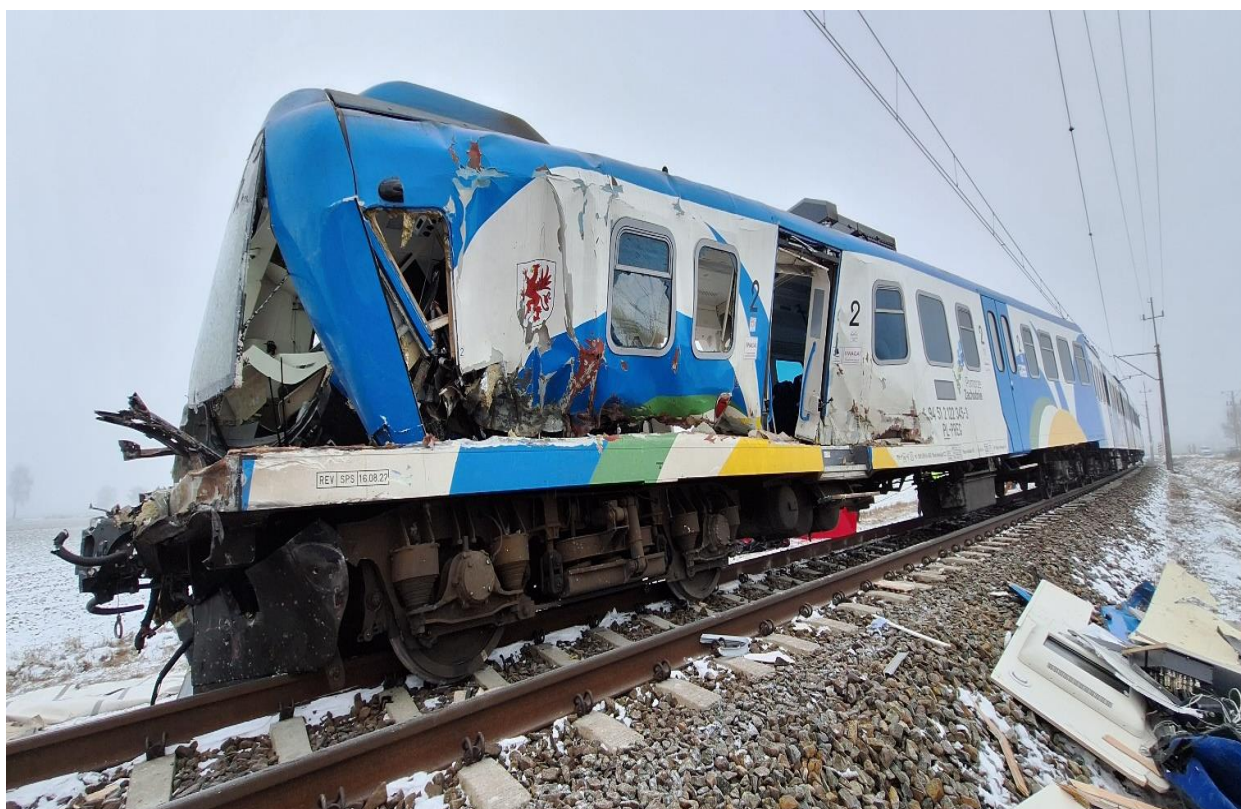
Photo 1 – Consequences of the occurrence for the railway vehicle (source: PKBWK)

The train consisted of the EN57AL-1527 electric multiple unit whose carriage B was damaged and derailed (photos 1 and 2).

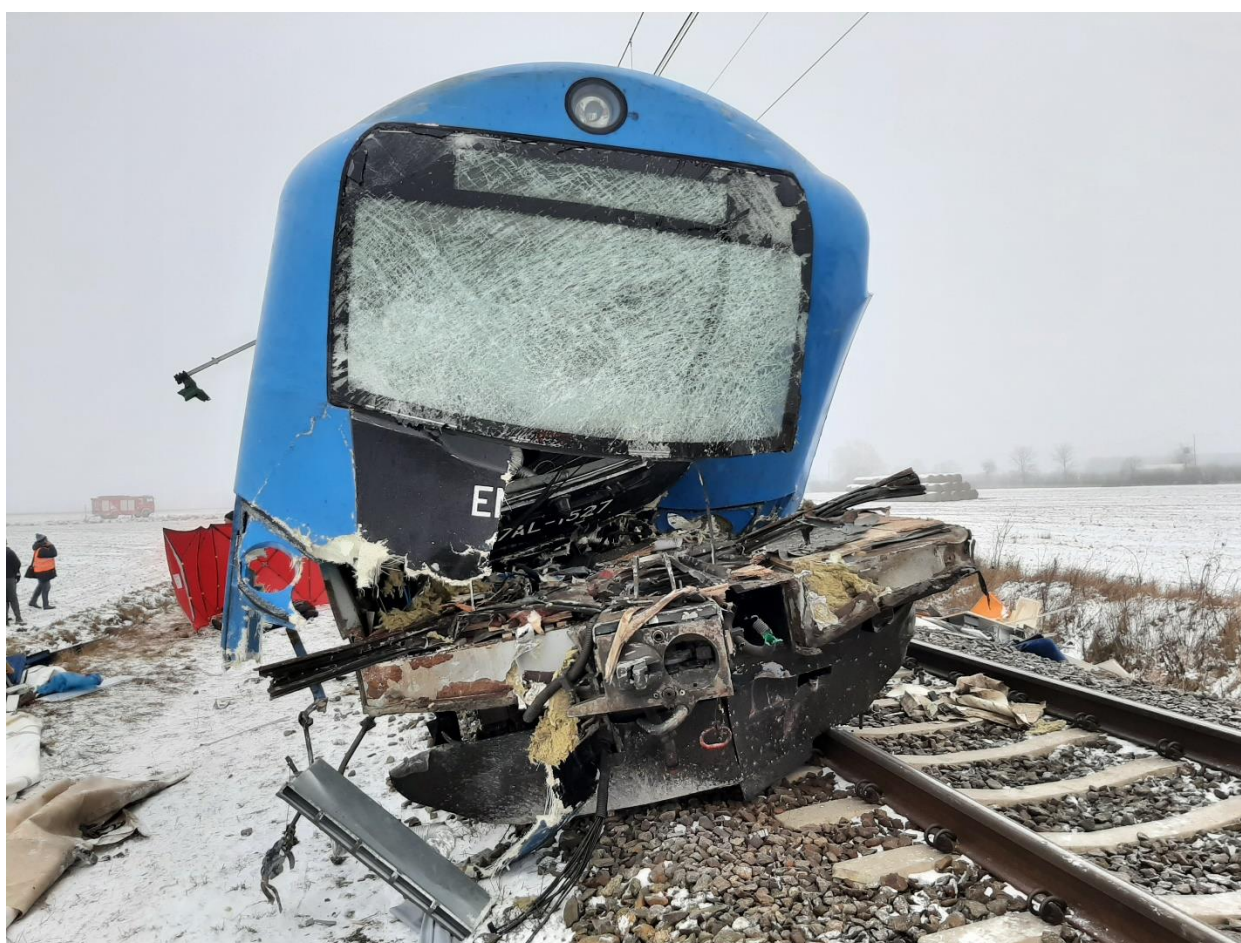
Photo 2 – Consequences of the occurrence for the railway vehicle (source: PKBWK)

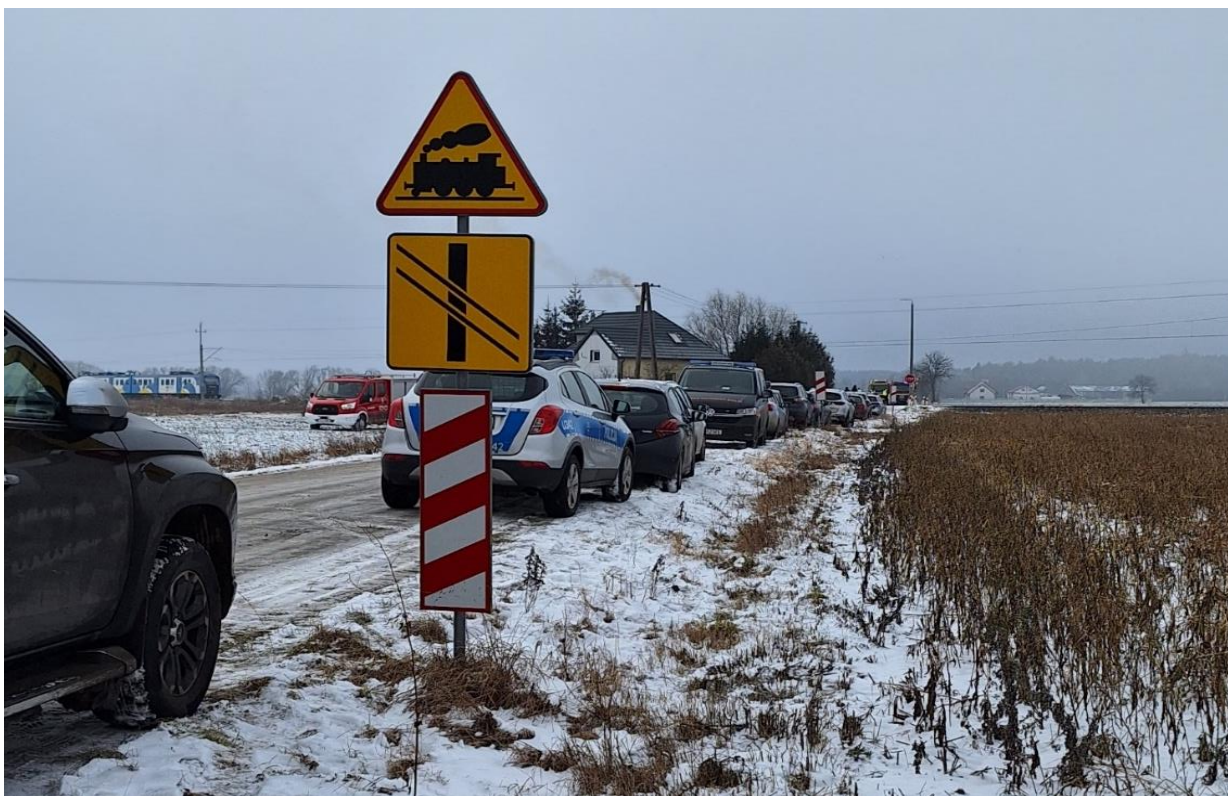
Photo 3 – Marking of the road leading to the crossing (source: PKBWK)

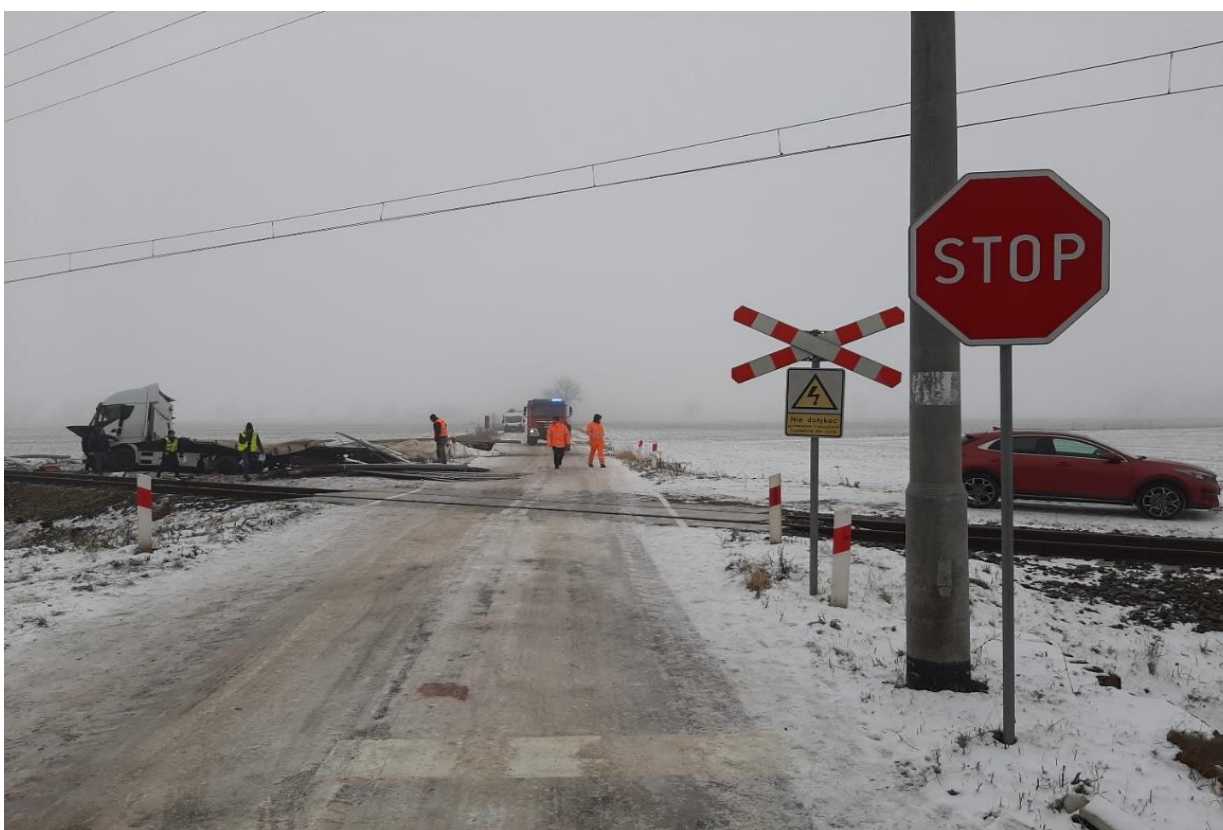
Photo 4 – View of the crossing from the direction of travel of the road vehicle (source: PKBWK)

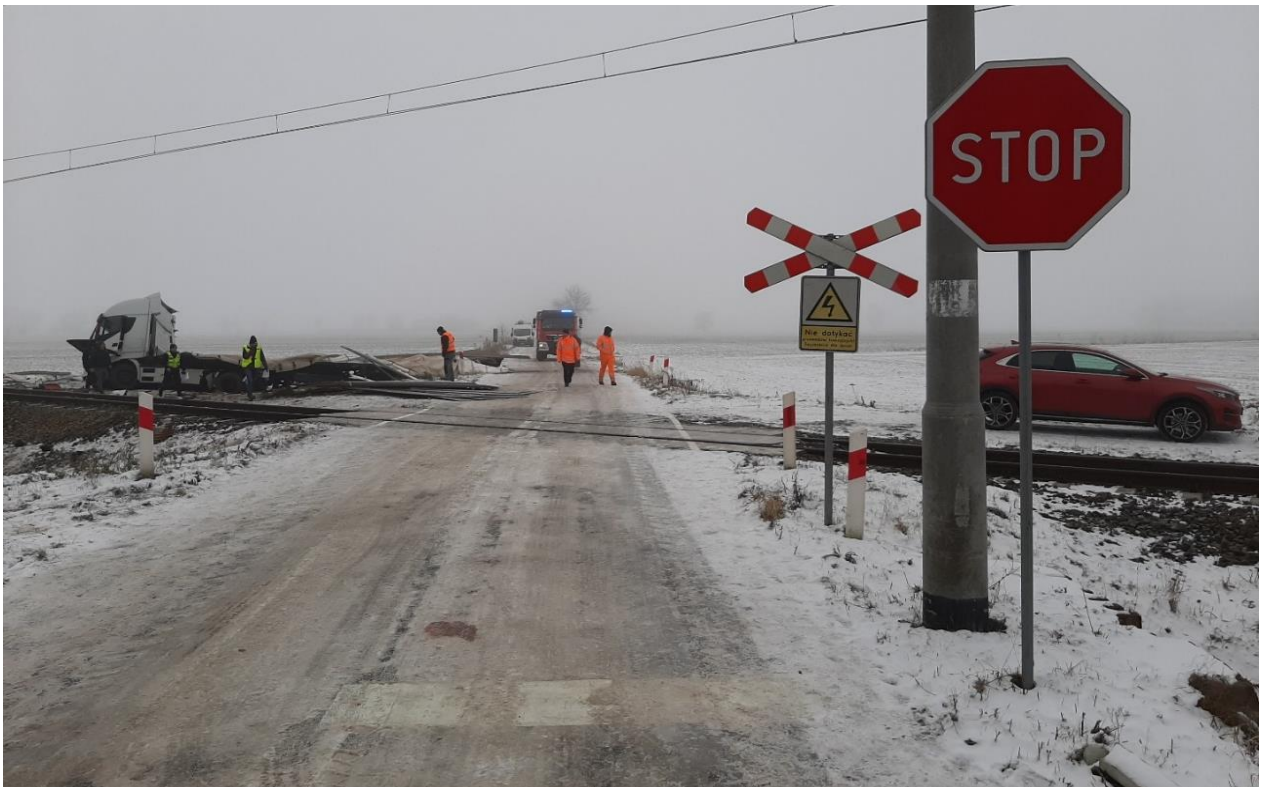
The approach road to the crossing from the direction of the moving road vehicle rises along a distance of 25 m

and has a slope of 2.3%. The angle of intersection between the railway line and the road is 53°.

Photo 5 – View of the crossing from the direction of travel of the road vehicle (source: PKBWK)

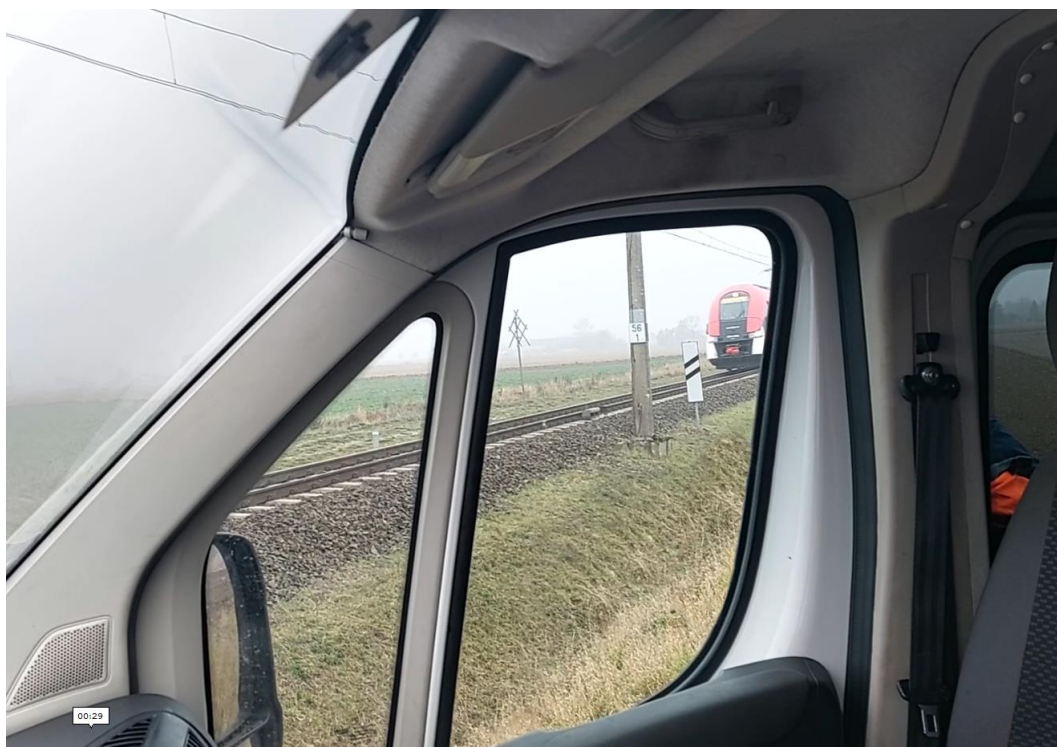
In the vehicle types used for the check, visibility through the windscreen and side windows was limited due to their design. Therefore, there is a need to amend the provisions defining the rules for measuring the visibility of the front of the train from the road. The amendments should take into account the constraints of road vehicle design.

Photo 6 – View from the driver's position in the Citroen Jumper car (source GDPWK).

In light of the foregoing, the Investigation Team recommends that the Minister of Infrastructure analyse the *Regulation of the Minister of Infrastructure and Development of 20 October 2015 on the technical conditions to be met by crossings of railway lines and sidings with roads, and on their positioning* (Journal of Laws of 2015, item 1744, as amended) to determine if it is necessary to add specific requirements to check the visibility of the train front from the road and account for conditions similar to those experienced by road users (e.g., drivers of various road vehicles).

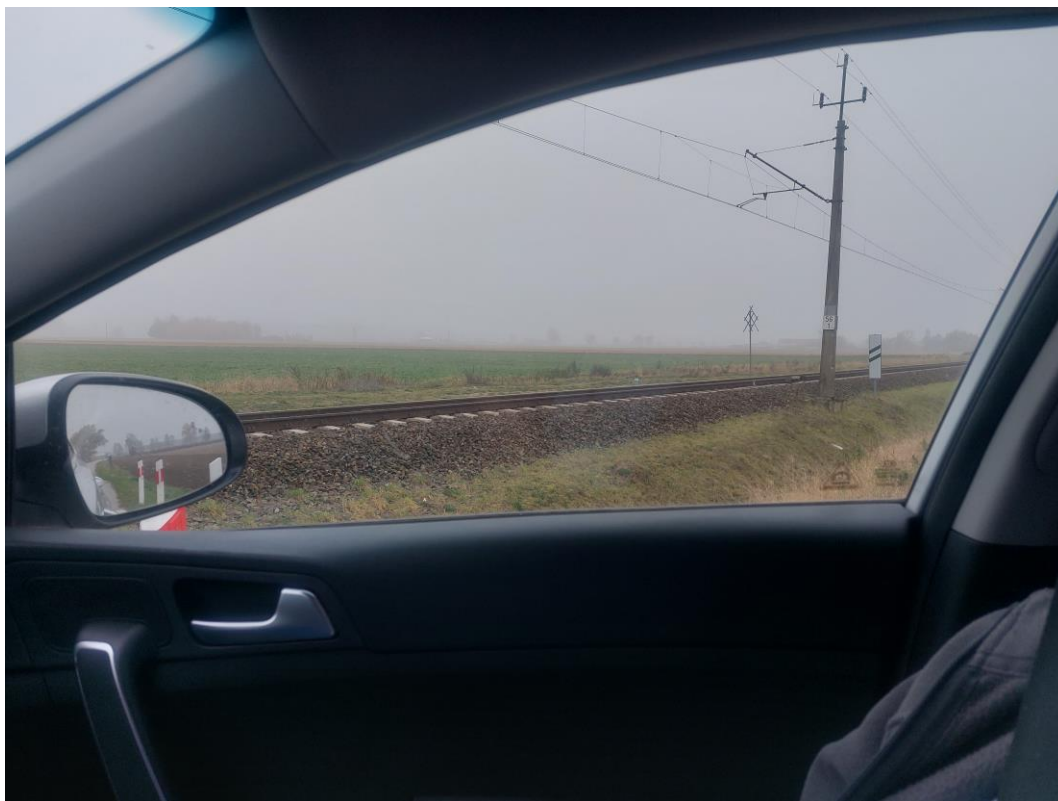
Photo 7 – View from the KIA Sportage car (source GDPWK)

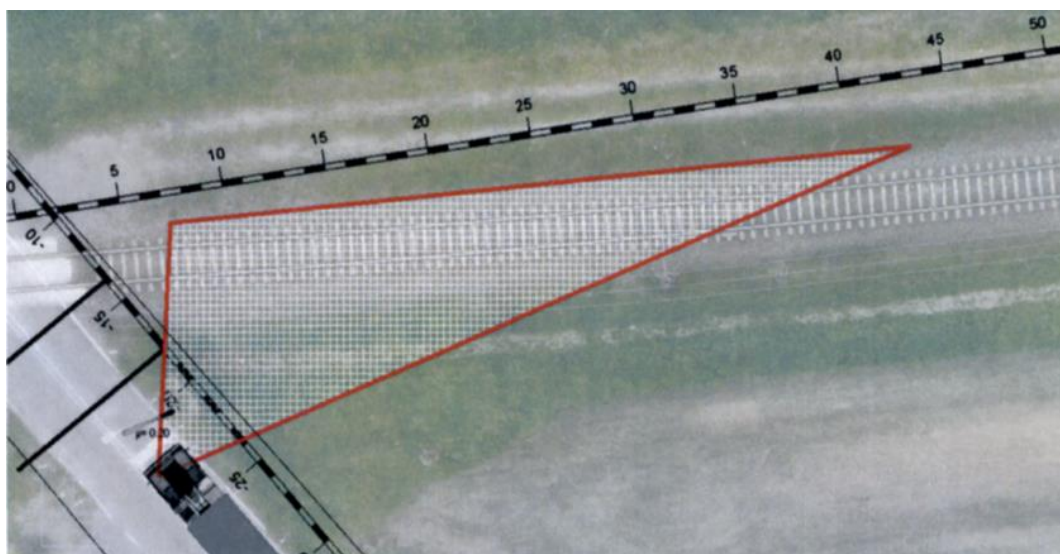
Photo 8 – Determined field of view from the position of the truck driver (source: Opinion of a forensic expert)

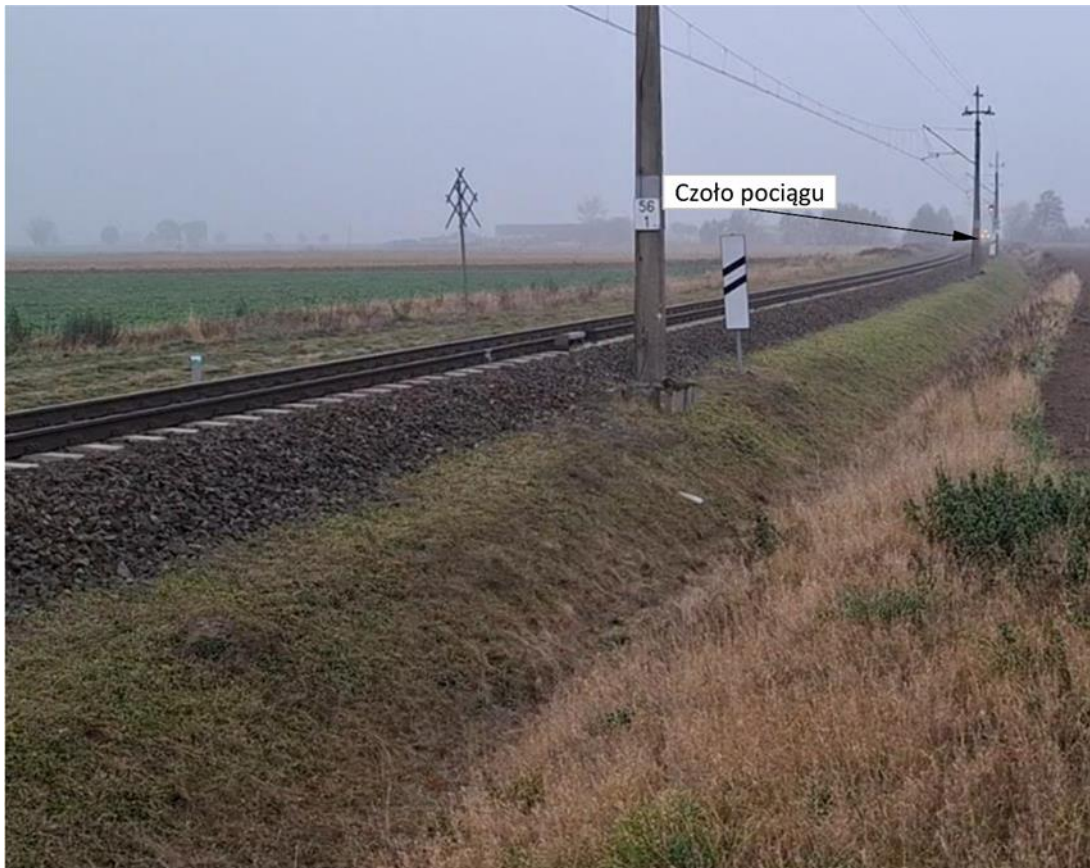
Photo 9 – Visibility of the train front from the pedestrian’s position (source: GDPWK)
