REPUBLIKA SLOVENIJA  
MINISTRSTVO ZA INFRASTRUKTURO IN PROSTOR

SLUŽBA ZA PREISKOVANJE NESREČ

# ANNUAL REPORT BY THE NATIONAL INVESTIGATING BODY OF THE REPUBLIC OF SLOVENIA IN RAILWAY TRANSPORT 2011

Ljubljana, 10 August 2012

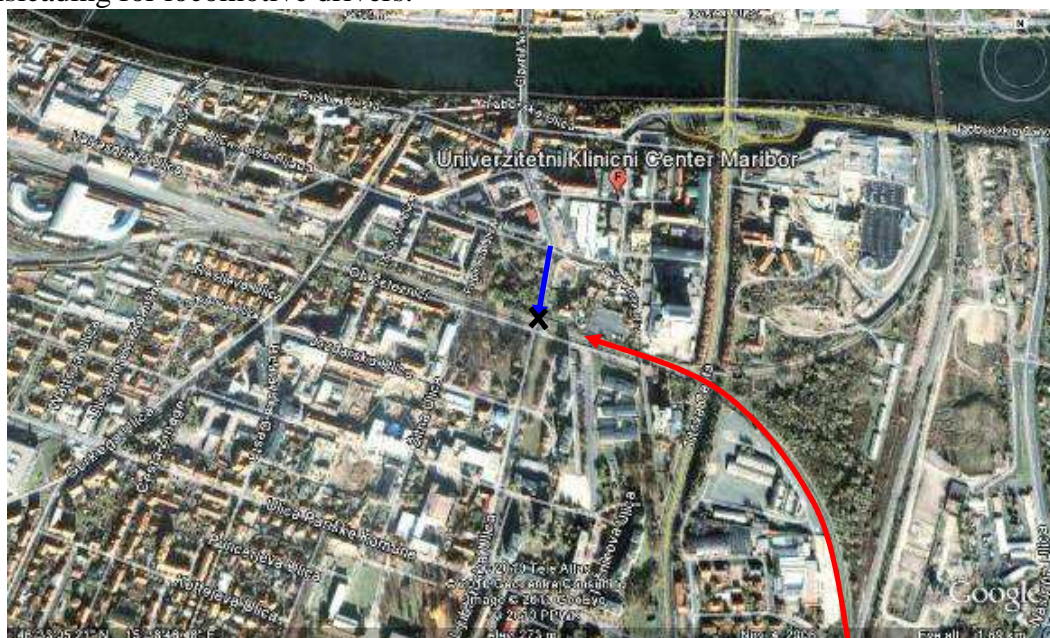
The direct cause of the accident was a malfunction in a brake on the locomotive train, which resulted in inadequate braking performance, and the locomotive driver of the train involved in the accident not being able to control his speed between the PS-C pre-entry signal and the US-C entry signal at Maribor Studenci station, and to stop in a safe and timely manner in front of the US-C entry signal at Maribor Studenci station, which was displaying signal 1: “Stop”.

The indirect cause of the accident was the marking of the US-C entry signal indicating the distance of the railway line between the PS-C pre-entry signal and the US-C entry signal at Maribor Studenci station that measures 668 m and the prescribed distance is 700 m with a permitted reduction of 5%. The PS-C pre-entry signal at Maribor Studenci station is not properly marked with signal 25 as prescribed: “Pre-signal marking” located at a distance that is up to 5% shorter than the braking distance, which is misleading for locomotive drivers.

Figure: The red arrow shows the direction of the train while the blue arrow shows the direction of the passenger vehicle, and the black cross the site of collision

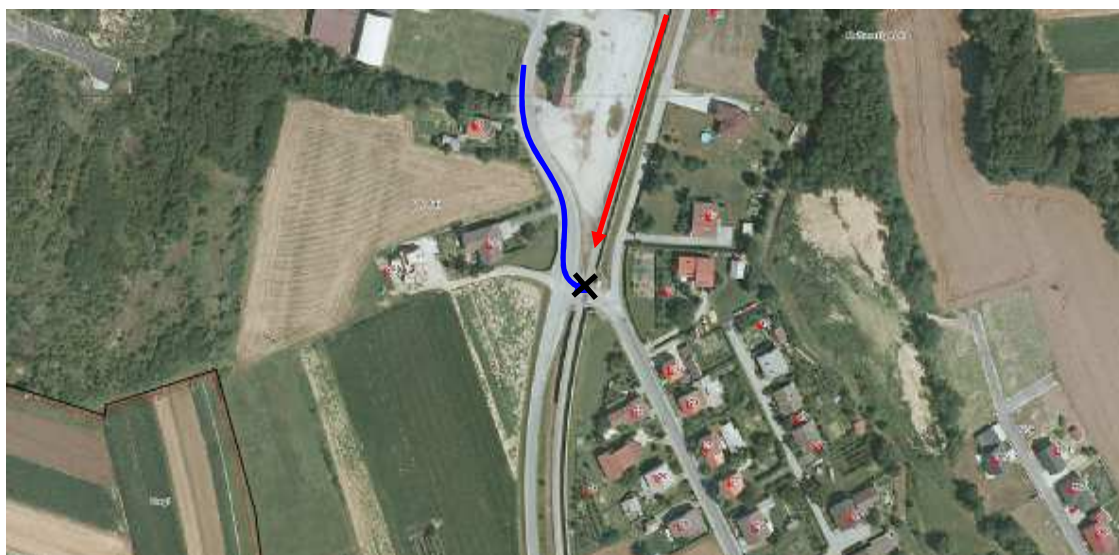
Pursuant to the protocol of the post-mortem examination of the deceased driver performed by the Pathology Department of Murska Sobota Hospital, the direct cause of the accident may have been cardiac arrest, since morphological and pathological modifications of the myocardium were detected.

If the driver did not experience cardiac arrest, the indirect cause of the accident could be assigned to unsuitable protection of the level crossing; since the level crossing is located within the area of the junction, and the noise barriers significantly diminish visibility at the level crossing, the ensuing traffic conditions require drivers to process a great amount of information within a very short period of time, which implies that the level crossing should be protected with four half-barriers closing all the lanes. It is also possible that the driver made an incorrect assessment of the given traffic situation. Perhaps he decided to drive over the level crossing because he was paying attention to the road traffic and was therefore unable to register the signalling devices at the level crossing in a split second. When driving on the opposite lane, he decided to cross the railway line, because he was not stopped by the half-barrier.

Figure: The red arrow shows the direction of the train while the blue arrow shows the direction of the passenger vehicle, and the black cross the site of collision

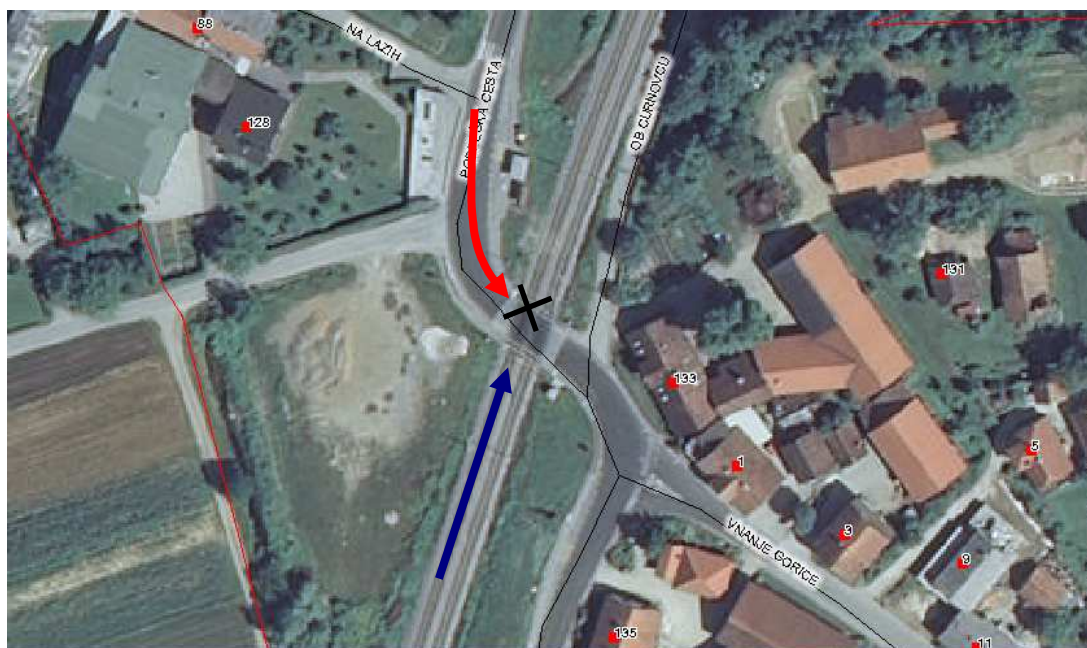
Figure: The blue arrow indicates the travelling direction of the train while the red arrow shows the freight vehicle and the black cross the site of the collision

The direct cause of the accident was the driver's tempting of fate when he circumvented the lowered half-barrier and drove onto the right-hand side track where regional passenger train no. 2615 was driving at that very moment.

The indirect cause of the accident can be attributed to the method of protection at the level crossing, since it allows road users to circumvent the lowered half-barriers and thus drive onto the tracks. Special attention should be paid to level crossings in urban areas.

Since lowered half-barriers are often circumvented at level crossings where the lowered half-barrier protects only half of the road, i.e. the lane in the travelling direction of a road vehicle and not the opposite lane, a gradual modification of protection at this type of level crossings with half-barriers for both lanes from both directions or barriers extending over the entire width of the road is recommended.
