Federal Public Service for
Mobility and Transport

Railway accident and incident investigation unit

Annual report 2009

Belgium

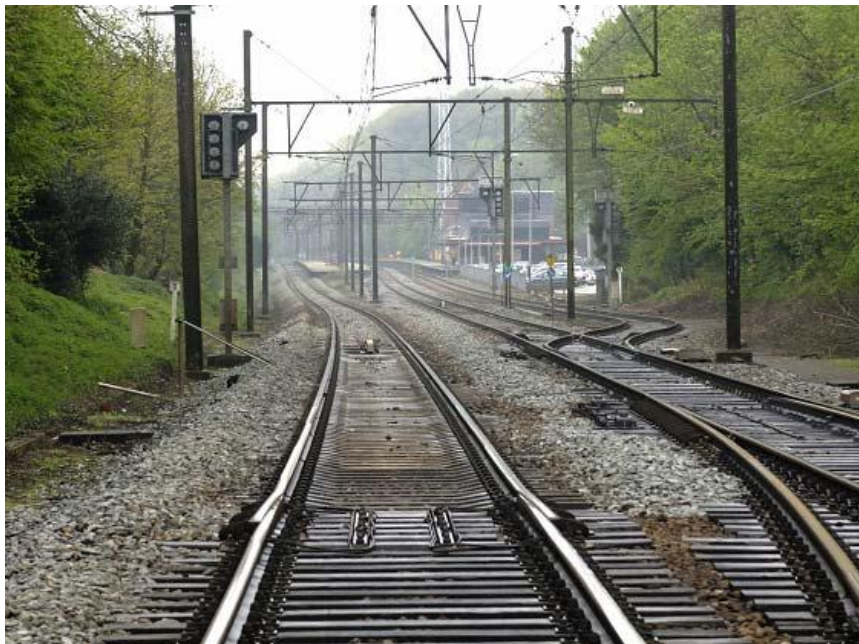
5.1 LA HULPE

At 9.21 a.m. on 29 November 2007, train 4629 (Luxembourg – Brussels-Midi), travelling on the normal track, struck two men working on a maintenance site organised on the tracks in service by the infrastructure managing entity, Infrabel, using personnel from an outside contractor, the Vossloh Company.

The accident occurred at the overall distance marker 20.385 located at La Hulpe station on line 161 (Brussels – Namur).

A member of the infrastructure managing entity's staff and a Vossloh Company employee were killed instantly.

The cause of the accident is the incorrect and casual application of the regulations covering safety of work sites on tracks:

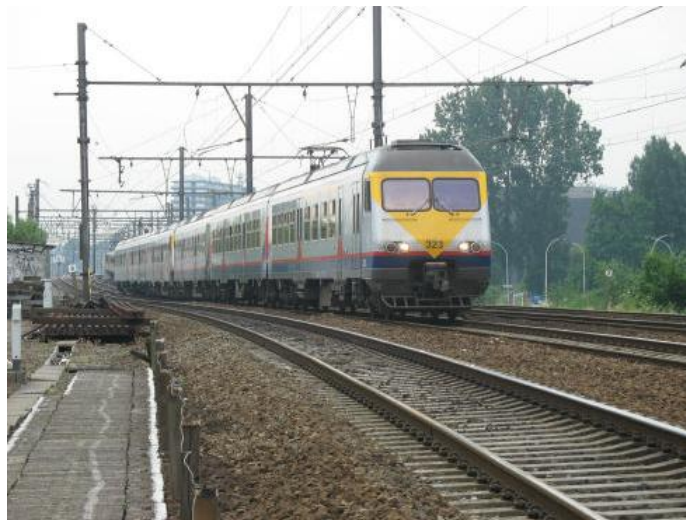
5.2 BERCHEM MORTSEL

On Friday 14 December 2007, at 8.12 p.m., train E2890, providing the interregional link between Leuven and Antwerp, struck a person on track A, not far from the station entrance (distance mark 42.800 on line 27).

At about the same time, the attendant on train E2640, running on the same line between Antwerp and Leuven, noticed that a passenger had used the emergency control system just after leaving Berchem, to open the door leading onto the track and alight from the moving train.

This action freed the door and it opened immediately. The victim was not prevented in any material way from jumping off the train after it had left the station. At that time, the train was travelling at a speed of between 30 and 50 kph.

The circumstances leading to the victim's presence between the tracks are not very clear. Very shortly afterwards, the victim was struck by a train travelling in the other direction and was killed instantly.

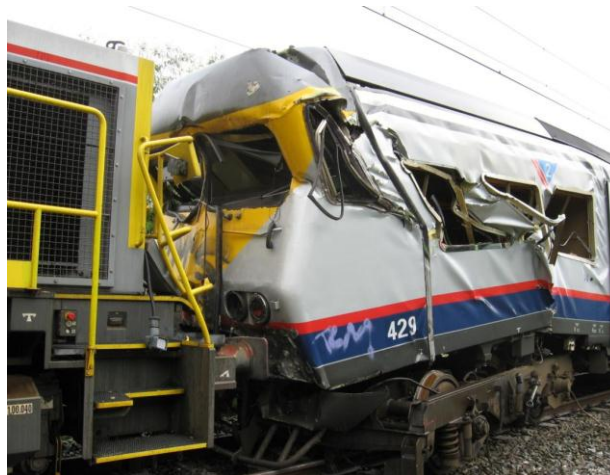
5.3 HERMALLE-SOUS-HUY

At 6.48 a.m. on Thursday 3 July 2008, on line 125 (Namur- Liege), passenger train E2405 was involved in a head-on collision with goods train Z74070 at distance marker 19.215, located in the municipality of Hermalle s/Huy.

Goods train Z74070 was stationary on track A, from Liege to Namur, at signal C10, which was red. The route taking that train to the private Dumont – Wauthier branch line (sets of points 1A and 1B, track B in the 'wrong' direction, set of points 2A) was set up in the Flemalle signal box at about 6.45 a.m. after the permanent route to Hermalle had been deleted. Passenger train E2405 was running on track B towards Liege. Surprised to see signal E10 set to red (to protect the route to the branch line for the goods train), the train driver triggered emergency braking. He was unable to avoid going through the signal, forcing the points 2A open and coming into a head-on collision with the goods train on track A.

However, analysis of the speed recorder for the passenger train, shows that signal K10, which preceded signal E10 set to red, did not display a double yellow light, as could have been expected.

This finding can be accounted for by a voltage drop that occurred in the electric power supply for the signalling system just before the passenger train reached signal K10, or as it was passing the signal. The voltage drop at that time has been confirmed by TECTEO.

The collision is thus a direct consequence of the fact that the driver of the passenger train failed to brake as the train approached signal K10.

The accident was made inevitable by the absence of technical equipment to control train operation and automatically trigger emergency braking if a train goes past a signal that requires it to stop or has gone out.

One of the recommendations thus concerns the urgent necessity of implementing an automatic train operation control system and the necessity of executing the current programme on a continuous basis.

A final recommendation stems from the finding that during the switchover, the backup power supply showed the same shortcomings as the normal power supply. It would hence be advisable to check the quality of the backup power supply before making any such switchover during a voltage drop, and cut off all electric power supplies if the backup quality is not satisfactory.

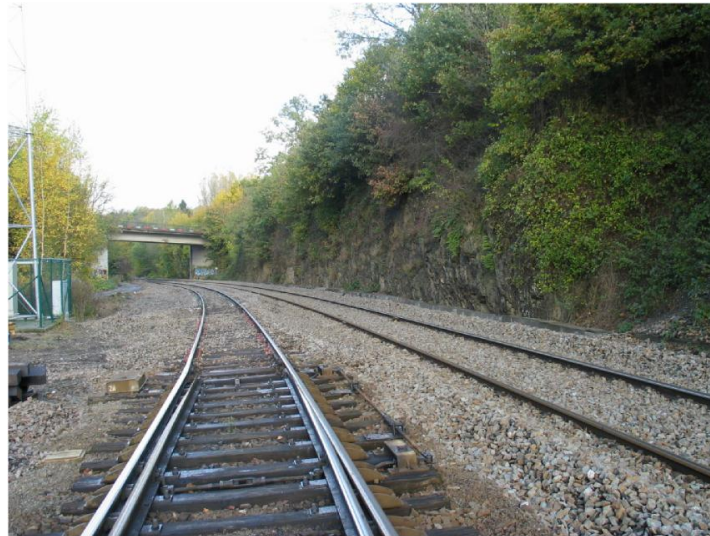
5.4 WALCOURT

At about 8.10 p.m. on Saturday 25 October 2008, on line 132, Charleroi to Couvin, at Walcourt station, a member of Infrabel's staff, the foreman on work train P 811, which was in service to replace the sleepers on track B (Couvin-Charleroi direction), was struck at distance marker (BK - borne kilométrique) 85.350 in the space between the tracks, by a train travelling in the opposite direction on track A (Charleroi-Couvin direction).

Once the situation had been sorted out, he jumped off into the space between the tracks and was within the clearance gauge of track A when train Z6169 arrived.

The work foreman of train P811 was struck by the train and killed instantly.

The primary cause of the accident is the victim's presence in the space between the tracks during work begun too early, before the protection system had been implemented.

All decisions modifying the usual site work procedures should be set out in a written procedure document providing traceability.

The procedures should be clearly explained at the beginning of work on the site and each time changes are made in the site organisation.
