**Statens haverikommission**  
Swedish Accident Investigation Board

A-138/11

# NATIONAL INVESTIGATION BODY (NIB) ANNUAL REPORT 2010

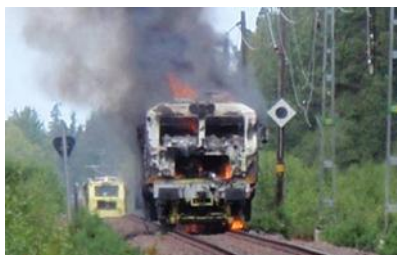
#### **RJ 2010:01**

#### **Fire in tamping machine SPR 3208B, on the Bäckefors - Ed section, O county, 20 July 2007**

On 20 July 2007 at 11:10, a fire broke out on a tamping machine on the section between Bäckefors and Ed.

Smoke was discovered coming from the tamping machine on an uphill gradient four kilometres from Bäckefors. The short haul train stopped at Tingvalla, approximately two kilometres north of Bäckefors, and flames shot out of the tamping machine while the personnel were running towards it to investigate.

At the time, the alarm-acknowledged lamp on the tamping machine was illuminated. The fault was reported but not addressed and was not included in the machinery records despite the fact that the fault had existed for several years. There was no fire detection alarm on the machine.

A spraybar had been replaced in the engine a few weeks prior to the event. The replacement had been carried out in the track environment by machine operators in accordance with Scania's instructions except that the nut had not been tightened to the required torque.

<b>Date and time:</b>	20/07/2007		
<b>Location:</b>	Bäckefors - Ed		
<b>Type of event:</b>	Fire in tamping machine		
<b>Type of train and train no.:</b>	SPR 3208B, DSS 4604, PLB 4080 (Swedish Rail Administration Production Machinery)		
<b>Road vehicles:</b>			
		<b>People on board</b>	<b>In the road vehicle</b>
<b>People on board:</b>	<b>Personnel:</b>	3	
	<b>Passengers:</b>	0	
<b>Number of fatalities:</b>	<b>Personnel:</b>	0	
	<b>Passengers:</b>	0	
<b>Number of seriously injured:</b>	<b>Personnel:</b>	0	
	<b>Passengers:</b>	0	
<b>Number of slightly injured:</b>	<b>Personnel:</b>	0	
	<b>Passengers:</b>	0	
<b>Damage to rolling stock:</b>	Total damage to SPR 3208B		
<b>Damage to railway infrastructure:</b>	Burnt off overhead contact line		
<b>Other damage:</b>	None		
<b>Summary:</b> See section 3.4			
<b>Publication of final report:</b>	27/01/2010		
<b>Recommendation RJ 2010:01 R1</b>	The Swedish Transport Agency is recommended to review the need for certification of maintenance and repair personnel.

<b>Recommendation RJ 2010:01 R2</b>	The Swedish Transport Agency is recommended to ascertain how Infranord ensures that documentation is produced for locomotive function and drawing follow-ups in the event of rebuilds or other changes.		
<b>Recommendation RJ 2010:01 R3</b>	The Swedish Transport Agency is recommended to ensure that Infranord reviews how locomotive function is to be assured in their own rebuilds, extensions, or when something is connected to a locomotive.		
<b>Recommendation RJ 2010:01 R4</b>	The Swedish Transport Agency is recommended to ensure that Infranord is sure how repair records should be maintained for annual follow-up, locomotive approval, and inspection.		
<b>Recommendation RJ 2010:01 R5</b>	The Swedish Transport Agency is recommended to ensure that Infranord reviews the safety management system for personnel training and procedures for the handover of machines between personnel.

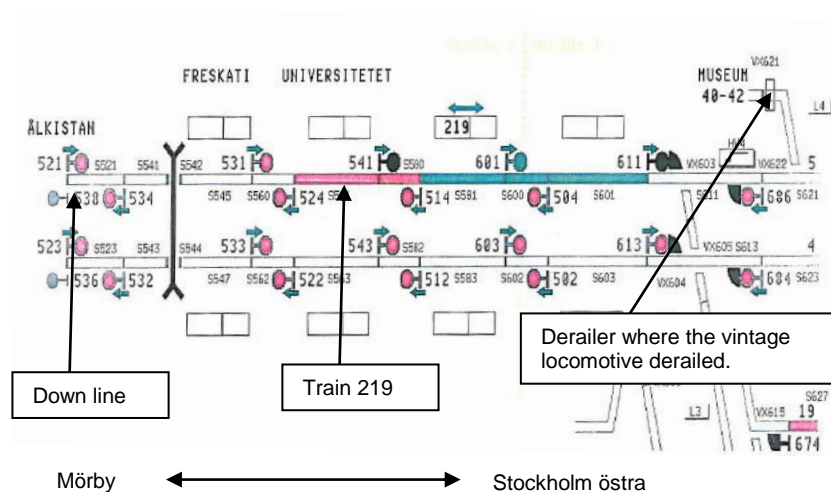
**RJ 2010:03**

**Near-collision of passenger train 219 and a shunting movement at Stockholm östra, AB county, 5 August 2007**

On Sunday, 5 August 2007, a near-collision occurred at Stockholm östra (east) between train 219 and a derailed shunting movement.

The direct cause of the event was that shunting to the main line began without oral starting permission from the dispatcher.

An underlying cause for the event developing into a near-collision was that the derailer could move to the on position and the interlocking route could be used even though the track section over the derailer and towards the point was occupied by a rail vehicle. This was possible because the track circuit for the section was not connected to the signalling system following a rebuild. Another underlying cause of the incident was that the traffic safety instructions did not contain rules on how an oral starting permission should be given.

<b>Date and time:</b>	05/08/2007		
<b>Location:</b>	Stockholm östra station		
<b>Type of event:</b>	Near-collision		
<b>Type of train and train no.:</b>	Multiple unit X10p, Locomotive X4P 37		
<b>Road vehicles:</b>			
		<b>People on board</b>	<b>In the road vehicle</b>
<b>People on board:</b>	<b>Personnel:</b>	3	
	<b>Passengers:</b>	no information	
<b>Number of fatalities:</b>	<b>Personnel:</b>	0	
	<b>Passengers:</b>	0	
<b>Number of seriously injured:</b>	<b>Personnel:</b>	0	
	<b>Passengers:</b>	0	
<b>Number of slightly injured:</b>	<b>Personnel:</b>	0	
	<b>Passengers:</b>	0	
<b>Damage to rolling stock:</b>	Minor damage to locomotive X4P 37		
<b>Damage to railway infrastructure:</b>	Collision with derailer		
<b>Other damage:</b>	None		
<b>Summary:</b> See section 3.4			
<b>Publication of final report:</b>	25/10/2010		
<b>Recommendation RJ 2010:03 R1</b>	The Swedish Transport Agency is recommended to check, in conjunction with authorisation and auditing of the infrastructure manager, that the safety management system ensures that safety-critical equipment meets the requirements for performing operations safely.

<b>Recommendation RJ 2010:03 R2</b>	The Swedish Transport Agency is recommended to carry out a compliance audit of requirements on archiving documentation of personnel competence and completed inspections.		
<b>Recommendation RJ 2010:03 R3</b>	The Swedish Transport Agency is recommended to investigate the feasibility of establishing a qualification registry (similar to the registry of driver licenses) for all personnel with duties of importance to traffic safety in order to facilitate transition between different operators.		
<b>Recommendation RJ 2010:03 R4</b>	The Swedish Transport Agency is recommended to check, in conjunction with the approval of traffic safety instructions, that there are clear rules for conducting safety-critical communications in order to avoid misunderstandings.

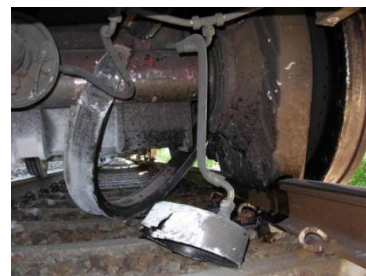
#### **RJ 2010:04**

#### **Accident, derailment of train 814 on the Rotebro - Upplands Väsby section, AB county, 4 June 2008**

On Wednesday, 4 June 2008, at 08:53, the first axle of the forward locomotive on passenger train 814 derailed on the section between Rotebro and Upplands Väsby. The trainset consisted of 10 carriages with a locomotive at both the front and rear.

The immediate cause of the accident was that the wheel flange on the first axle's left wheel burst due to fatigue and split off, which caused the locomotive to derail. SHK has not been able to establish what initiated the fatigue fracture.

The underlying cause of the wheel flange splitting off was that the device to keep the flange in place, should it burst, did not function as intended.

<b>Other damage:</b>	None		
<b>Summary:</b> See section 3.4			
<b>Publication of final report:</b>	20/12/2010		
<b>Recommendation RJ 2010:04 R1</b>	The Swedish Transport Agency is recommended to explore the possibility of ensuring the implementation of a comprehensive study on the risks of material fatigue on wheel flanges caused by long runs or high speeds.		
<b>Recommendation RJ 2010:04 R2</b>	The Swedish Transport Agency is recommended to ensure that railway undertakings, during periodic or emergency maintenance, have procedures to ensure that wheels are adequately inspected so that wheels with incipient fractures are prevented from leaving the workshop without being attended to.		
<b>Recommendation RJ 2010:04 R3</b>	The Swedish Transport Agency is recommended to ensure that railway undertakings have procedures that help personnel take the correct action when faults are reported that may have serious safety implications.
