The Rail Safety
Inspection Office

NIB ANNUAL REPORT 2011

according to Article 23(3) of Directive 2004/49/EC

September 2011

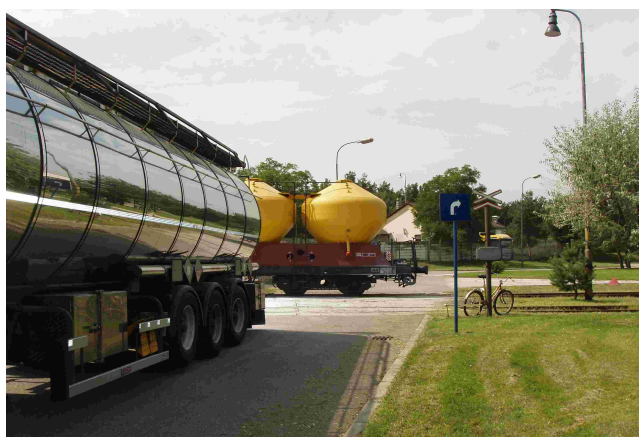
Grade:	accident
Date and time:	13 th August 2010, 10:52 (8:52 GMT)
Occurrence type:	level crossing accident
Description:	collision of shunting movement (locomotive + 1 wagon) with a lorry at level crossing
Type of train:	shunting movement
Location:	passive level crossing in km 0,588 of FOSFA, a. s., siding (double track level crossing)
Parties:	FOSFA, a. s. (owner of the siding) Advanced World Transport a. s. (IM + RU)
Consequences:	no fatality and injury total cost CZK 401 000,-
Direct cause:	way how the lorry and shunting railway vehicles approached the level crossing
Contributory factor:	driver of lorry didn't respect a traffic sign: "Do not enter, one way!"
Underlying cause:	incompability of maximal line speed allowed and visibility condition of the level crossing in terms of railway and road safety
Root cause:	none
Recommendations:	not issued

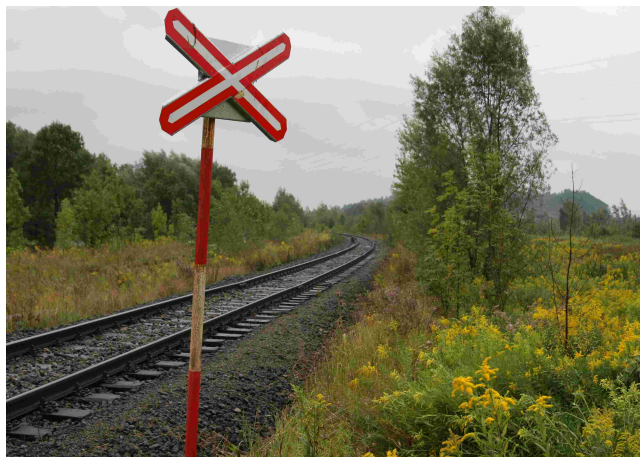
Grade:	accident
Date and time:	31 st August 2010, 16:04 (14:04 GMT)
Occurrence type:	level crossing accident
Description:	collision of siding train No. 425040 with a passenger car at level crossing in km 0,535 (P10627 – mark of LC)
Type of train:	siding train No. 425040
Location:	passive level crossing (traffic sign only), km 0,535 at siding „Vlečková
Parties:	Advanced World Transport a. s. (IM + RU + owner of the siding)
Consequences:	no fatality no injury total cost CZK 60.000,-
Direct cause:	- third party – level crossing user (driver didn't comply with regulations) - poor level crossing condition (insufficient visibility)
Underlying cause:	none procedure for level crossing inspection and maintenance (appropriate employee didn't make the inspections)
Root cause:	none
Recommendations:	not issued

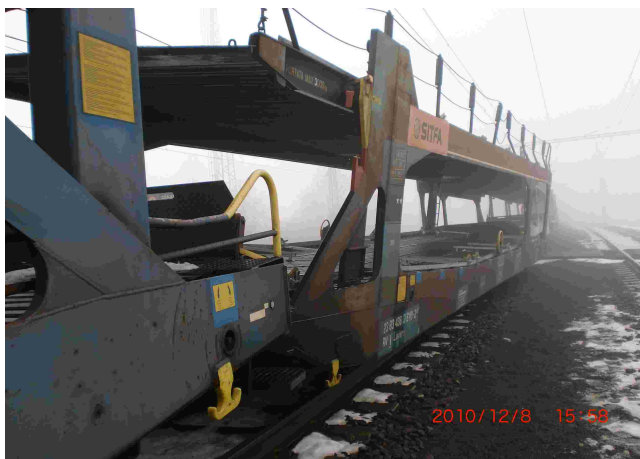
Grade:	serious accident
Date and time:	8th December 2010, 10:50 (09:50 GMT)
Occurrence type:	train derailment
Description:	derailment of 1 wagons (13th wagon) of freight train No. 46659 while running between Přerov and Prosenice stations
Type of train:	freight train Nex 2. nsl. 46723
Location:	open line between Přerov and Prosenice stations, track No. 2, km 186,771, (Přerov – Bohumín main line)
Parties:	Správa železniční dopravní cesty, s. o. (IM) PKP CARGO, S. A. (RU) SITFA, Via Bruno Buozzi 28, 10024 Moncalieri (owner of the wagons).
Consequences:	no fatality and injury total cost CZK 20 150 000,-
Direct cause:	rolling stock – bogie/wheel (wheel vertical force loss of the wagon – technical failure)
Underlying cause:	incorrect spring leaf was placed into the wagon than is provided by technological procedures – design
Root cause:	none
Recommendations:	not issued

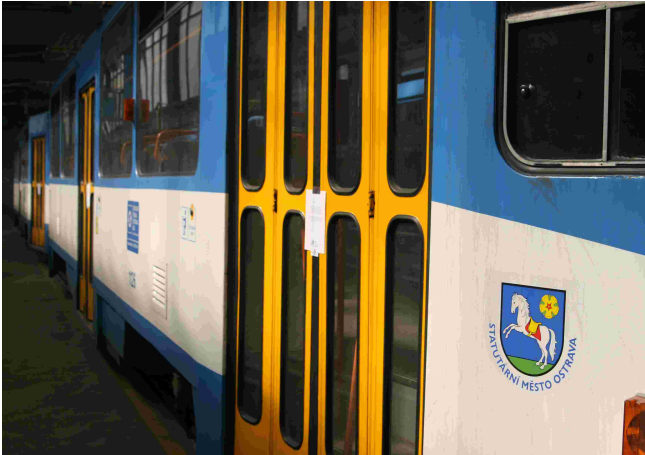
Grade:	accident
Date and time:	21st April 2011, 12:24:49 h (10:24:49 GMT)
Occurrence type:	accident to person caused by rolling stock in motion
Description:	A person was locked into the doors by the arm (during the disembarkment) and towed him for cca 23 m
Type of train:	tramway, type T6A5 – CS
Location:	the City of Ostrava, Tylova stop
Parties:	Dopravní podnik Ostrava, a. s. (IM + RU)
Consequences:	1 fatality (passenger) total cost CZK 0,-
Direct cause:	operations – closure of the doors during disembarkment of passengers at the stop
Underlying cause:	human factor – wrong step of tram driver before the departure (inadequate pre-departure and departure safety procedures)
Root cause:	none
Recommendations:	1) Addressed to Dopravní podnik Ostrava, a. s. (RU): <ul style="list-style-type: none">● It is recommended to equip all types of trams with technical device ensuring that doors start closing after 3 seconds of audible and visual warning.● It is recommended to develop procedures establishing efficient supervisory system of operational safety, defining scope, extend and frequency of checks, responsibilities of employees and their supervisors and details of documentation. 2) Addressed to Czech National Safety Authority (Drážní úřad): <ul style="list-style-type: none">● It is recommended to take own measure forcing implementation of the first recommendation by all relevant railway (tramway) undertakings.

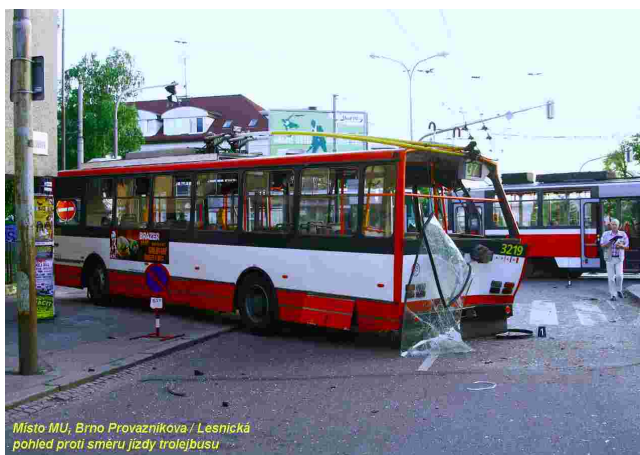
Grade:	serious accident
Date and time:	23 rd May 2011, 19:17 (17:17 GMT)
Occurrence type:	trains collision (between tram and trolleybus. A trolleybus is considered a train according to Czech national law)
Description:	tramway No. 9 collided with a trolleybus No. 37 in the area of the four-approach intersection. After the collision the tram derailed.
Type of train:	tram T6A5 – CS type trolleybus 14 Tr type
Location:	the City of Brno, in the area of the four-approach intersection Drobného – Lesnická – Provazníková – Třída Generála Píky
Parties:	Dopravní podnik města Brna, a. s. (IM + RU)
Consequences:	1 fatality (passenger in trolleybus), 3 serious injuries (passengers), 10 light injuries (passengers and 2 staff – drivers of tram and trolleybus) total cost CZK 1 085 569.-
Direct cause:	trolleybus driver's operational error (didn't respect red signal)
Contributing factor:	exceeding the maximum speed of the trolleybus about 15 km/h

Underlying cause:	none
Root cause:	none
Recommendations:	not issued

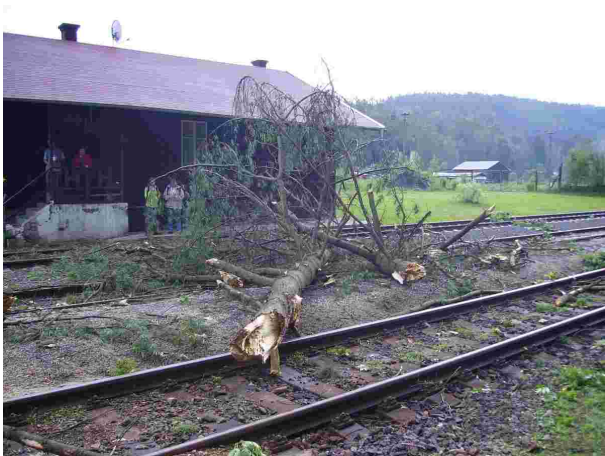
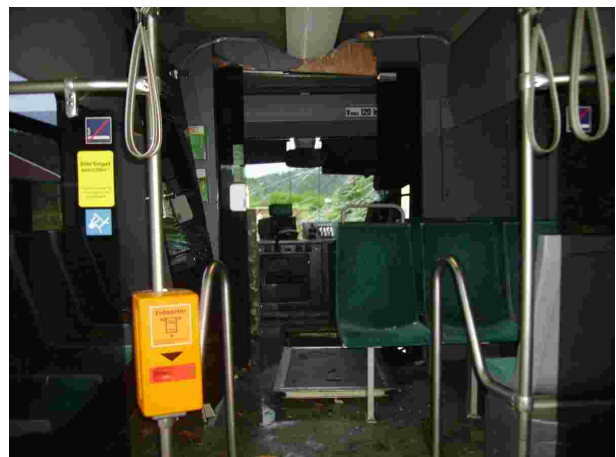
Grade:	accident (according to our national law it is serious accident due to damage which is more than 5 000 000 CZK)
Date and time:	22 nd June 2011, 17:06 (15:06 GMT)
Occurrence type:	train collision with an obstacle (fallen tree)
Description:	regional passenger train No. 20826 approached to the Kraslice předměstí stop. When the train was going at the platform a tree fell at the rear part of the train
Type of train:	regional passenger train No. 20826
Location:	Kraslice předměstí stop, km 21.093; Sokolov – Kraslice regional line
Parties:	Správa železniční dopravní cesty, s. o. (owner of the track) VIAMONT a. s. (IM) VIAMONT Regio a. s. (RU of the regional passenger train) Vogtlandbahn-GmbH (owner of the railcar)
Consequences:	0 fatality and injury total cost CZK 7 583 957,- (EUR 312 225,50)
Direct cause:	third parties – a break and a fall the tree on the train due to an excessive wind during a local storm and internal rot of the tree

Underlying cause:	none
Root cause:	none
Recommendations:	not issued
