BEA-TT

Land Transport Accident
Investigation Bureau

ACTIVITY REPORT 2010

**Bureau d'Enquêtes sur les Accidents
de Transport Terrestre [Land Transport Accident Investigation Bureau]**

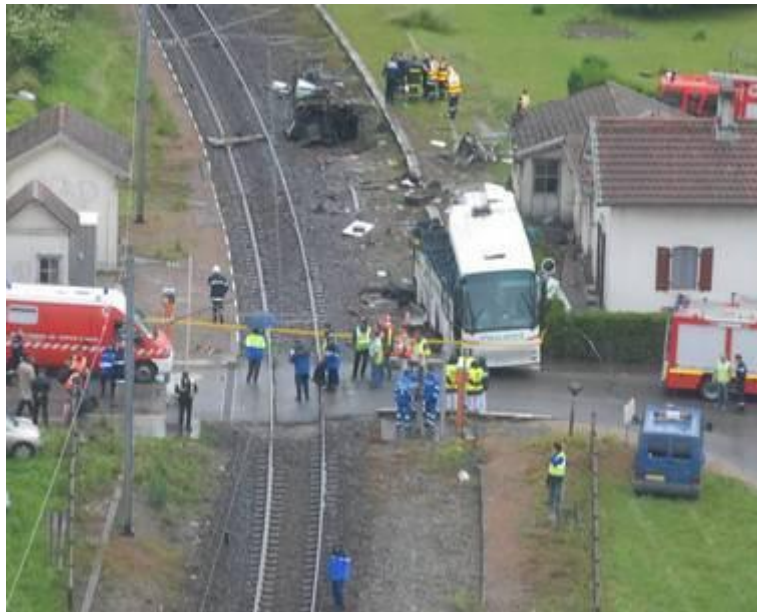
Collision between a TER and a coach which occurred on 2 June 2008 on level crossing No 68 at Allinges (74)

At about 13.55 on Sunday, 2 June 2008 a coach carrying school children was struck by a Regional Express Train in the village of Allinges (Haute-Savoie). The accident occurred on level crossing No 68 on the railway line from Evian to Annemasse and the RD 233 connecting Allinges to the RD 1005, on the shore of Lake Léman.

The result of this accident was 7 dead and 33 injured (of which 3 were seriously injured), all passengers in the coach.

The immediate cause of this accident was the stopping of the coach on the level crossing with the back end fouling the railway line.

The cause of this stop, which it was not possible to determine precisely was a combination of mechanical problems (fuel injection system, gearbox) and human factors (panic by the driver, bad manoeuvring).

At the end of this investigation the BEA-TT issued three recommendations aiming to:

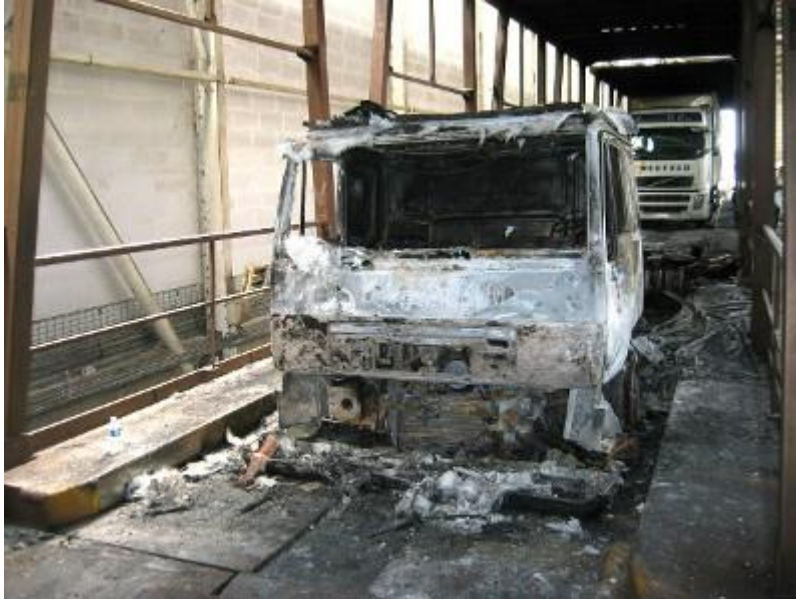
Fire on board the Eurostar freight shuttle 7412 on 11 September 2008

On 11 September 2008, the Eurostar freight shuttle 7412 left the English terminal at Folkestone on time (at 15.36³). It was loaded with twenty five lorries and two vans. The amenity vehicle where the truck drivers were accommodated was in its normal place, immediately behind the leading locomotive.

At about 15.45 a fire was detected on board this train. The train stopped shortly before 15.59 close to KP 49 situated in the last interval of this tunnel (interval No 6).

As far as material damage was concerned all the loaded wagons and the lorries were burnt out. The two locomotives and the passenger carrying vehicle suffered damage resulting from the high temperature and the smoke to which they were exposed. The north tunnel, where the shuttle was operating, suffered very serious damage and could not be reopened for traffic until February 2009.

The initial cause of the fire is still not known exactly but it seems likely that a road vehicle caught fire and the fire had then spread to the rest of the train. It should be noted that one of the vehicles carried had an electrical defect and it was not possible to switch off its

The investigation led to 39 recommendations, most of which were in the following areas:

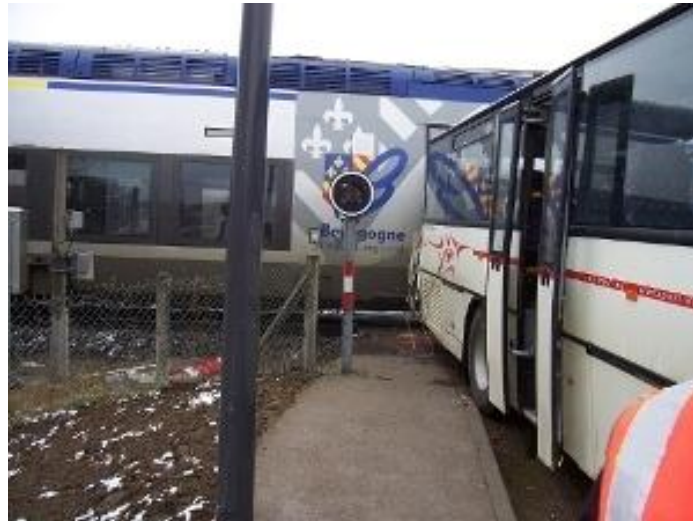
Collision between a TER and a coach on 3 February 2009 on level crossing No 4 at Nevers (58)

On Tuesday, 3 February 2009, at 13.28, in the town of Nevers (Nièvre) on level crossing level No 4, a TER unit carrying 23 passengers struck the left side of the back of a coach carrying 44 passengers (37 children from a primary school and 7 supervisors), which was fouling the railway line. The TER was running the Dijon - Nevers service and the coach the trip from Pouilly-sur-Loire - Nevers

The impact occurred at a speed of 38 km/h; it did not cause any significant injuries but the two vehicles involved suffered material damage.

The direct cause of this accident was an error of judgement by the driver of the coach which fouled the level crossing because the traffic conditions did not guarantee that it could pass completely over the level crossing. In addition there are two other factors that might have played a part in the accident:

Three recommendations have been formulated; the evaluation of the system of regulation by traffic lights of the calling forward of the line of vehicles on the level crossing and the assessment of the automatic detection devices for vehicles stopped on level crossings⁵.

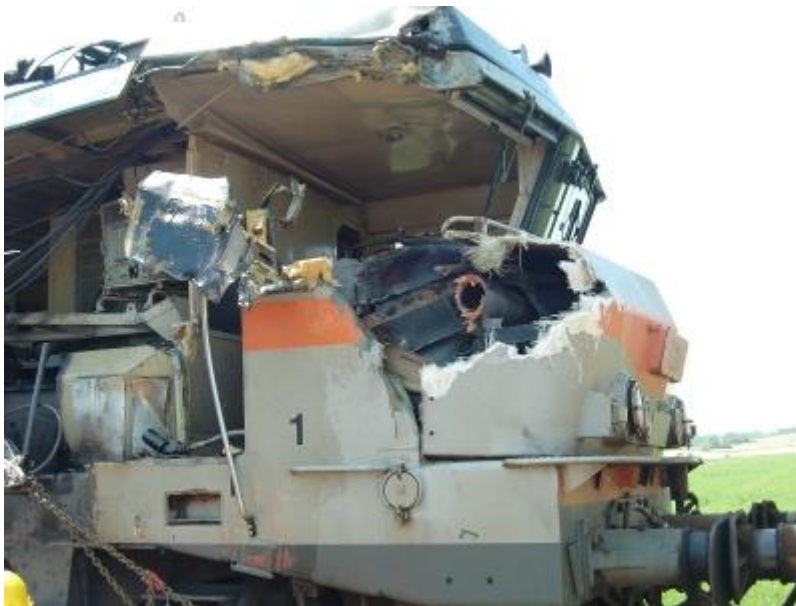
**Collision between a train and
the load of a passing train that occurred
on 20 May 2009 in Livernant Tunnel at Charmant (16)**

On Wednesday, 20 May 2009, at 0.39 the articulated arm of a forestry vehicle loaded on train ECR 41249 of Euro Cargo Rail struck the passing train SNCF 56724 in Livernant Tunnel at Charmant (16).

This accident caused slight injury to the driver of train 56724, the partial destruction of the locomotive and damage of varying severity to the wagons and loads of the two trains as well as damage to the track and railway equipment.

The immediate cause of the accident was the uncontrolled rotation of the turret and articulated arm of the Skogsjan forestry vehicle causing it to foul the loading gauge of the adjacent track.

- > the improper locking of the mobile parts of the machine by the consignee, who was not an experienced professional, when the wagon was loaded in Germany;
- > the defective implementation by DBSR (German railway undertaking that took charge of this consignment) of the advise and checking procedure laid down for this type of consignment.

- > the non-detection of the defects of immobilisation of locking and stowing during technical examinations in transportation;
- > the lack of clarity of the action to be taken by drivers if they hear noises of impacts which did not enable the train to be stopped when running in dangerous conditions before the accident.

This led the BEA-TT to issue five recommendations regarding:

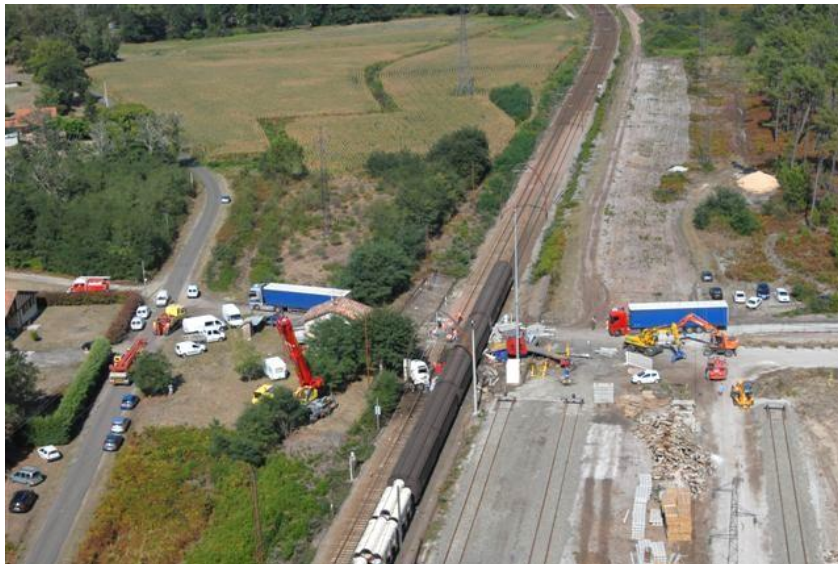
Collision between a freight train and a heavy goods vehicle on level crossing No 77 at Laluque (40) on 25 September 2009

On Friday 25 September 2009, at 12.46, SNCF freight train No 56701 running towards Bayonne hit a road tractor and semi-trailer loaded with railway sleepers on level crossing No 77 situated on the line from Bordeaux to Irun, close to the station of Laluque (Landes).

The installations of the level crossing were damaged as well as a catenary support. The front of the locomotive was smashed in, the tractor was seriously damaged, the semi trailer was destroyed and its load scattered.

The immediate cause of the accident was the sudden stopping of the heavy goods vehicle during the manoeuvre carried out on the level crossing.

- > the direct cause of the stopping associated with a possible driving error or a technical failure could not be precisely determined;
- > the under estimation of the risk on the level crossing by the road driver leading him to carry out a manoeuvre containing a risk of stopping on the level crossing;
- > the absence of information from the two road drivers involved on the procedure for access and moving around on the site leading them to follow the erroneous indications of the persons present on the site;
- > the lack of clarity, both in the publication and carrying out of the rules for traffic in force on the work site, leading to the staff working on the site unduly cluttering up the main internal traffic road and to give road drivers erroneous information and instructions.

This investigation resulted in the formulation of five recommendations regarding the drawing attention of the professional drivers to the specific risks of the level crossing, the systematic preparation of safety procedures between transporters and the reception undertakings, and to the procedure for the operation of a rail site served by road.

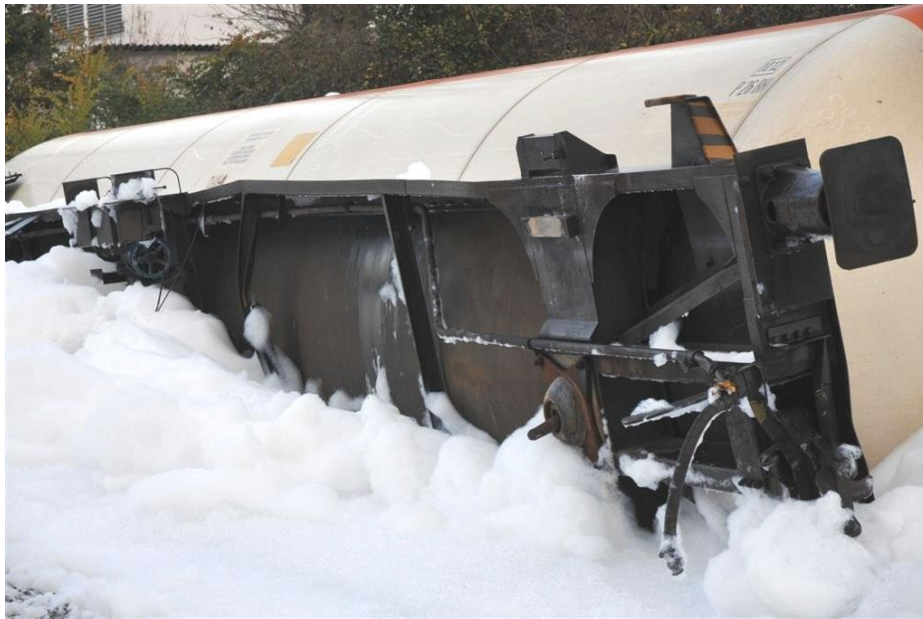
Derailment of two wagons carrying dangerous goods at Orthez (64) on 24 November 2009

On Tuesday 24 November 2009, at 18.14, two tank wagons of a complete train of dangerous goods (train 84892), running between Bayonne and Lacq, derailed at low speed in the town of Orthez (Atlantic Pyrénées), just before the station.

The first of these wagons situated in 26th position and loaded with propane tipped over damaging its emptying equipment and causing a leakage of the product.

The second, situated in the 27th and last position, remained standing upright and did not suffer any significant damage.

This investigation led to the formulation of a recommendation regarding the track, three recommendations concerning the maintenance of rolling stock and one recommendation about the lubrication of rails.
