# Railway Accident Investigation

**ANNUAL REPORT*****2010***

**Federal Railway Accident Investigation Office**

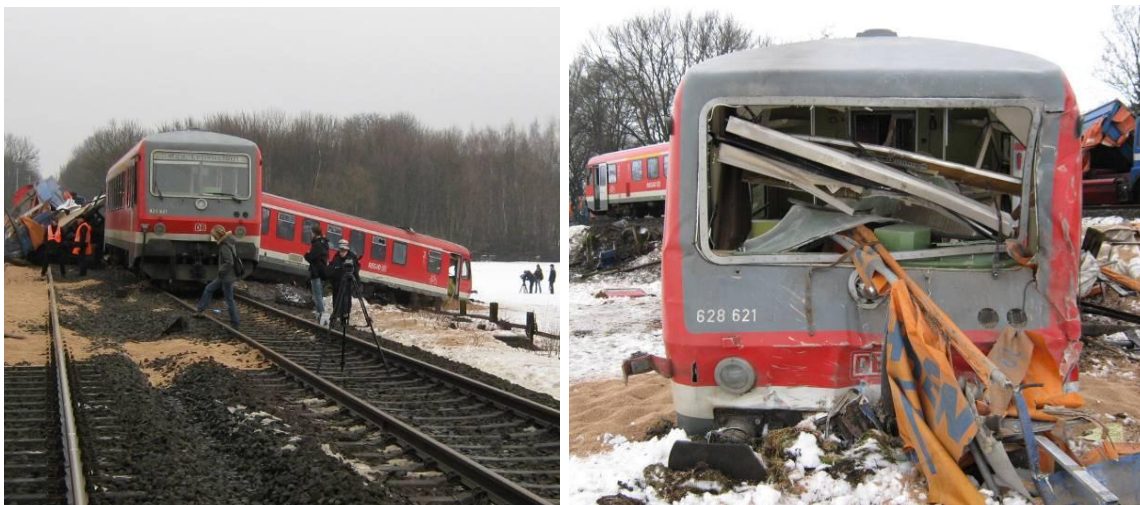
Illustration1

As a consequence of the collision, the leading motor coach 628 621 of the two-coach diesel multiple unit derailed and then swung diagonally across the line and slid down the embankment towards the right in the direction of travel. In the process, sixteen people were injured, three of them seriously. The damage to property is estimated at some EUR 2 264 000.

The driver of the lorry drove his vehicle from the level crossing at km 4.353 along the track towards Braunschweig. After some fifty metres the lorry got stuck on the track. The driver of the local train which approached a few minutes later did not see the lorry on the track in time to stop his train. Hence a collision was inevitable.

‘In order to ensure passengers can be evacuated rapidly and safely in an emergency, the functionality (labelling, operation and risk of injury) of the requirements concerning emergency entry and exit windows in component approval EBA 05 G 08A (10/05) and windows of identical design should be reviewed.’

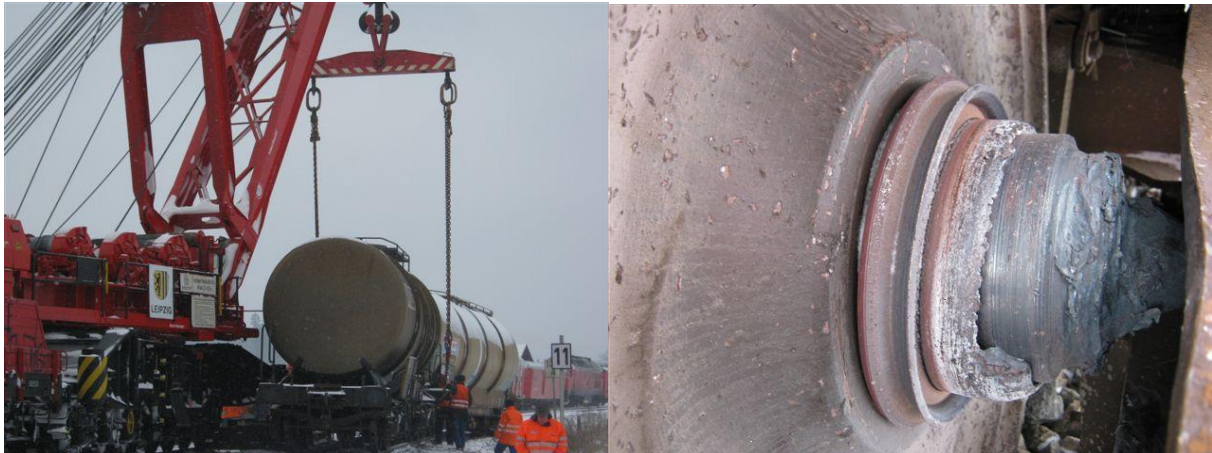
Illustration 2

As a result of the derailment, the buffers of the fourth wagon (tank wagon number 33 87 792 9 243-6, UN No 2014, hydrogen peroxide) rode over the third wagon. Dangerous goods did not escape.

The permanent way was severely damaged over some 330 m; three switches had to be completely renewed.

Investigations to date show that the cause of the derailment was clearly the collapse of the bearing of the third wheel set of the third wagon through the cage breaking up and the subsequent hot box and broken axle journal.

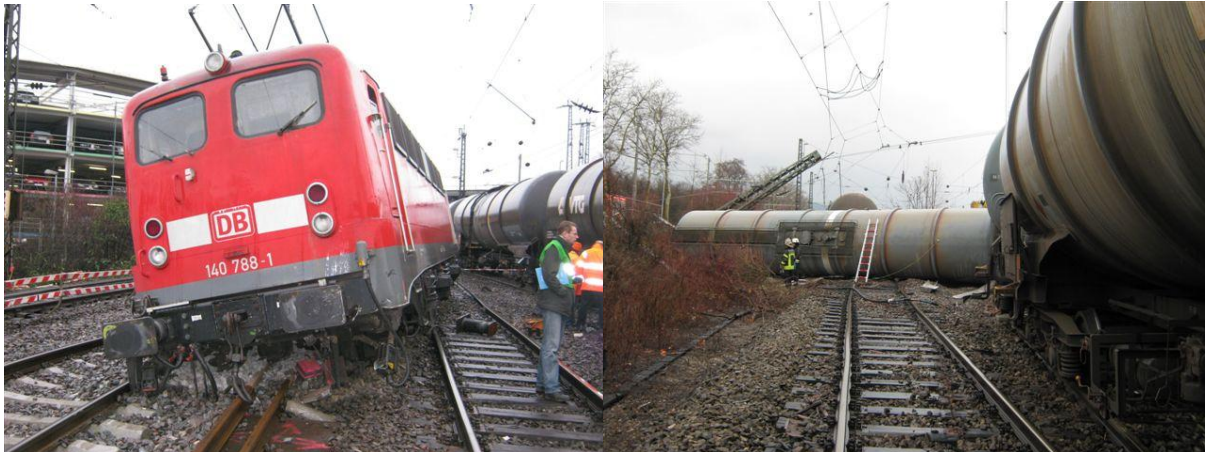
Illustration 3

The driver was slightly injured. The derailment damaged or destroyed some 250 track metres of track and switch and crossing work together with a lattice mast and the catenary. Fuel oil escaped from two places of leakage in the tank of the first tank wagon which had overturned and was wedged. Some 300 to 400 litres [of fuel oil] escaped into the ground. Three tank wagons and two locomotives of class 140 were severely damaged.

The cause of the derailment is to be attributed to deficient tamping and alignment work carried out as part of permanent way renewal.

On the curve between No 391 and No 394 switch a cant of 40 mm was created. There was no cant at that point before the work began.

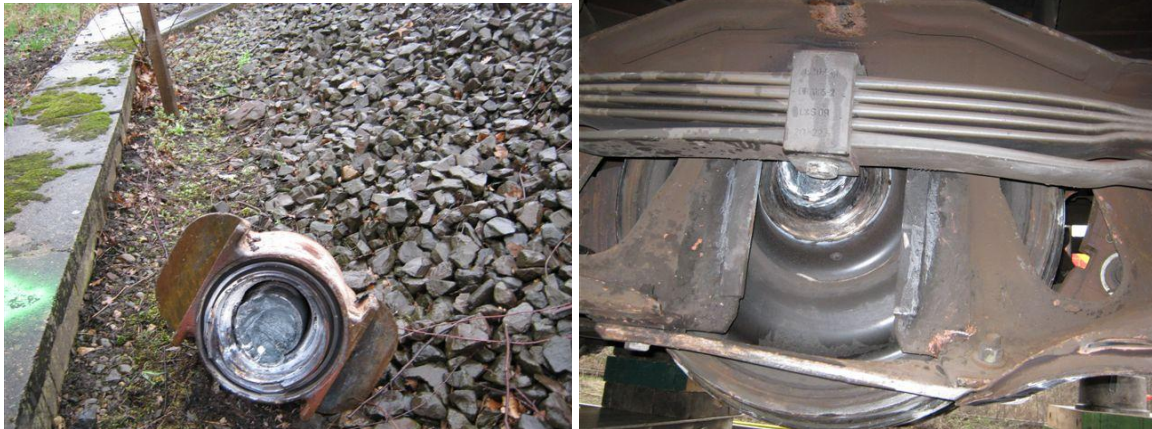
Illustration 4

The permanent way was seriously damaged. No-one was injured.

The investigation to date shows that the derailment was caused by an axle bearing running hot and the axle breaking in consequence (broken axle journal).

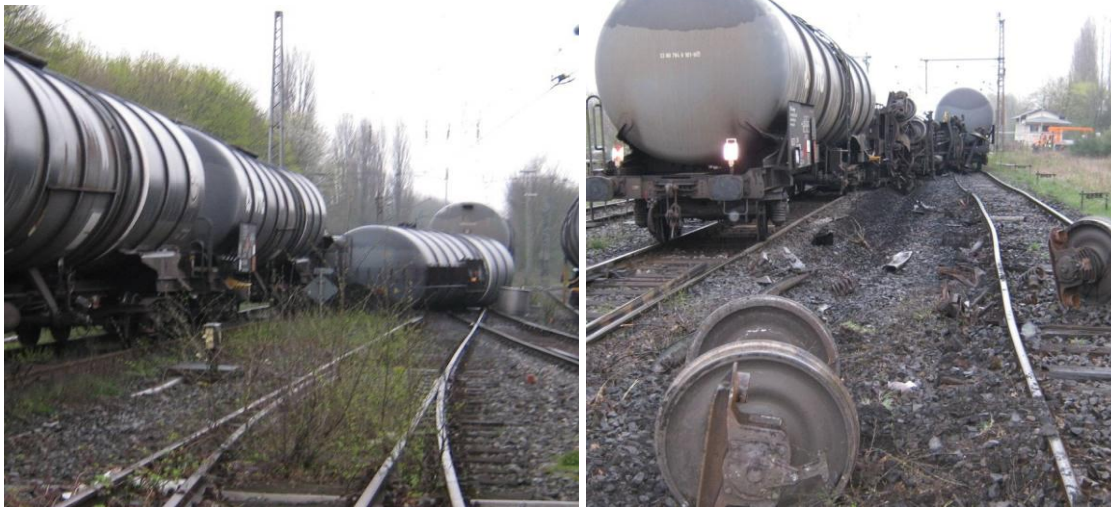
Illustration 5

As a consequence of the derailment, the penultimate wagon – a tank wagon loaded with acetone (UN No 1090 RID class 3) – tipped over. This caused leaks close to the pressure relief valve and to a flange joint in a connecting pipe. Hence some 75 kg of the product leaked out. Damage to property as a result of the derailment was some EUR 285 000. No-one was injured in the accident.

The derailment of the last two wagons was caused by switch No 62 moving from the right to the left under penultimate wagon of the train.

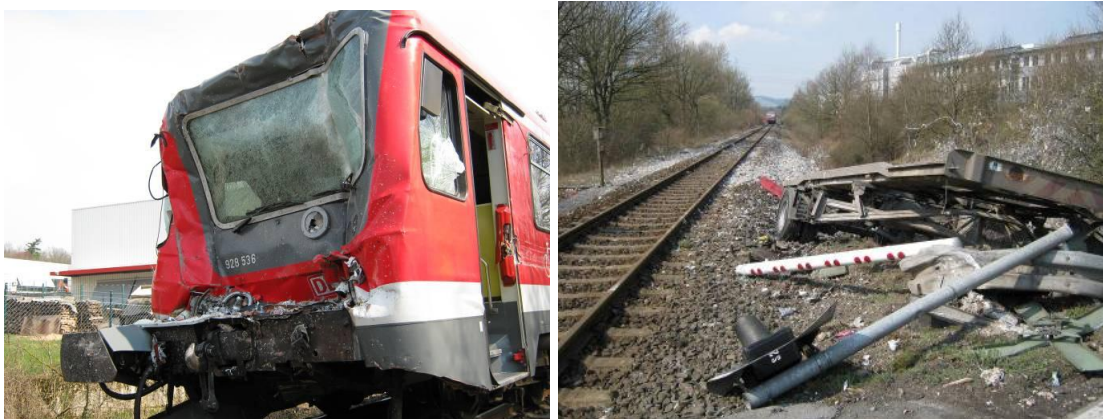
Illustration 6

Nineteen people were slightly injured in the collision.

The cause of the accident was slow clearance of the crossing by road users (setting back to allow other traffic to pass).

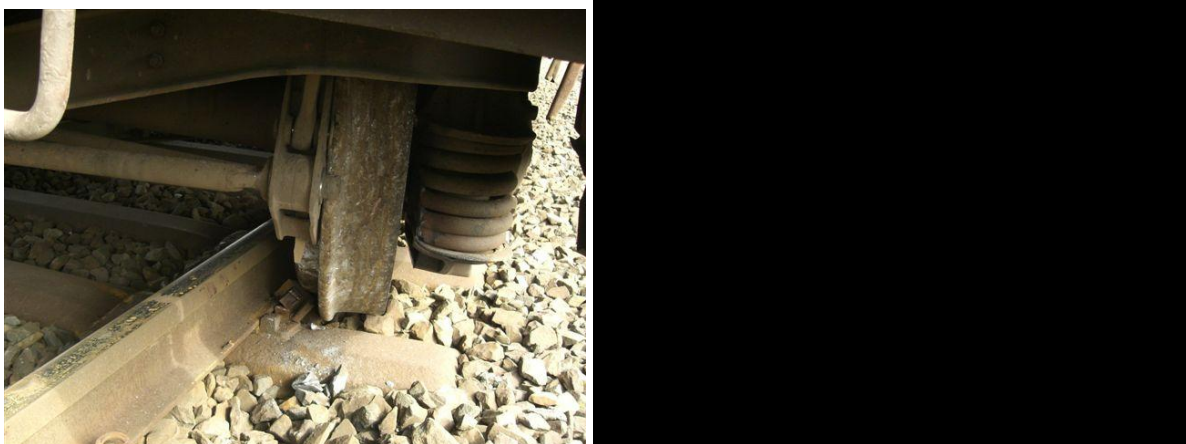
Illustration 8 (for missing pictures see the original version)

Since train CFN 47595 ran on for about another 11 km with the bogie derailed, there was very considerable damage to the permanent way.

A wheel with a loose or displaced tyre was discovered on the fifth wagon from the rear. Further technical investigations into workshop practices have been commissioned to clarify the circumstances.

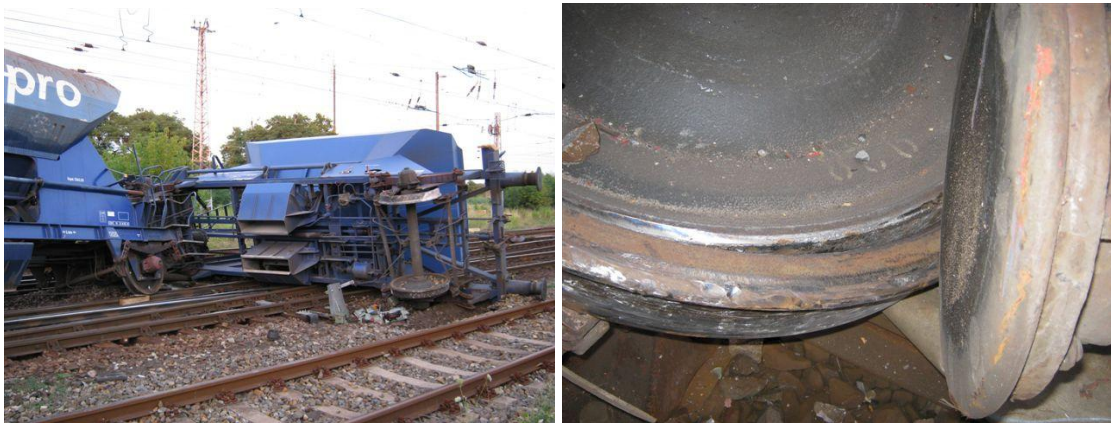
Illustration 11

Significant damage to the permanent way, in particular switch No 221 was seriously damaged.

Wagon 23 84 6437 395-6 was derailed with all wheels and wagon 23 84 6437 389-9 tipped over.

The cause of the derailment was a loose wheel tyre on wagon number 23 84 6437 389-9 which tipped over. Further technical investigations into workshop practices have been commissioned to clarify the circumstances.

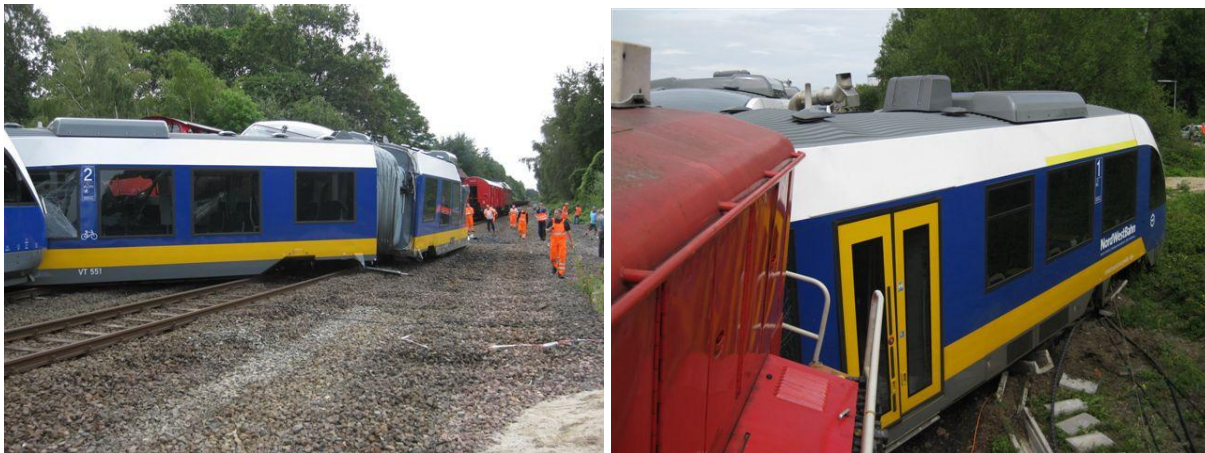
Illustration 12

The driver of the multiple unit and the driver of the works train were slightly injured in the accident. The locomotive and the first wagon of the works train, together with the first three units of the total of ten stabled units, were derailed. There was significant damage to rolling stock and railway installations.

The cause of the collision is attributable to unauthorised entry of the works train to No 1 track already occupied by vehicles. Mistakes in operating procedures by members of the operating staff of Geldern station were critical.

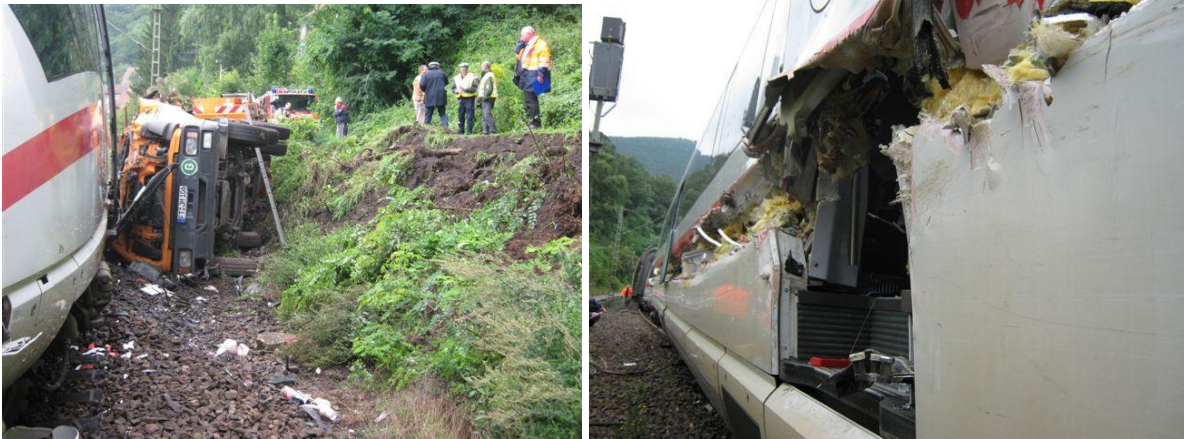
Illustration 13

Of the some 320 passengers in the train, 15 passengers, the driver and two members of the train crew were slightly injured.

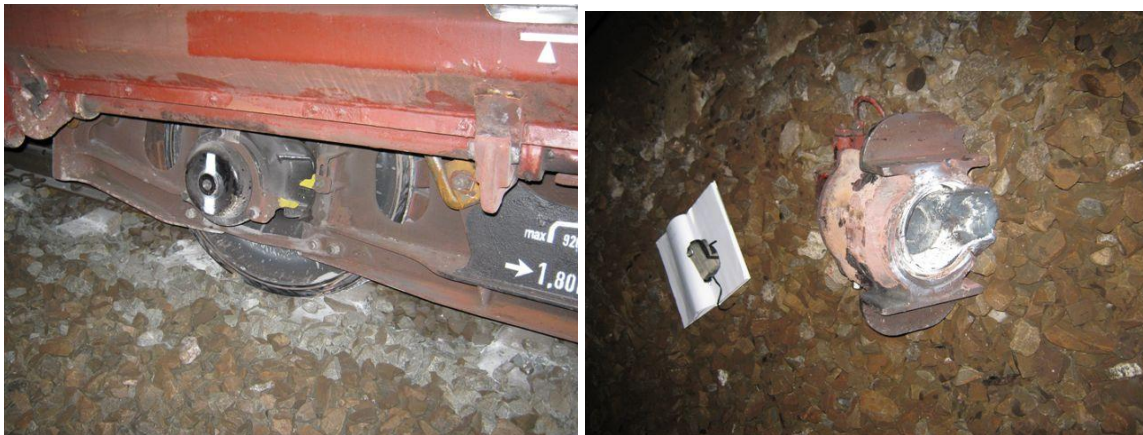
Illustration 14

Some 1 600 m of track and switch and crossing work were destroyed or damaged by the derailment.

The cause of the derailment was the axle bearing of the second vehicle in the train, wagon 81 80 6640 706-0, shearing. The bearing was found on the left in the direction of travel and related to wheelset type: 004 and wheelset number: 939 469+90.

Most probably the fracture of a stay bolt on the wheelset pump led to the wheelset locking and hence to a broken journal.

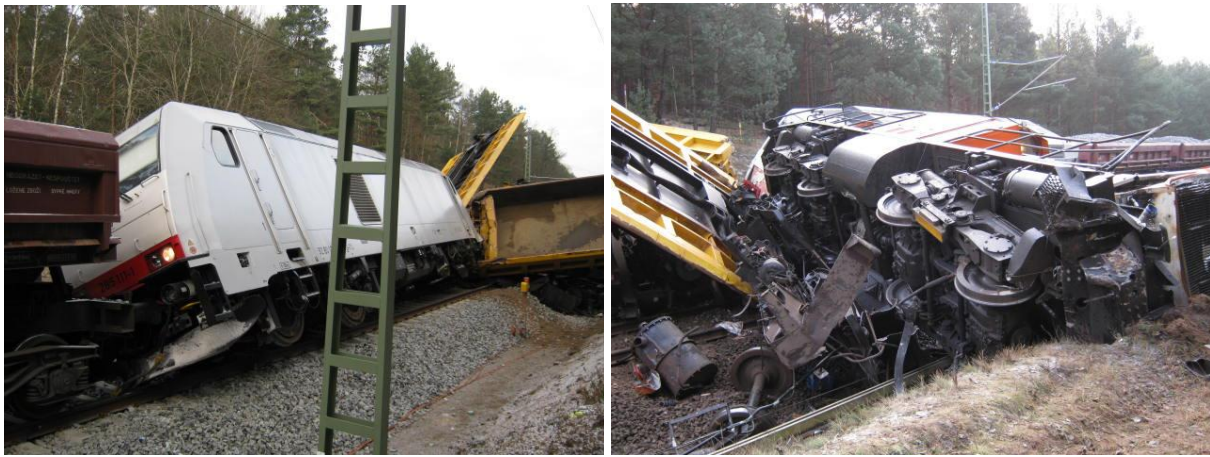
Illustration 15

Both bogies of the fourth loaded wagon became derailed; the fifth wagon was derailed one bogie.

The catenary over both tracks was torn down. The permanent way was severely damaged in the area directly around the accident.
