COMISIÓN DE
INVESTIGACIÓN DE
ACCIDENTES FERROVIARIOS

ANNUAL REPORT 2010

Investigation of general interest rail network accidents and incidents

Rail Accident Investigation Commission – CIAF. September 2011

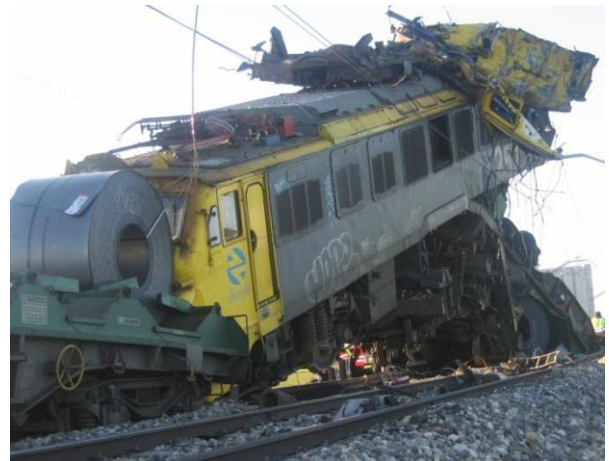
The accident, which took place on 26 March 2010 in the vicinity of Arévalo station, was caused when a Renfe Operadora freight train, stopped before the entry signal of the said station, was overtaken by another freight train, from the same rail company, which found the approach signal indicating line clear. As a result of the collision, the driver of the second train died. On the basis of the relevant investigation, the Commission made three recommendations.

Condition of trains involved (source: CIAF)

Number of recommendations			Final recipient of recommendations		
3			1-2 Adif 3 UTE Dimetronic-Thales		
<p>18/10-1 By carrying out work on interlocks or blocking systems, a system of analysis and assessment of the installing company's safety operations will be established, in accordance with standard UNE-EN 50126 and the project safety plan and its additional protocols. (Safety case of the installation).</p> <p>18/10-2 When implementation of these works may affect the operation of the safety installations that they regulate (signals, markers, track equipment, etc.), the following measures should be taken:</p> <ul style="list-style-type: none"> • Interruption of traffic or, failing this, establishment of an alternative blocking system that guarantees safety of same. • Once the works have been completed, and before allowing normal traffic to resume, there will be onsite checks that all safety installations (signals, markers, track equipment, etc.) comply with the provisions. • These terms shall be included in the corresponding instructions, specifying: <ul style="list-style-type: none"> - Activities to be carried out, those responsible for same and the necessary safety conditions. - Periods for cutting traffic during tests. - Tests (conformity) to be carried out in temporary situations to which the period of loss of interlocking gives rise, to make them compatible with the traffic. <p>All the above will result from documented risk analysis to be carried out jointly with the installing company.</p> <p>18/10-3 There must be a review of the processes of the company's Safety/Quality Management System relating to safety installations, both new and as amendments to those in existence, and in cases of maintaining rail traffic, with the aim of avoiding situations similar to those of the event.</p> <p>In these cases the functions and responsibilities of the company's head of commissioning, as the expert on the technical risks arising from these situations, must be clarified.</p> <p>The company's safety teams must ensure that activities for verification/validation of systems or subsystems to be installed, or modification of those existing, are carried out effectively. In addition, this safety team shall approve onsite activities prior to commissioning.</p> <p>All the above must be documented as evidence (safety case) before authorising commissioning of the installation, irrespective of whether it is new or a modification of an existing installation. All this will be specified individually for the actual project in hand.</p>

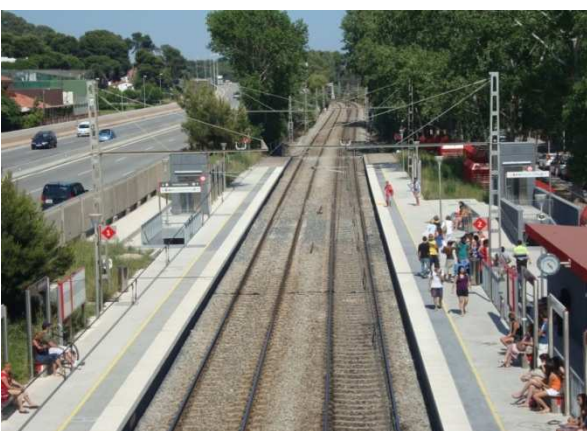
View of the Platja de Castelldefels halt (source: CIAF)

Of these four accidents, we would draw your attention to the occurrence at the halt of Platja de Castelldefels (Barcelona), on the night of 23 June 2010, when, after alighting from another train, a crowd of users crossed the tracks with the intention of heading for the halt exit, and were struck by a train that did not have a prescribed stop at the halt. The halt is provided with an underpass. As a result, 12 people died and another 10 were seriously injured.
