AIRCRAFT, MARITIME AND RAILWAY ACCIDENT
INVESTIGATION UNIT DIRECTORATE

SPECIALIZED RAILWAY ACCIDENT AND INCIDENT INVESTIGATION
UNIT

ANNUAL REPORT 2010

Specialized Unit for Railway Accident and Incident Investigation

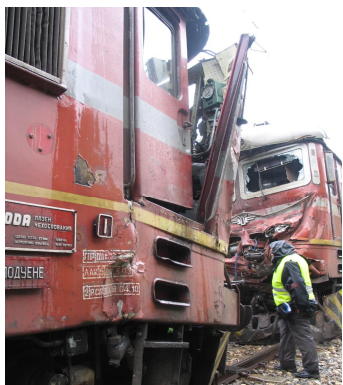
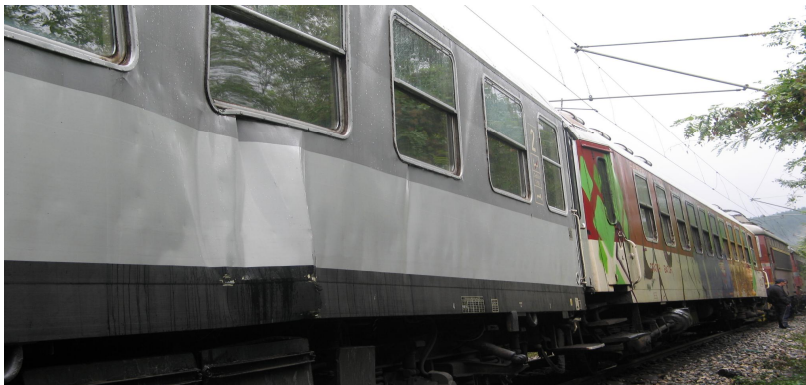
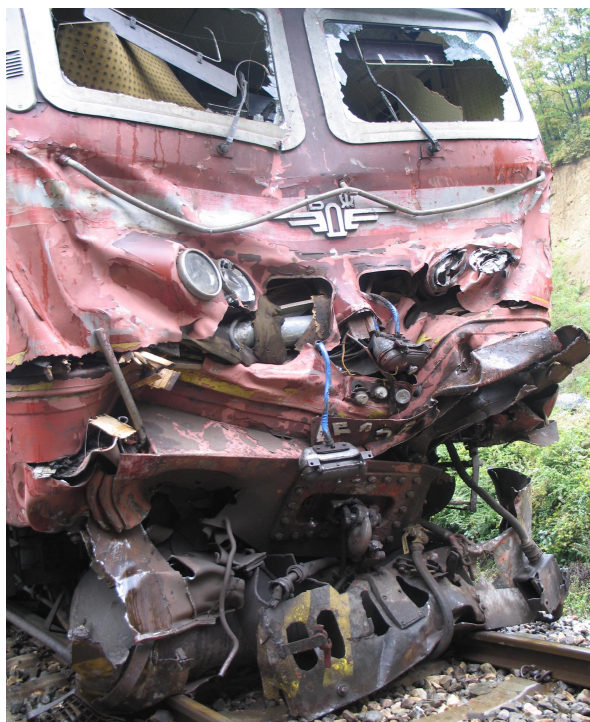
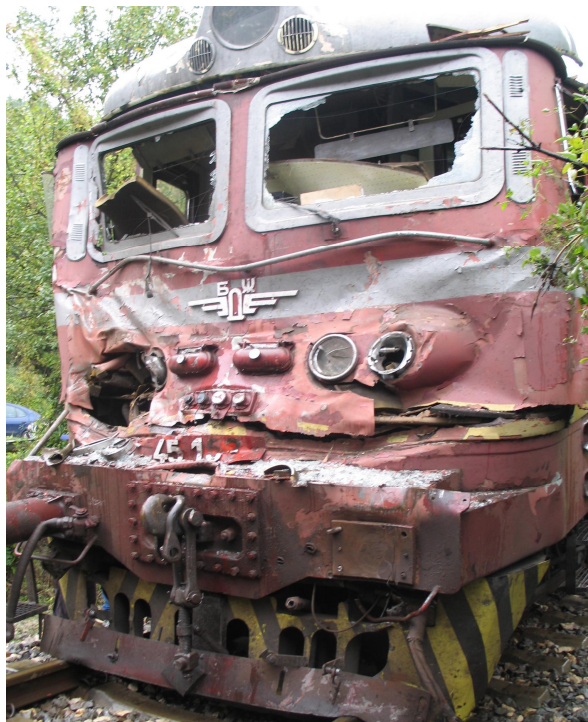
Dragoil at km 47+796, Head-on collision between working and servicing train No. 10352 on the route Dragoman ó Dimitrovgrad RS and interstate fast train No. 293 on the route Belgrade ó Sofia, with the task to study and analyze the reasons why the accident started, and to prepare a report with safety recommendations after the investigation. From the decoding of the speed measuring band of the electric locomotive No. 45-152 is clear that the two trains met and collided Head-only at 7:55 at km 47+796. The RRS did not derail during the collision. The accident resulted in material damages to the RRS. This is seen from Figure 1, Figure 2, Figure 3 and Figure 4.

In conclusion of the analysis made it is clear that categorically the reason is not technical failure, decisive was the human factor. Often experienced staff is lacking, which can intervene fast and in adequate way and to offer solutions, with which to prevent certain accident.

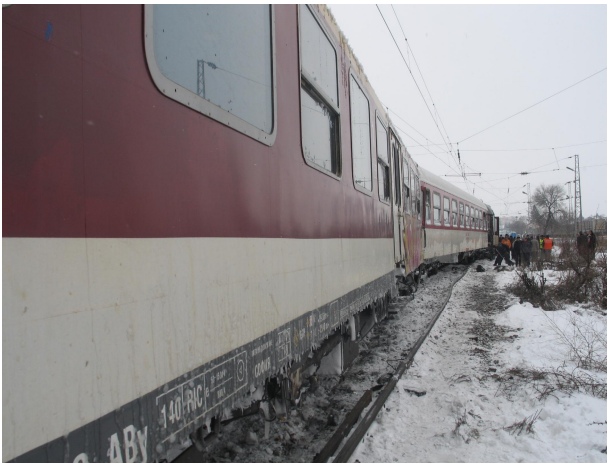
It was established that as a result of the collision of the derailed wheel axle with the front of the free catch of switch No. 3 in station of Kurilo, are derailing third car No. 50522974150-7 with the two bogies, fourth car No. 51523143009-8 with the two bogies and fifth car No. 03514619 - with the first bogie. This is clear from Figure 1 and Figure 2. At km 18+029 is established broken part of the head of right rail in the joint and is found the piece with length of 137 mm to 2 (two) metres in the right after the broken place, in the direction of traffic.

From the place of derailment to the entrance switch of station Kurilo clearly are seen interrupted tracks of impact by the derailed wheel axle on the joint in the gauge and in the left side of the rail way.

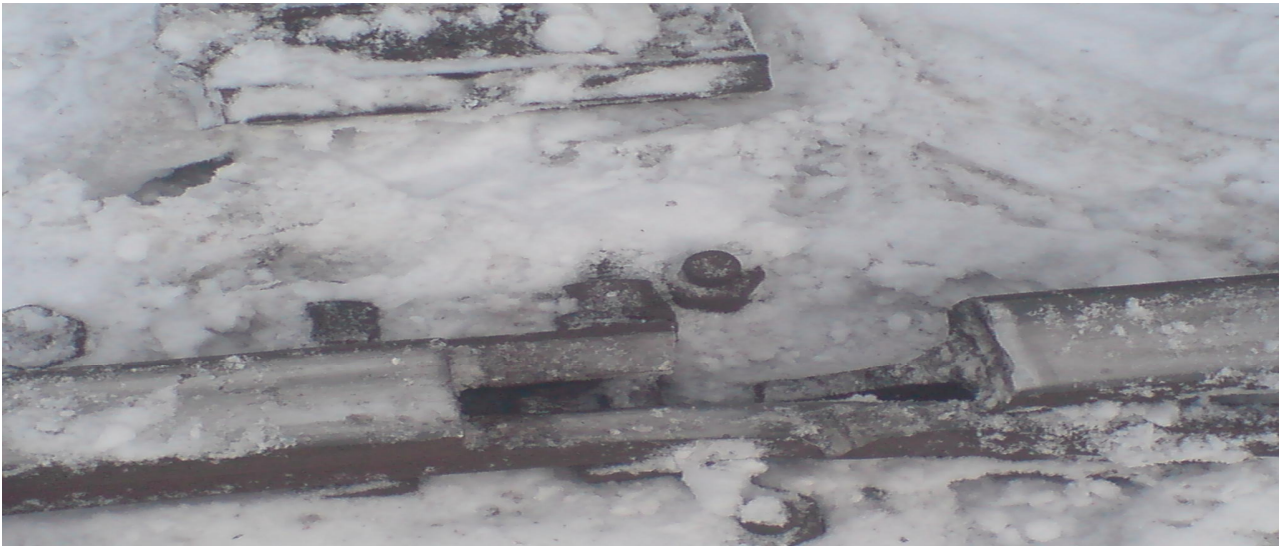
Figure 3

According to what is seen on Figure 3, the commission for technical investigation concludes that the cause of the accident is fresh breaking off of 137 mm piece from the head of the right rail in the direction of traffic at km 18+029 under the train No. 383 when the second bogie of the second car No. 50522974143-2 passed, which resulted in the derailment of the second wheel axle. The resulting movement in this condition of wheel axle for 4800 m without the undertaking of braking resulted in damages on the railway infrastructure and derailment of the remaining cars at switch No. 3 in the station of Kurilo.

- The rules for middle repair of passenger cars;
- The instructions for routine maintenance and repair of all types of passenger bogies;
- Protocols for balance of passenger cars;
- Instructions for check-up, repair and testing of air-cushion;
- Instructions for car axles;
- Instructions for the train conductor;
- Instructions for the head of passenger train.

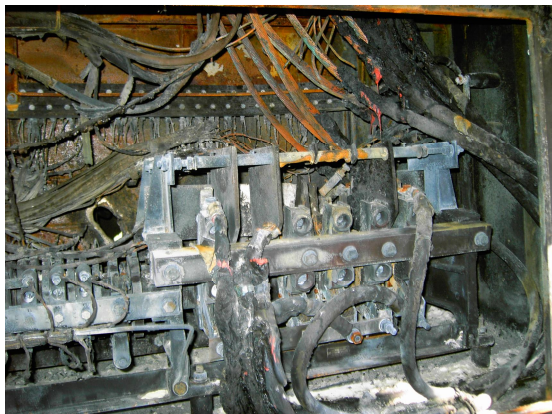
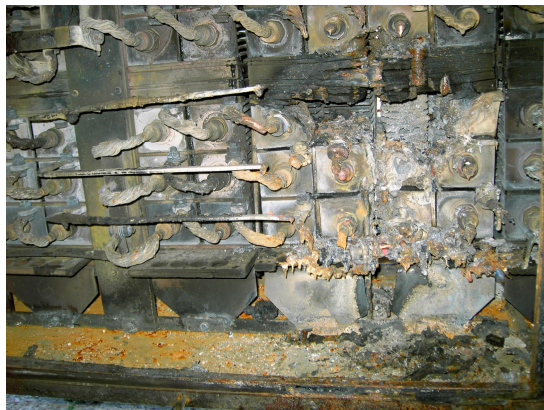
According to what is seen on Figure 1 and Figure 2, the assistant of the locomotive engine-driver and the head of the train immediately undertook actions for stopping the thick smoke from the cabinets of the main controller (MC) and the rectifying block (RB) with the available portable fire extinguishers from the electric motor train, which are 5. The locomotive engine-driver also assisted with the extinguishing. With the available fire extinguishers the participants managed to stop the fire but after 10-15 seconds they started again. At 06:50 the head of the train called 112 and asked for help from Regional service Fire safety and rescue of the town of Aytos. The fire was extinguished at 07:30 or fifteen minutes after the arriving of the first fire truck.

The commission for investigation concludes that the immediate technical cause of for started accident - fire in the cabinet of the train rectifier and in the cabinet of the main controller of section No. 32-157.0/32-357.4 from EMT 32-157/32-158 is the short circuit in the power circuit at traffic regime of section No. 32-157.0/32-357.4 from EMT, after departure of train No. 80251 from the station of Aytos.

- The leakage of vents in the shoulder VP1 of the train rectifier of section No. 32-157.0/32-357.4 from EMT is caused by fault started in the main controller after the release of EMT from main repair done in Locomotive Depot Plovdiv – section Stara Zagora;

- Defects in the work and control of the repair staff during the repair operations of EMT section No. 32-157.0/32-357.4 in Locomotive Depot Stara Zagora.

4. The leaders of Bulgarian State Railways EAD to regulate the norms for performing of check-up, repair and control (including observing the mechanic, geometric and electric standards of operation) of all elements and their connecting cables, participating in the power circuit, in the regime *õtravelö*, as well as in the regime *šbrakingö*, when a failure occurs and during the emergency repair.

5. To be measured the angle diagram of the main controller, the diagram taking of the distribution of power for the rectifiers and tuning of maximum power protectors of the rectifiers of EMT series 32-00, according to the approved methods and in all cases of fault and after emergency repair of an element participating in the power circuit, in regime *õtravelö*, as well as in regime *õbrakingö*.

6. Having in mind the omissions made during the time of performing of repair operations in the specialized units for repair of EMT series 32-00, to make precautions regarding additional training and familiarizing with the technical requirements when performing depot repair, for the repair staff involved with this activity. To raise the level of the technical control during admittance, repair and transferring of EMT series 32-00 from the leading repair staff and QuC, in order not to allow violations of the requirements on which the technology of the performed depot repairs is based.

7. To control the condition and to bring in good working order the gaskets of the covers of the boxes of the train rectifier (RB), the main controller (MC) and the reactor (RE).

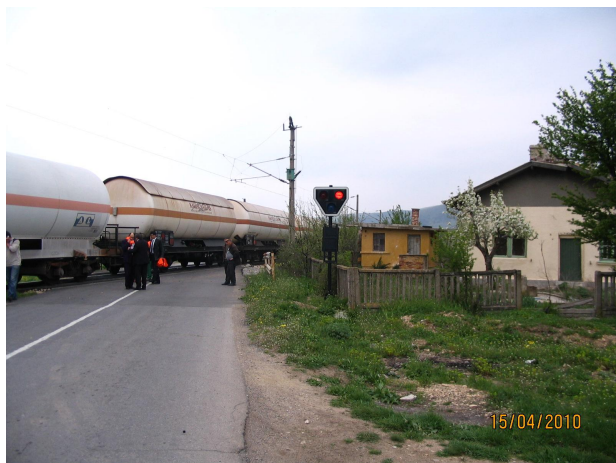
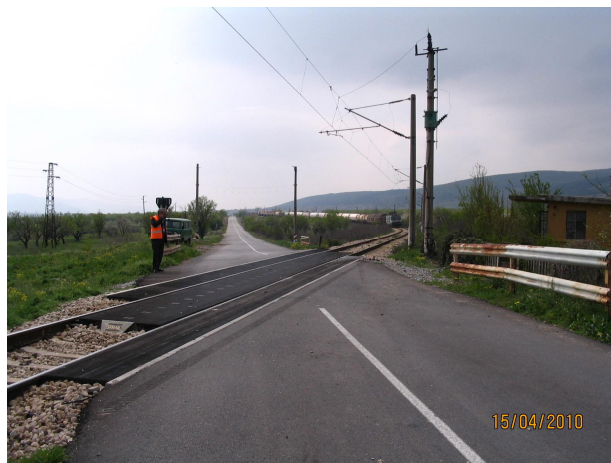
Seeing the car, the locomotive engine-driver activates the train brake in regime *fast braking*, according to what is seen on speed measuring band of the locomotive but due to the short distance, despite the fact that the train was secured with the necessary brake weight, it was not possible to avoid the head-on collision of the locomotive with the automobile and this happened at 11:30.

During the investigation of the railway accident it was established that on the crossing at km 290+285 at the side of the automobile road are missing signs 34.1 and B2, according to what is seen in the statement of facts.

By letter No. 611/22.04.2010 from the director of railway section Karlovo is notified the chairman of the operational group and the missing signs are restored after the accident.

2. The Director General of SE NRIC to take the necessary measures for control of the availability and the condition of the road signs for marking the railway crossings, in order to restore them promptly after their stealing or violation.

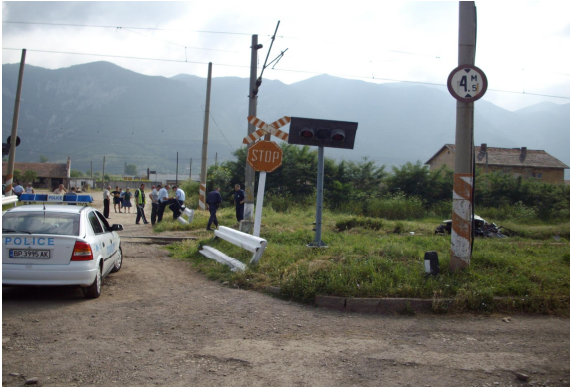
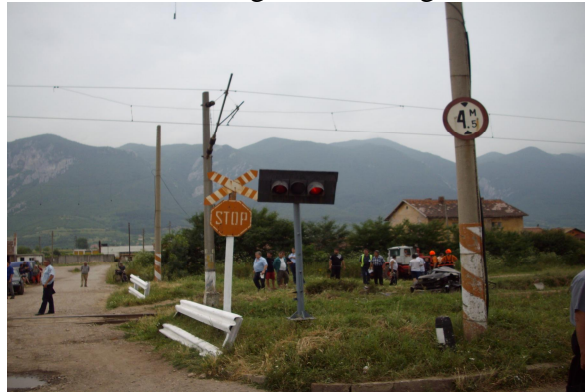
About 100 metres before the crossing, the locomotive engine-driver saw that the automobile enters the danger zone of the crossing and stops on the rail way. The locomotive engine-driver immediately activated the automated train brake in regime "fast braking", according to what is seen on the speed measuring band of EMT but due to the short distance it was not possible to avoid the collision with the automobile and this happened at 16:30. Evidence that ACA was working correctly at the moment of collision is the statement of facts for the condition of ACA, as well as the picture material produced after the accident. This is seen on Figure 1 and Figure 2.

The most probable cause for the occurred accident, established by the analysis of the facts and the circumstances is the incorrect passing of the road transportation vehicle – personal automobile Volkswagen Golf with license No. BP 4741 AC, driven by regular driver during railway crossing at km 21+294 in the inter-station section Vratsa – Beli Izvor with correctly activated automated crossing alarm due to the imminent passing of train No. 70206.

1. In order to minimize the risks of accidents on the railway crossings, due to violation of the Road Traffic Act by the drivers of road transportation vehicles, the manager of the railway infrastructure should analyze the risk crossings and should equip them with video surveillance, which is to be made jointly with the national and municipality authorities.

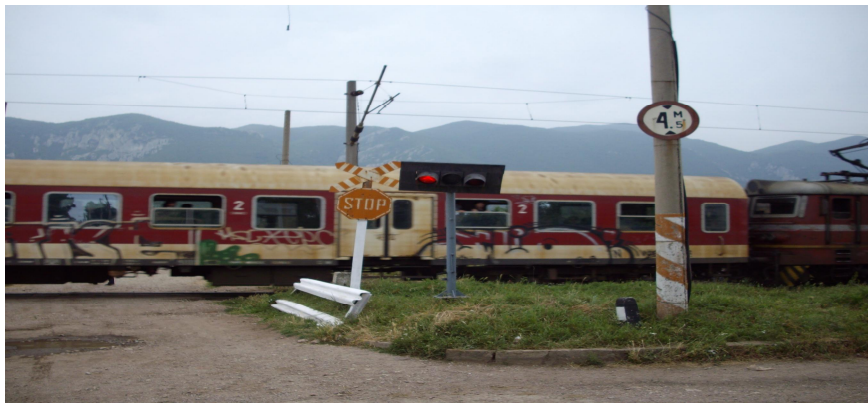
Figure 3

The investigation policemen and the operational group made examination of the equipment of the crossing and a statement of facts for ACA was drafted. After releasing the traffic are made tests of ACA. It was established that in both directions ACA works properly. This is seen on Figure 3.
