# **NIB ANNUAL REPORT 2009**

Accident Investigation Board

FINLAND

## PREFACE TO THE REPORT

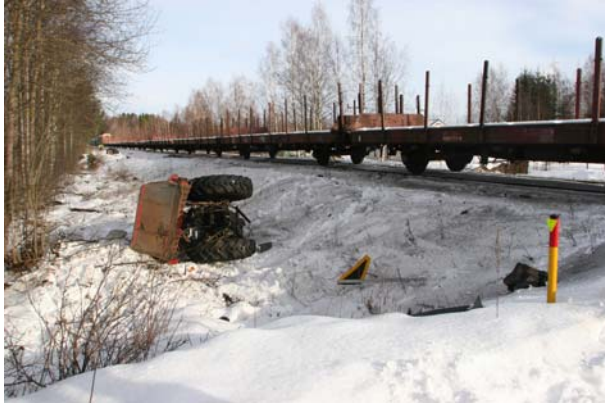
**B1/2008R**

**Fatal level crossing accident in Laukaa on  
25 February 2008**

On 25 February 2008 at 9.53 a.m., a fatal level crossing accident occurred on Laukaa's Kauramaa unprotected level crossing. A tractor returning along an agricultural road from ploughing work drove without stopping in front of a freight train en route from Jyväskylä to Suolahti. The only person in the tractor was the driver, who died from his injuries in hospital later that day. The damage to the tractor and rolling stock totalled around € 30,000.

The accident occurred because the driver of the tractor did not observe the approaching train and drove onto the level crossing without stopping. Furthermore, the crossing did not meet level crossing safety requirements on the part of the wait platform and with respect to sightline. Too short a wait platform, in particular, may have caused the driver to focus more than usual on controlling the tractor, to which extra equipment was hitched, as it approached and arrived at the crossing. The driver's visibility may also have been impaired due to the sun shining against him. The agricultural road was intended only for agricultural use and not for through-traffic.

In order to prevent similar accidents, the accident investigation commission recommends the removal of the Kauramaa level crossing. Two safer routes in the vicinity of the track offer access to the agricultural fields. In addition, the accident investigation commission pays attention to the notion of the Ministry of the Interior Rescue Department that mobile phones should be used in the localisation of accidents, or, alternatively, that the feasibility of supplying all trains with GPS positioning equipment should be reviewed, which would ensure fast and accurate relay of location information to the emergency response centre. As other observations, the investigation commission suggests that tractors used in road traffic should be equipped not only with safety cabins but also seat belts.

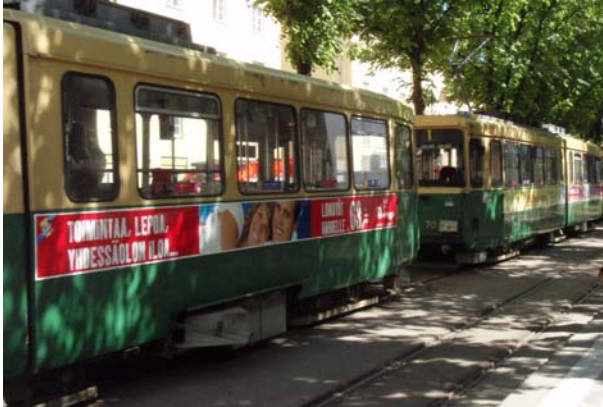
## B2/2008R

### Collision of trams on Mäkelänkatu in Helsinki on 13 June 2008

On Friday, 13 June 2008, at 1:50pm, a line-1 tram collided with the rear of a line-7B tram on the Mäkelänrinne stop, on Mäkelänkatu, in Helsinki. Two passengers were severely injured. A tram driver and 22 passengers were slightly injured. Several others received lesser injuries such as bruises and neck and shoulder pain and headaches caused by whip flash. The rails were not damaged and the trams remained on the rails. The rear of the line-7B tram was substantially damaged. For example, the chassis of the rearmost car was bent out of shape. The front of the line-1 tram was somewhat damaged, but after minor repairs it was temporarily operative. The damage to the trams resulted in a total cost of EUR 60,000.

The cause of the accident was that the driver of the tram approaching from behind was not able to stop the tram in time. The driver apparently tried to stop the tram via incorrect braking methods in the belief that the brakes were not working properly. The background factors were the driver's inexperience, the possibility that the driver anticipated that the tram ahead would leave the stop earlier, and the driver's suspicion that the brakes were not working properly and therefore the use of the incorrect braking method.

In order to prevent the occurrence of similar accidents, the investigation commission recommends that tram drivers be taught to brake in the proper way. In order to specify just one correct way to brake in different kinds of situations, Helsinki City Transport should determine the most efficient way to brake for each type of situation. In addition, tram drivers should be provided with a personalised and progressive training programme in which performance is documented and thus skills are proved to be properly learned.

In order to ensure that floor hatches do not release during collision or other situations and thereby cause injury to passengers, the investigation commission recommends that methods be sought to ensure that tram floor hatches remain fastened in all conditions. In order to improve first-aid availability on trams, the commission recommends that trams be equipped with a first-aid kit.

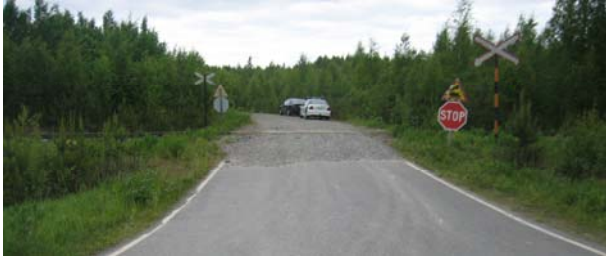
**B3/2008R**

**Fatal accident at the Huikuri level crossing  
in Liperi, Viinijärvi on 25 June 2008**

On Wednesday, 25 June 2008, at 4:22.50 pm, a level crossing accident involving a scooter and a rail bus en route from Joensuu to Pieksämäki occurred at the Huikuri level crossing. The accident was fatal to the driver of the scooter. The personnel and passengers of the rail bus remained uninjured. The scooter was wrecked beyond repair. The rail bus incurred damage to its left front corner and the obstruction clearing device. The repair costs of the rail bus amounted to EUR 1,400.

The direct cause of the accident was that the driver of the scooter drove onto the level crossing without stopping. The driver of the scooter probably did not notice the rail bus at all or saw it too late. Contributing to this were the following factors:

- the level crossing was very close to a highway with substantial traffic
- the driver of the scooter was focusing on maintaining balance as the road surface changed from tarmac to gravel
- the level crossing was not equipped with an active warning installation
- the rail bus was approaching the crossing at 120 km/h
- rail buses are silent and quite neutral coloured, which makes them difficult to see.

In order to prevent similar accidents, the investigation commission recommends that the Huikuri unprotected level crossing be removed. Furthermore, in order to improve railway safety, the investigation commission reiterates recommendation S230 of investigation report B2/2007R: *The structure of the obstruction cleaning device of Dm12 rail bus should be such that it is either formed of one piece or possible additional parts are attached sufficiently well.*

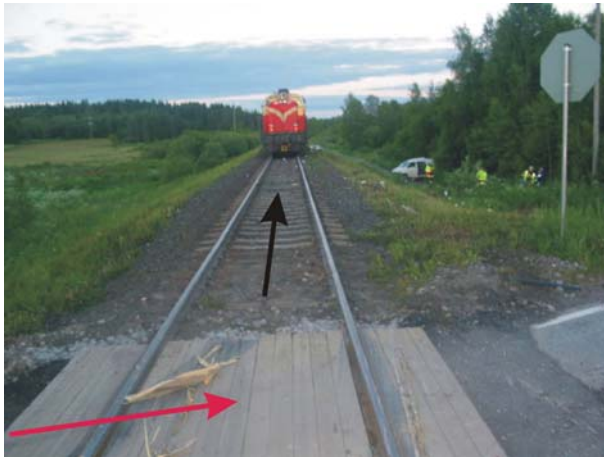
**B4/2008R**

At 22.41.40 on Monday 7 July 2008, a van and a train consisting of two locomotives en route from Ylivieska to Iisalmi collided on the Vehkatie unprotected level crossing in Kiuruvesi, resulting in the death of the van driver. The van was wrecked beyond repair and the locomotive's front and bogie structures were slightly damaged. The cost of the accident on the railway side was in excess of € 50,000.

The direct cause of the accident was that the van driver drove onto the level crossing without stopping. It is probable that the driver noticed the approaching train too late and was unable to avoid the collision. The evening sun was shining low on the horizon from the direction of the approaching train and this may have made observation difficult. It is possible that the driver's attention was focused on a newly arrived text message or that the driver was looking for the mobile phone. It is also possible that visibility in the direction of the train was blocked by the vehicle's chassis structures, because the vehicle approached the level crossing at an angle to the track.

In order to prevent the occurrence of similar accidents, the investigation commission recommends the removal of the Vehkatie level crossing. Before its removal, the level crossing should be closed by Kiuruvesi town through temporary arrangements. Also, a track speed limit of 70 km/h should be set to run through the crossing until its removal. Furthermore, "No thoroughfare!" signs should be placed without delay on Vehkatie road and the Ratakatu-Kirkkoharjuntie crossing, and heavy vehicles should be prohibited from driving through the level crossing.

In order to ensure the accuracy of level crossing location information, the investigation commission recommends that emergency response centres update the level crossing location data of their ELS systems to match the tasoristeys.fi database, as set out in the relevant regulations.

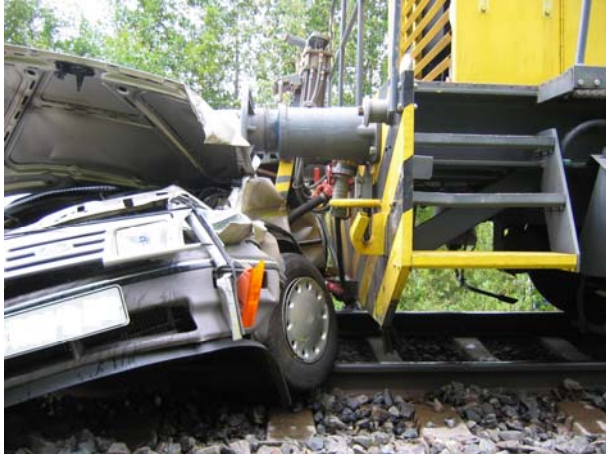
**B5/2008R**

**Fatal level-crossing accident in Suonenjoki  
on 26 August 2008**

The accident was fatal to the driver of the car. The car was damaged beyond repair and the railway work unit, which was a service railcar, incurred minor damage.

The direct cause of the accident was that the car driver drove onto the level crossing without stopping. In all probability, the driver completely failed to observe the railway work unit approaching from the left. The lack of a proper wait platform, a sharply rising road and limited visibility made it difficult to observe the surroundings and drive the car at the same time.

To prevent the occurrence of similar accidents, the investigation commission recommends that the sightlines of the level crossing be improved and the wait platforms reconditioned to meet regulations, and that the level crossing be equipped with a warning sign. If it becomes apparent that sightlines cannot be improved and that the wait platforms cannot be reconditioned, then the level crossing should be removed or equipped with a half-barrier.

In addition, the investigation commission recommends that the Finnish Rail Administration inform the parties in charge of road maintenance of their obligation to build and maintain road segments leading to level crossings as set out in the relevant regulations. The Finnish Rail Administration should also provide appropriate information on any track changes made and shortcomings discovered during inspection rounds. It is also suggested that the Finnish Rail Administration and the Ministry of Transport and Communications initiate a nationwide campaign about the obligations of road maintainers with regard to level crossings.

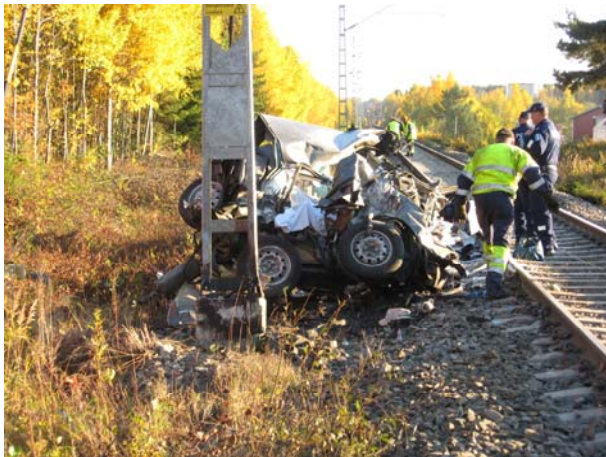
**B6/2008R**

**Fatal level crossing accident in Iisalmi on  
25 September 2008**

On 25 September 2008 at 4.18 p.m., a level crossing accident leading to two fatalities occurred at the half barrier equipped level crossing of Suurisuo in Iisalmi. The accident occurred when a private car driving slowly westward along Parkatintie road collided with a passenger train en route from Kajaani to Helsinki. The two persons in the car died instantly. The car was wrecked beyond repair. The costs arising from the accident to railway rolling stock and equipment amounted to EUR 30,000.

The direct cause of the accident was that the car driver drove onto the level crossing without stopping. The driver applied the brakes only after the car had driven beneath the lowering barrier and was hit by it, with the result that the car stopped on the track. It is likely that the driver did not notice the level crossing warning signs or the lowering barriers. Potentially contributory factors possibly included the sun shining in the driver's face, a worn windshield, the driver's impaired eyesight, hearing and alertness.

In order to prevent similar accidents, the investigation commission recommends that the red blinking filament lamps of the barriers and warning signs of the Suurisuo level crossing be replaced by blinking or flashing LED lights. Identical replacements should be made at similar level crossings where it has been noted that the sun dazzles the driver when approaching the crossing.

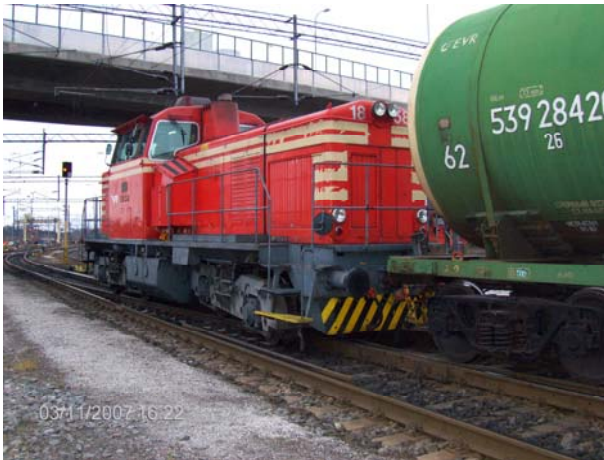
**C7/2007R**

**Derailment of one wheelset of a locomotive during shunting work in Vainikkala on 3 November 2007**

On Saturday 3 November 2007 at 12.59 p.m., one wheelset of a locomotive was derailed at a railway yard turnout in Vainikkala when a shunting unit was pushing wagons onto the track. The turnout tongue was twisted and the Railex locking device was damaged.

The incident occurred because the shunting worker had pressed the local turnout button reversing twice while the locomotive was on the turnout. The first wheelset derailed during the first change in position. The shunting worker gave the second command before the first operation was complete, with the result that the switch blades started turning back and the locomotive's remaining wheelsets were directed correctly along the track.

In order to prevent the occurrence of similar incidents, the Accident Investigation Board of Finland recommends that local turnout reversing buttons be located close to the turnouts.

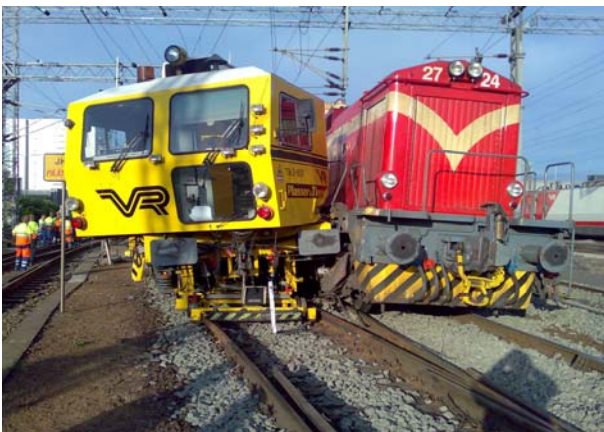
**C5/2008R**

**Collision of a locomotive and a turnout tamping machine at the Jyväskylä railway yard on 8 June 2008**

with a tamping machine involved in work. The engine driver applied the emergency brakes, but the locomotives were unable to stop in time and the front corner of the foremost locomotive collided with the left corner of the tamping machine. The force of the collision caused the right rail to collapse underneath the tamping machine.

The collision damaged the tamping machine in places including the chassis, body, automated controls, bogie and wheelsets. The foremost locomotive incurred damage on the right side of the maintenance deck and hand rails. About 20 metres of track were damaged. The total damage to track and equipment amounted to € 214,000.

The direct cause of the accident was that the front of the tamping machine, which was at work on turnout V032, extended so close to turnout V024 that the locomotives were unable to safely pass the tamping machine. Since turnout V032 was reserved because it was being replaced, turnout V024 was also reserved. In order to control and reverse turnout V024, the traffic controller had to use the VHP<sup>1</sup> command. The traffic controller was unaware of the precise location of the tamping machine. Another factor contributing to the accident lay in the fact that the tamping machine's foreman and the traffic controller had not agreed on the precise limits of the work area.

In order to prevent the occurrence of similar accidents, the Accident Investigation Board of Finland recommends that track job notifications precisely detail the dimensions of work areas and that the traffic controller ensure that no other units are within the vicinity of the turnout before giving the relevant VHP command. In addition, the recommendation S180 of investigation report B1/2002R is reiterated: "*The initiation training programmes for train operators should be extended to include all stations and railway yards within the area of responsibility of the train operators in question.*"
