The Rail Safety
Inspection Office

NIB ANNUAL REPORT 2022

according to Article 24(3) of Directive (EU) 2016/798

September 2023

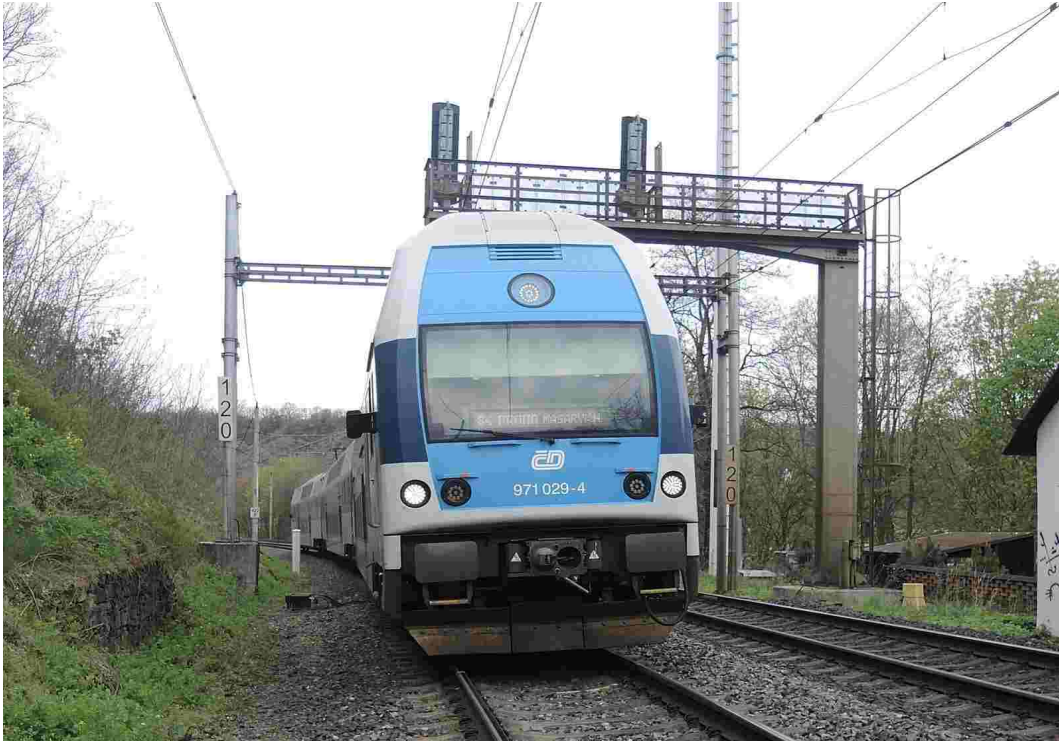
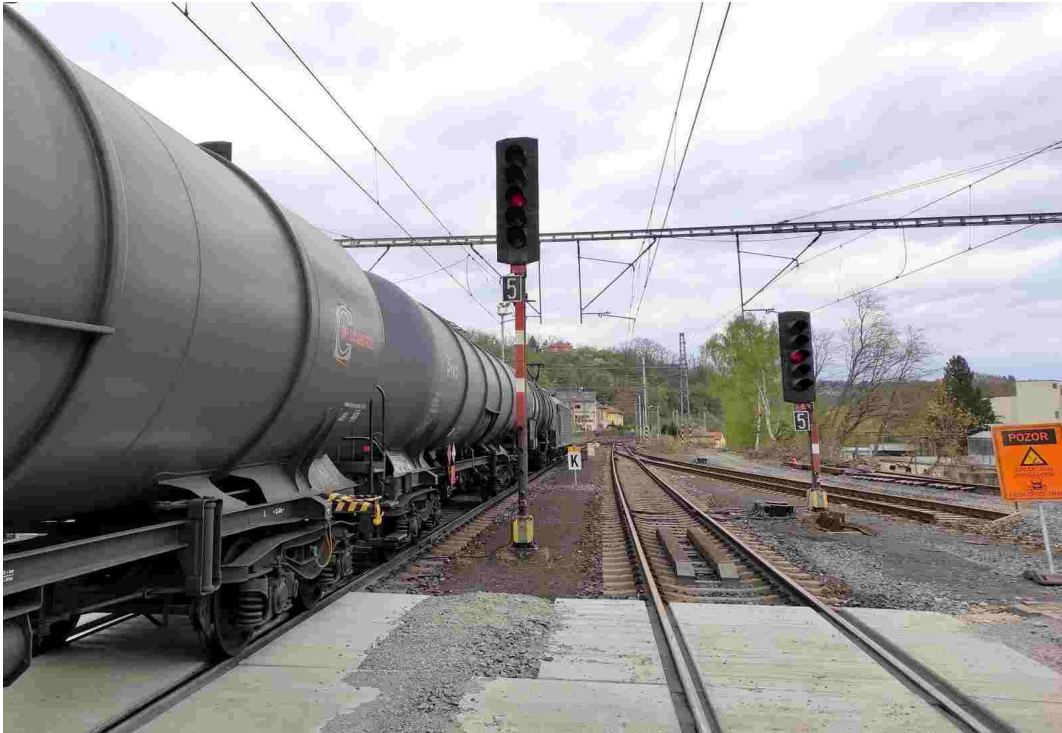
- Date and time: 10th May 2021, 6:12 (4:12 GMT).
- Occurrence type: unauthorized movement.
- Description: unauthorized movement of the regional passenger train No. 9608 behind the main signal device and entry to the train route for the regional passenger train No. 6903.

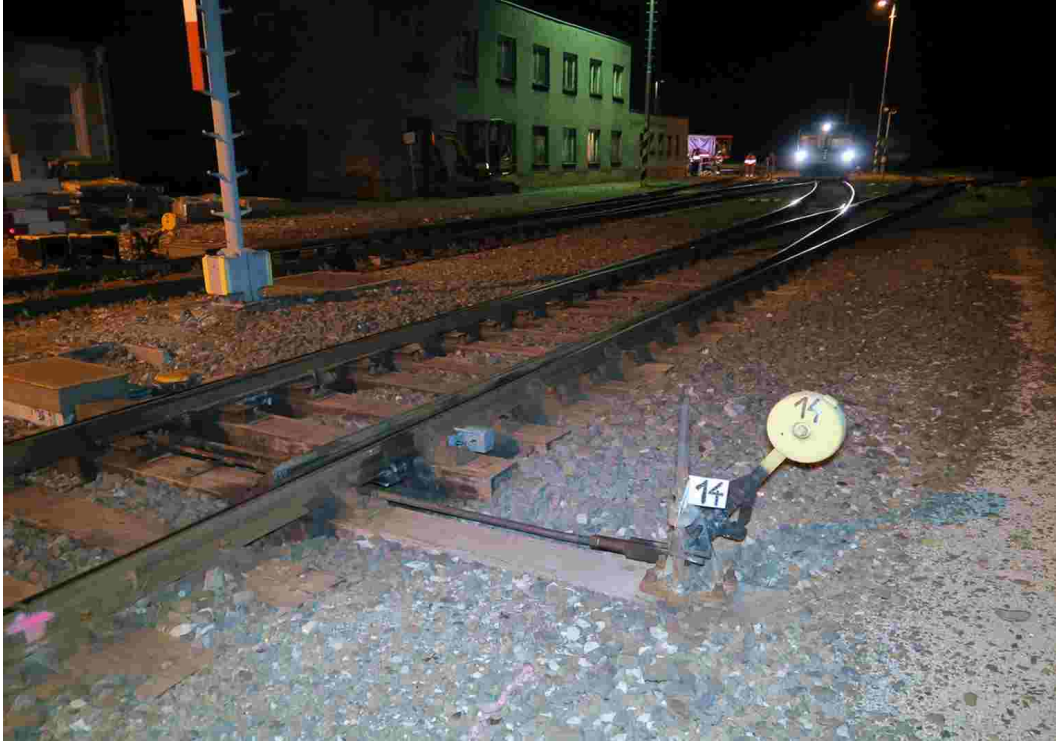
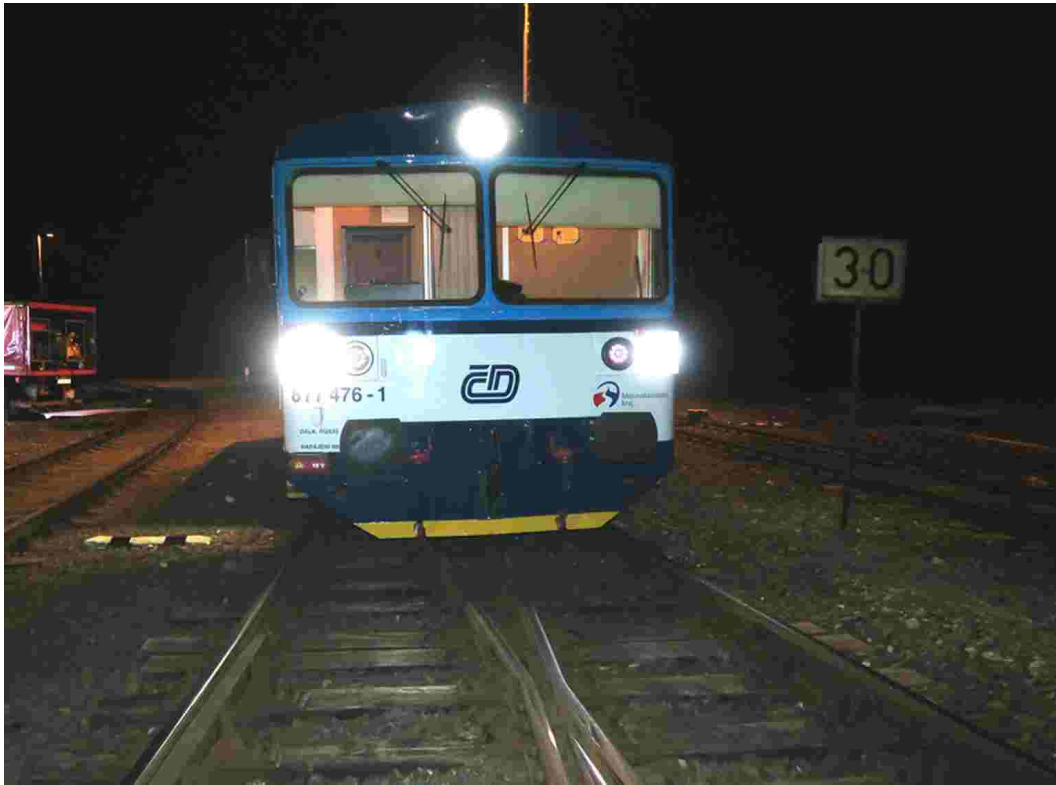
- Date and time: 18th June 2021, 10:10 (8:10 GMT).
- Occurrence type: a train collision.
- Description: an unauthorized movement of the shunting operation behind the signal device Se12 and its consequent collision with the standing regional passenger train No. 9010.

instructions for driving the individual and connected (active) locomotives will be feasible in practice, simple and unequivocal. Until the modification of the Decree No. 173/1995 Coll. will be done it is necessary to determinate the rules in case, when it is not possible to drive the locomotive from the driver's footplate where it is the best view ensured (when the driver's footplate of the second locomotive for shunting in the opposite direction is practically unattainable), this should be defined including determination of the speed limit.

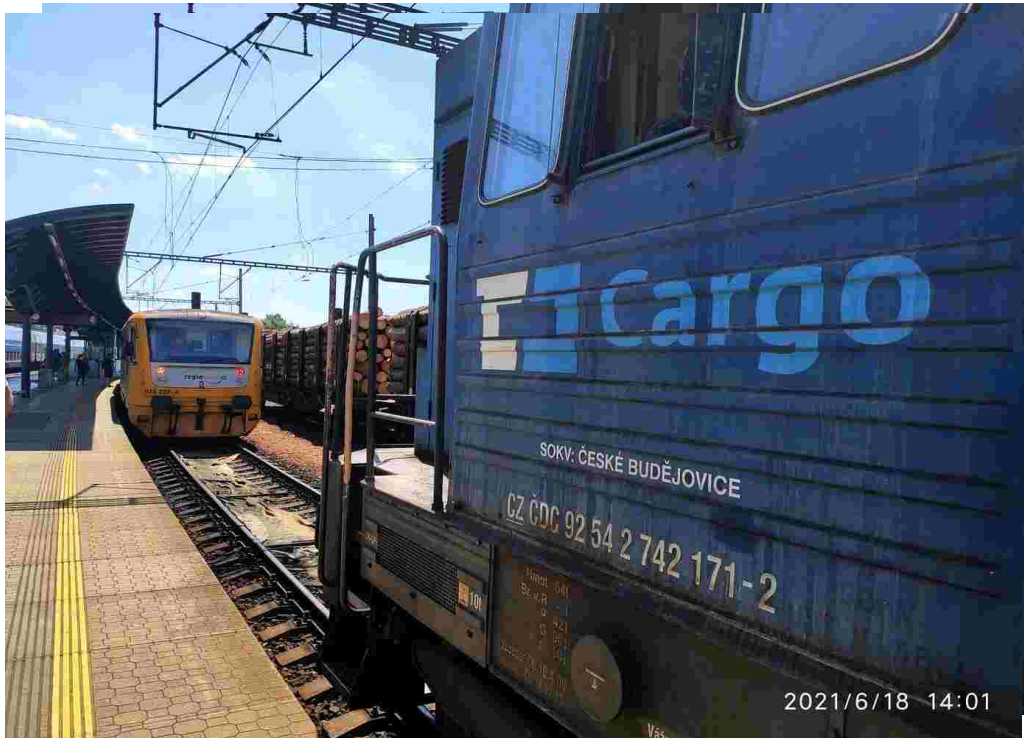
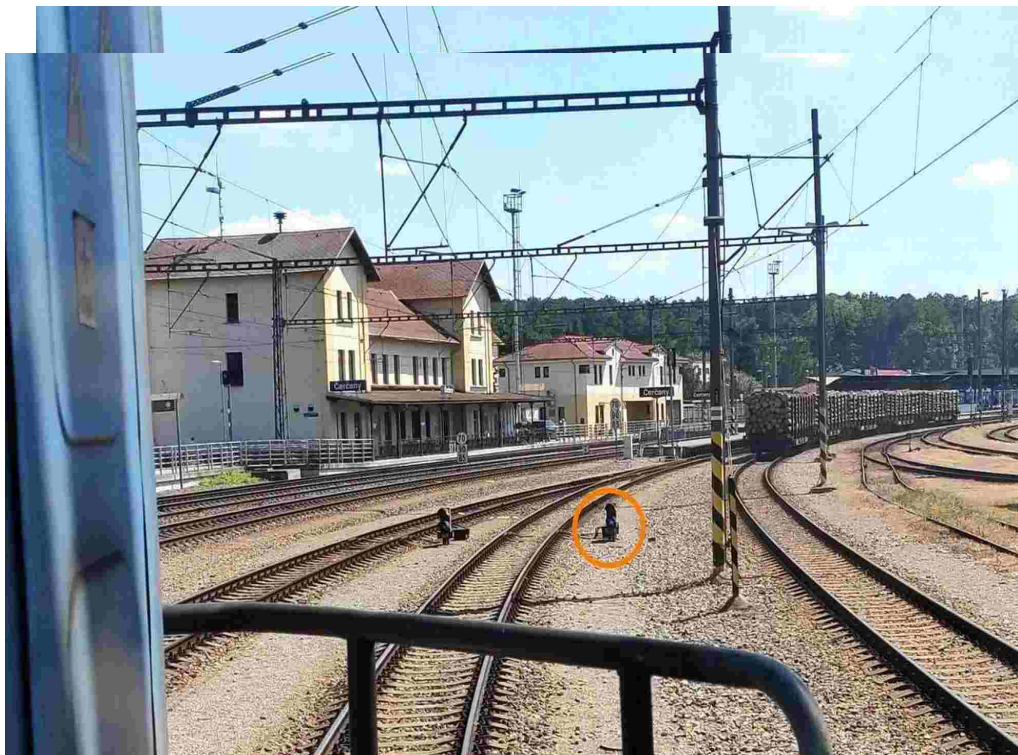
- Date and time: 15th July 2021, 14:19 (12:19 GMT).
- Occurrence type: train derailment.
- Description: derailment of diesel railcar of the regional passenger train No. 21209.

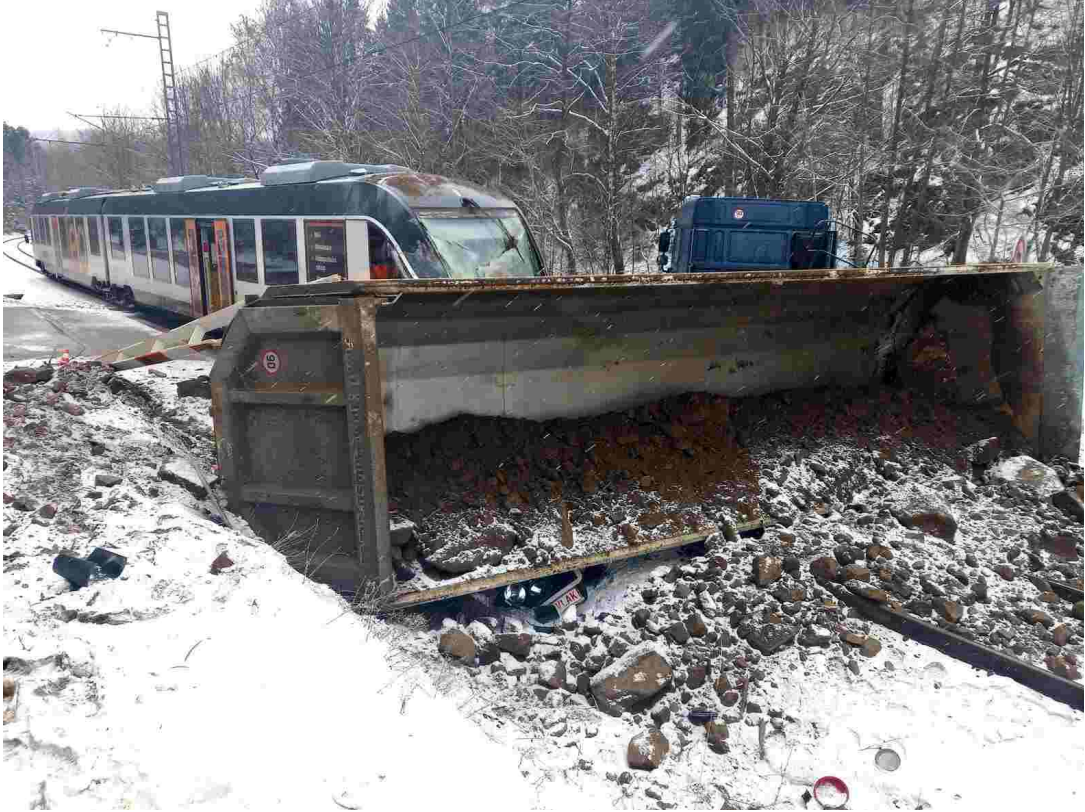
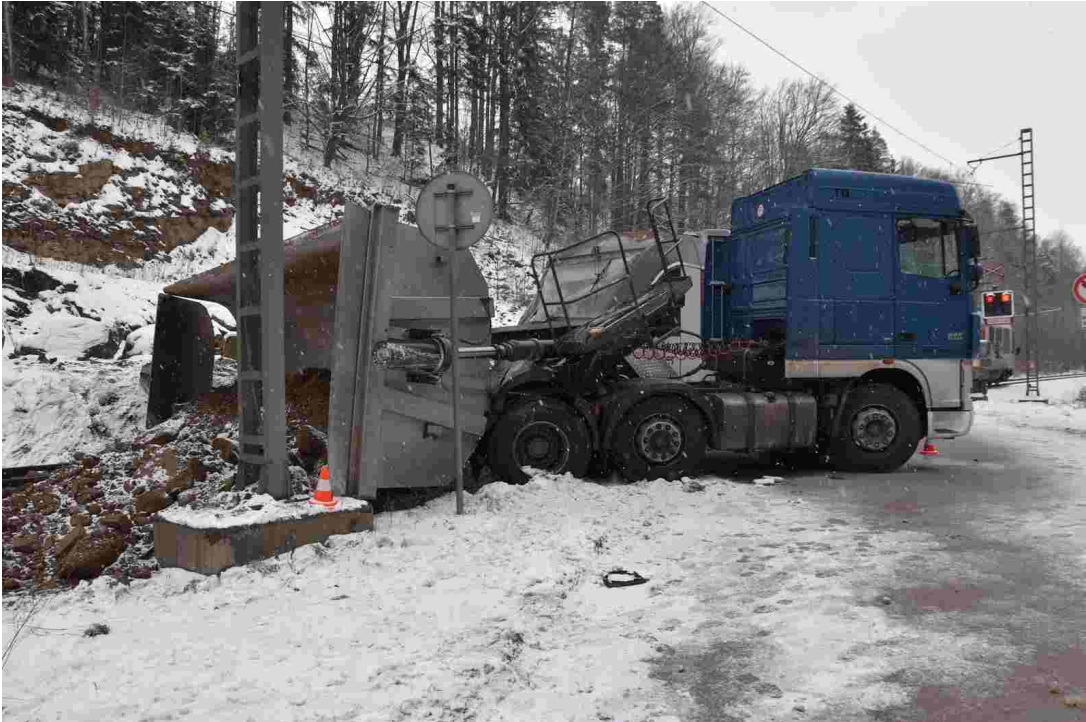
- Date and time: 29th December 2021, 5:45 (4:45 GMT).
- Occurrence type: level crossing accident.
- Description: collision of the regional passenger train No. 14901 with the lorry with consequent derailment.

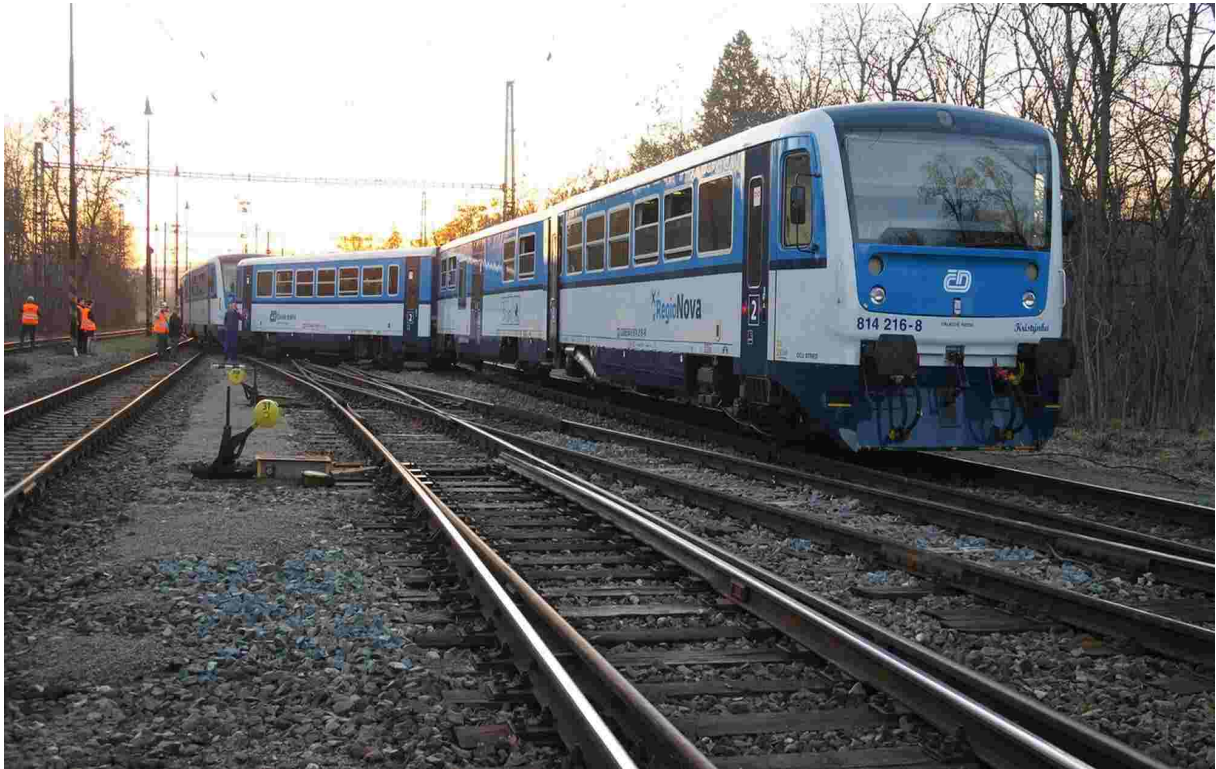
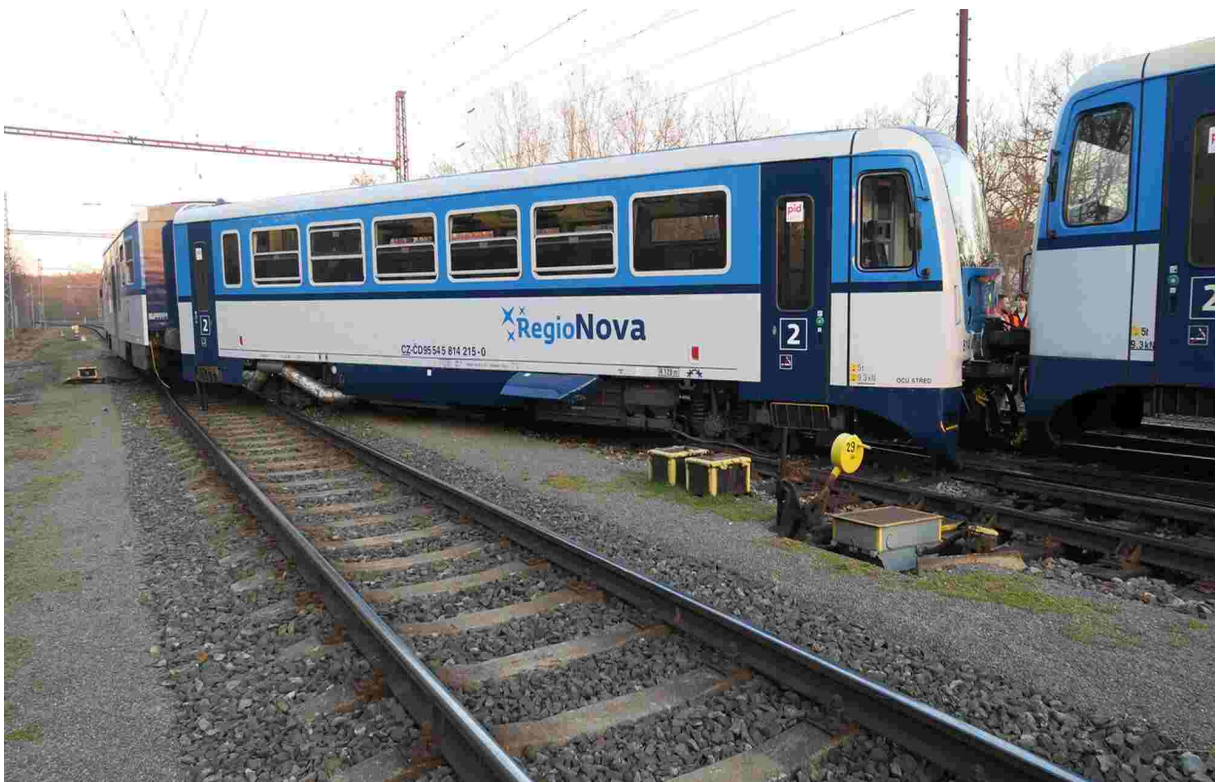
- Date and time: 1st April 2022, 5:56 (3:56 GMT).
- Occurrence type: train derailment.
- Description: unsecured movement of the regional passenger train No. 18000 with consequent derailment.

- Contributing factor:
- none.
- Systemic factor:
- none.
- Recommendation:
- Addressed to the Czech National Safety Authority (NSA):
- as a part of its activities as a national safety authority, to take own measure to ensure installation of construct adjustment for holder of bolt of spring switch mechanism which prevent to locked up of connecting lock (without the switch being in resetting mode) at all IMs who operates switches which are equipped by mechanism of self-returning switch by producer AŽD Praha s. r. o.
