The Rail Safety
Inspection Office

NIB ANNUAL REPORT 2023

according to Article 24(3) of Directive (EU) 2016/798

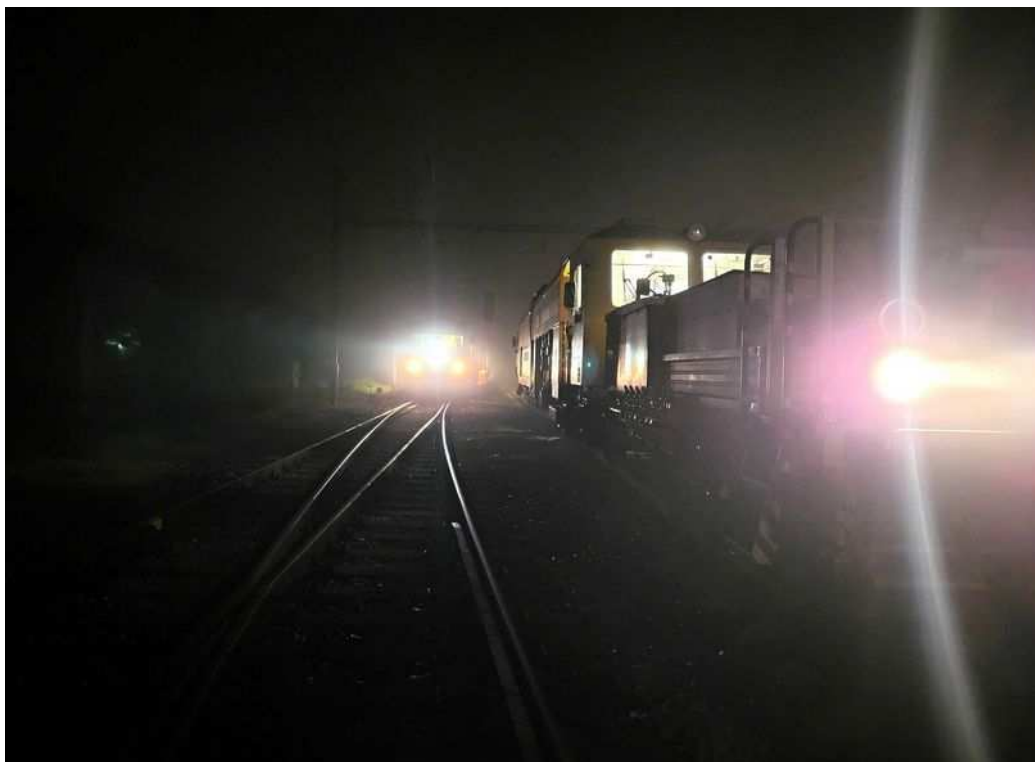
Date and time: 30th October 2022, 20:02 (18:02 GMT).
Occurrence type: unauthorized movement (SPAD).
Description: unauthorized movement (SPAD) of the regional passenger train No. 8415 behind the main (departure) signal device S1 and entry to the train route for the regional passenger train No. 8416.
Type of train: the regional passenger train No. 8415;
the regional passenger train No. 8416.
Location: Vlastec station, the main (departure) signal device S1, km 44,791.
Parties: Správa železnic, státní organizace (IM);
České dráhy, a. s. (RU of the regional passenger trains No. 8415 and 8416).
Consequences: 0 fatality, 0 injury;
total damage CZK 6 703,-
Causal factor:
