MAJANDUS- JA
KOMMUNIKATSIOONI-
MINISTEERIUM

Unit for Investigation of Railway Accidents

Annual report of railway accidents investigated in 2009

Tallinn 2010

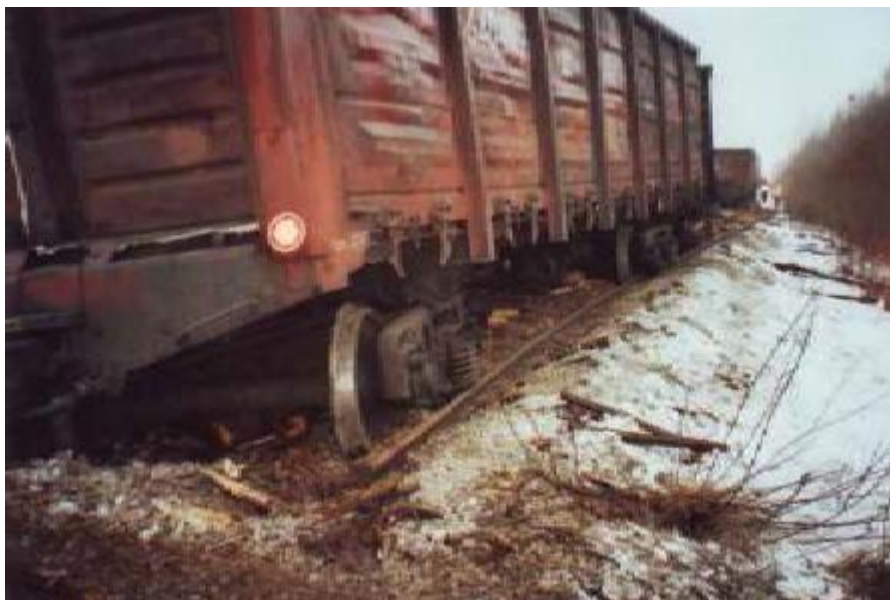
Kunda 04.12.2008

In the daytime, at 13.15, six last wagons of the freight train belonging to AS Kunda Trans were derailed on the railway infrastructure of the same company on Kunda – Rakvere open track in Aluvere fen.

The freight train was travelling at the speed of 38km/h instead of allowed 25km/h on the rail embankment of low maintenance. During autumn rains the track bed under permanent way had softened because of excessive moisture accumulated there. Vibrations generated by the train lead to the movement of soil. The interaction of train weight and displacement of soil lead to rail fracture and breaking of sleepers, that in turn caused the derailment of the last wagons.

People were not injured in the accident. The six derailed wagons suffered damages, their wheelsets, bogies and brake and couple systems were damaged. Railway infrastructure was damaged to the extent of 138m. The rail fracture was fixed and sleepers were replaced in a 1 km track.

The investigation report included five recommendations made to AS Kunda Trans for improvement of their safety management system, for specification of the extent of their

employees' responsibility and strengthening of supervision. Two recommendations were made to the Safety Authority for management of supervision.

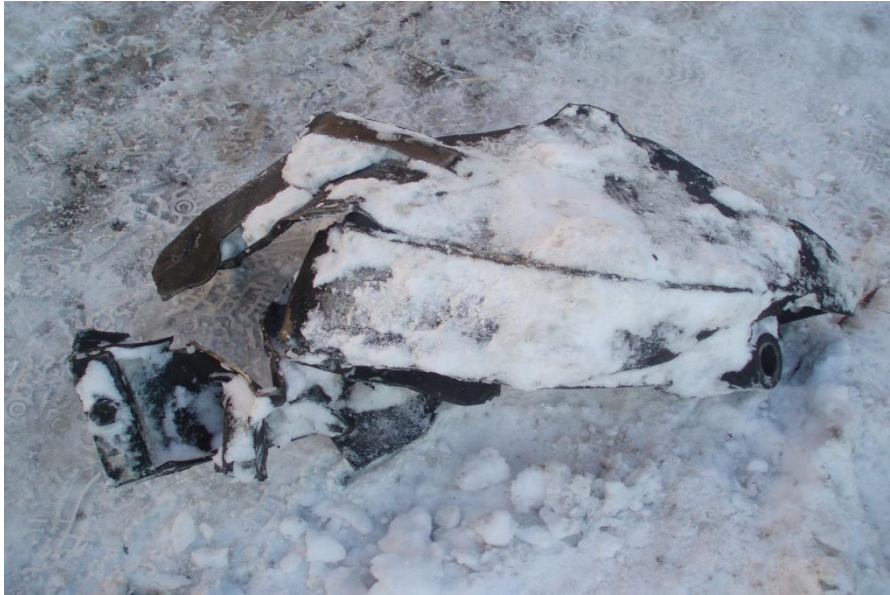
Vaivara 18.02.2009

At 09.24 in the morning the bottom cover of the enclosing frame of gear reducer had come loose in the B-section of the locomotive 2TE116 No. 795 in freight train. After falling into suspension it hit and damaged the guard sleeper of switch No. 30. At the distance of 58m of switch No.30 and while approaching switch No.6 the cover dropped off the enclosing frame and by falling on the track damaged the guard sleeper. The bottom cover of the enclosing frame of gear reducer stopped at the switch heel block. The incident occurred at the switch during entrance to Vaivara station. According to the Railways Act it was an accident. According to the Safety Directive it was an incident.

The locomotive had undergone maintenance within the last 24 hours in a locomotive maintenance unit in the Russian Federation and they had discovered a dent in the rolling section of the metal tyre located at the sixth wheelset, but the dimensions of the dent were within tolerance limits. We are not convinced that the bolts of the bottom cover of the gear reducer were rigidly fastened.

The cause of the accident was the clearance of the fastening bolt in the bottom cover of the gear reducer, loosening of the fastening of bolts, falling off of bolts and falling down of the

bottom cover of the gear reducer and its coming loose of the gear reducer. The contributing factor was the resonance generated during rotation of the dent, located in the rolling section of the metal tyre of the sixth wheelset, with the vibration of the tip of the clearance of the bottom cover.

Four recommendations were made to the RU in the investigation report for improvement of railway safety and reduction in the number such accidents: as a part of the safety management system of the undertaking to specify documented instructions on carrying out inspection of locomotives, to analyse different activities of the inspection of locomotives during training of locomotive crews, to develop practical skills of locomotive crews in following instructions and to ensure carrying out of maintenance in accordance with legal acts. The Safety Authority was made a recommendation to analyse requirements established for maintenance.

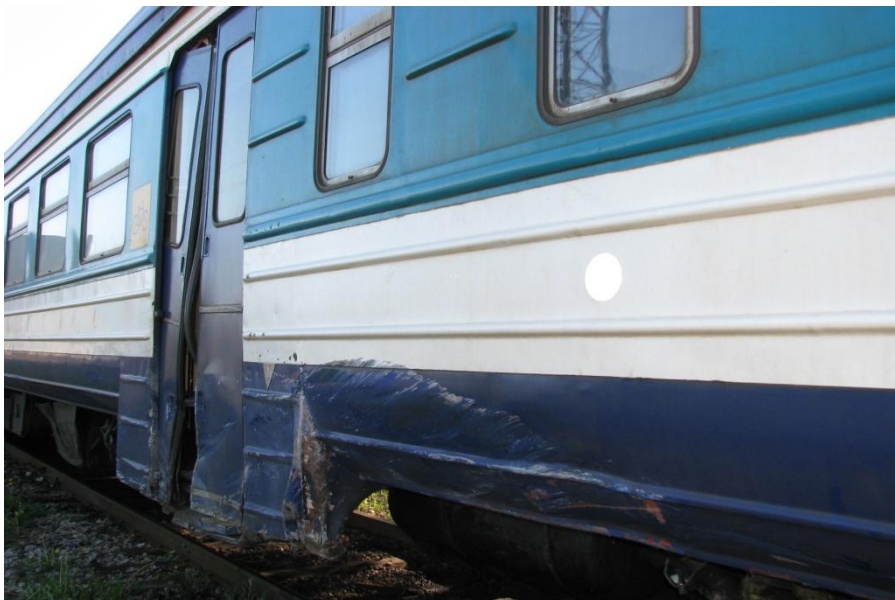
Vägeva 24.05.2009

At 18.35 in the evening a car collided with a passenger train at automatically regulated Vägeva level crossing while driving along a rural road.

The car driver was slightly intoxicated by alcohol, did not pay enough attention and was driving too fast for the traffic conditions. He crashed into the side of the train between the first bogie and the first vestibule. The fact that it was difficult to see the flashing traffic lights of weak intensity in bright sunlight was also instrumental to the event.

As a result of collision the car was thrown to the meadow next to the road, the car driver died, the car overturned, stopped on its roof and became unfit for use. The compressed air system and power system and automatic doors of the railcar DR1B-3720 at the head of a 5-car diesel train were damaged. The surface of external paint was damaged as well as the compressed air system of the railcar trailer DR1B-4720 that was the second car of the train.

A recommendation to the IM in the investigation report was to plan equipping the level crossing with modern crossing traffic lights. Five recommendations were made to the Safety Authority. They were asked to map the technical, legal and organisational problems concerning putting into service of automatic control and data recording systems or upgrading and extension of the use of existing systems.

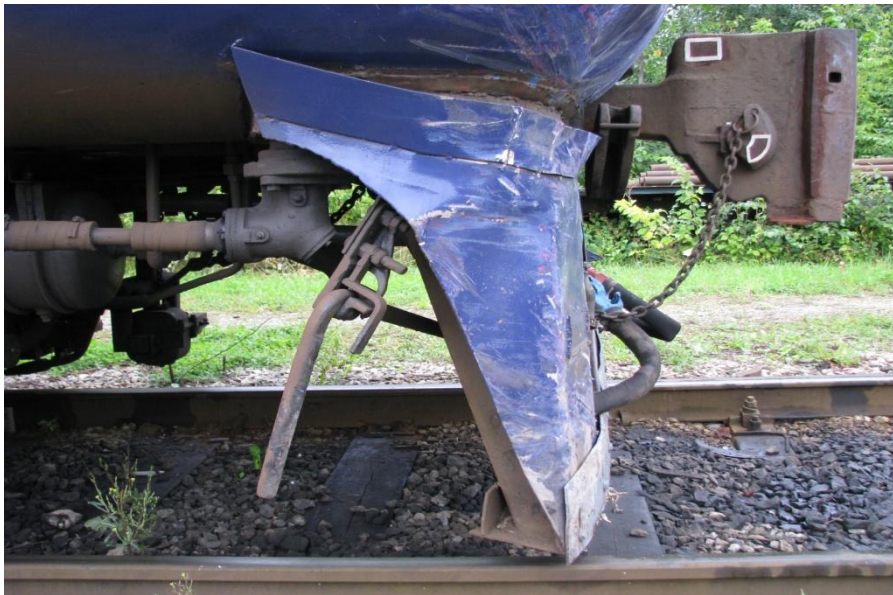
Tiksoja 26.08.2009

At 09.41 in the morning the collision of a passenger train and car occurred on automatically regulated Tiksoja level crossing, outside of densely populated areas.

A diesel train travelling as a passenger train hit the right side of the car. The front of the car was thrown to the oncoming lane and the rear into the ditch, out of the road. The train stopped on the tracks at 260 m from the level crossing.

Following the accident the car driver, who was alone in the car, died. The automatic coupler, snow plough and compressed air hoses of the railcar DR1BJ-3717 at the head of the 3-car diesel train were damaged as a result of the accident. Railway infrastructure remained intact. The car broke into two parts. The whole body and the right side of the car were damaged. Glass was broken and the doors on the right side and the passenger seat were torn off. The car became unfit for use.

Railway safety conditions are worsened by a dwelling, outbuildings and orchard located at the distance of 15.5 m from the level crossing. They are blocking the visibility of the locomotive crew and car driver of each other.

At the end of the investigation report there were two recommendations made to the IM for making risk analysis of the level crossing. One recommendation was made to the Safety Authority for evaluation of the adequacy of the risk analysis. The police were made a recommendation for executing surveillance and the local government received a recommendation for finding a new place of residence for these people.
