NIB ANNUAL REPORT 2022

Safety Investigation Authority

This is the annual report of railway sector of the Safety Investigation Authority, Finland for calendar year 2022.

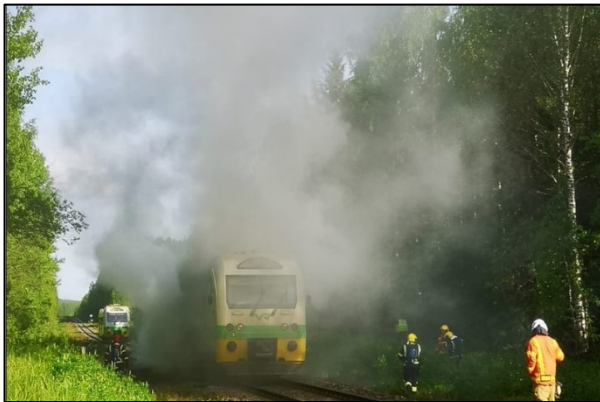
R2021-01 (ERA FI-10069)

Fire in the Dm12 rail bus between Huutokoski and Siikamäki in Joroinen on 5 June 2021

The rail bus sustained considerable damage in the fire. The fire started due to a crack in the fuel return pipe. Fuel leaked inside the engine compartment casing, impregnating the combustible material accumulated there, which caught fire due to the heat of the turbocharger. The structure of the engine compartment of a rail bus allows impurities to accumulate inside the casing, creating favourable conditions for a fire. The purpose of the casing is to prevent problems caused by the snow and ice that accumulate around the engine during winter. Cleaning the space in railway yard conditions is difficult.

- 1. VR-Group Ltd ensures that the rolling stock is maintained in the safe condition required by the authorisation for placing in service.*
- 2. The railway operators inspect the types of extinguishers available on the rolling stock and ensure that they have been selected correctly in relation to the most likely types of fire.*

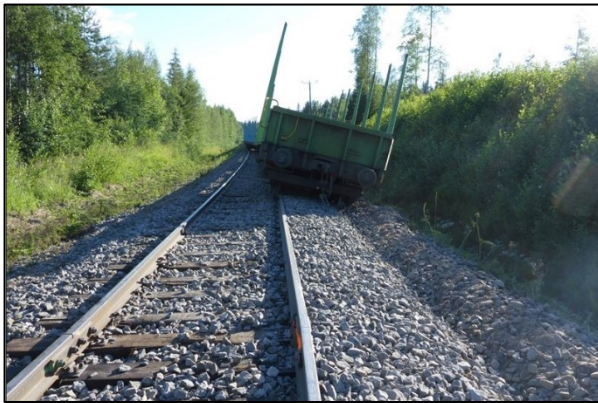
R2021-02 (ERA FI-10083)

**Derailment of a freight train in Vesanka on
3 July 2021**

The derailment of the wagons was caused by two separate lateral movements that formed under the freight train, that is, track buckles. When the hot weather continued, the track support structure

that had become weakened further due to the railway work was not able to provide sufficient support for the tracks. The rail joints that were in poor condition were not flexible enough when the rails heated, which also contributed to the formation of track buckles.

- 1. The Finnish Transport Infrastructure Agency instructs that when preparing for railway work on the surface structure of sections of track where the support layer is weakened, the condition of the support layer and the rail joints should be examined, and they should be taken into account in the planning, scheduling and implementation of the work. The ability of the rail to withstand lateral forces in particular must be verified in the final inspection.*

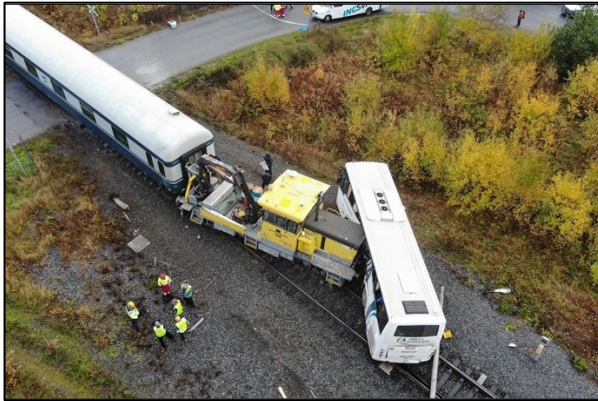
R2021-03 (ERA FI-10140)

Level crossing accident in Kaskinen, 5 October 2021

The bus driver and the seven passengers on the bus sustained injuries of varying degrees in the collision. The material damage caused by the collision was extensive. The accident did not affect commercial rail traffic.

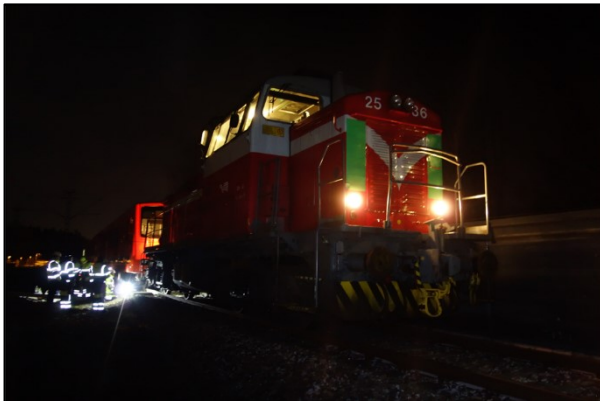
R2021-04 (ERA FI-10162)

R2021-04 Derailment of a train transferring rolling stock in Oulunkylä on 2 December 2021

The train broke in two between the locomotive and the metro. The break occurred because the towing adapter and the metro coupling malfunctioned at the same time. After the train broke up, the brakes of the locomotive locked up automatically after the brake pipe was cut off. A measurement carriage had been connected after the metro to act as the braking unit. However, due to the implementation of the temporary brake pipe, its brakes did not work and as a result, the metro collided with the locomotive. During the collision, the coupling of the metro came loose and fell under the train, derailing the other axle of the metro. The metro suffered significant damage in the accident. The damage to the locomotive and the track were less severe.
