Ministry of
Construction and Transport

ANNUAL REPORT 2022
Transportation Safety Bureau
Hungary

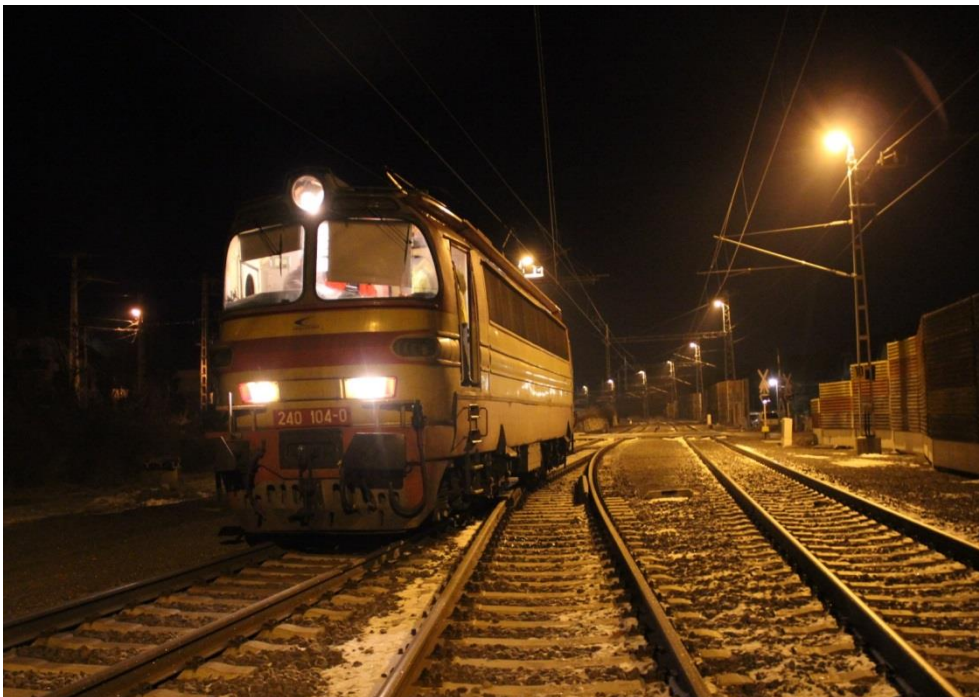
SUMMARY OF OCCURRENCE № HU-10061

- *the traffic control staff on duty at the train regulating signal box II authorised the train to enter the station area on an unenclosed track with the "M" signal at danger, and therefore the safety equipment did not monitor the traffic safety conditions*
- *one switchman, contrary to what is described in the ÁVU, did not observe the train in the window when it was entering, so he could not see where the train was and did not tell the switchman operating the equipment which switches could be changed*
- *the switchman setting the points shifted points 2/a under the incoming train after the first bogie had passed but before the second bogie, diverted the second bogie and caused it to derail*

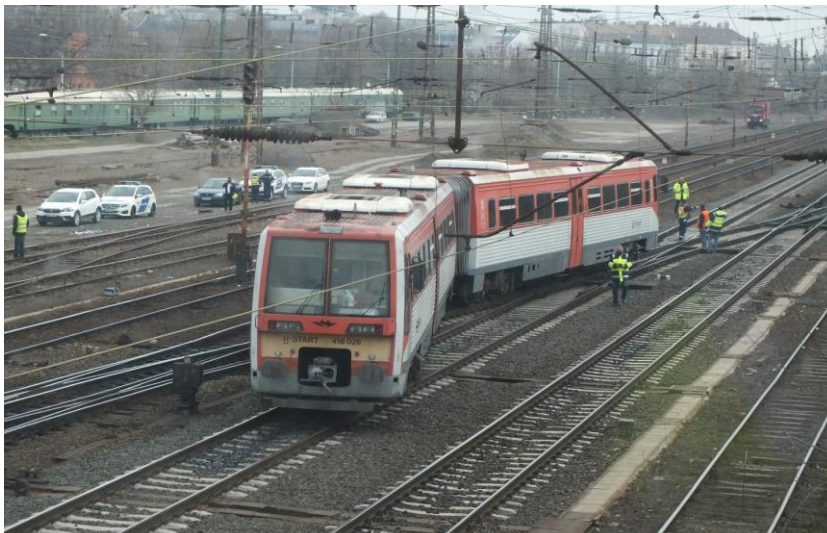
SUMMARY OF OCCURRENCE № HU-10043

Grade:	<i>Railway incident</i>
Date and time:	<i>5 April 2021 (13:06)</i>
Location:	<i>Nagykanizsa (station)</i>
Occurrence type:	<i>Wrong side signalling failure</i>
Movement type:	<i>Regional passenger train</i>
Description:	<i>Train no. 8905 entering Nagykanizsa station accidentally arrived on the occupied track no. II. instead of track no. I. which was locked for this train. The train stopped in a distance of about 50 meters from the InterCity train no. 855, which was waiting for departure. No injuries occurred.</i>
Consequences:	<i>0 fatality / 0 serious injury No damage (0 EUR)</i>
Parties:	<i>MÁV Zrt. (IM) MÁV-START Zrt. (RU)</i>
<u>Direct cause(s):</u>	<ul style="list-style-type: none"> • <i>for the train no. 8905, the switch number 67 was incorrectly positioned, which was not detected by the safety equipment</i> • <i>the switchmen did not check the serviceability of switch No 67 by test setting when setting the track for the train No. 8905</i>

<u>Contributory factor(s):</u>	<ul style="list-style-type: none"> • <i>the station shunting unit burst the switch No. 67 open when pulling it out from Track II, because the switch operators did not set it in the correct position, the shunting crew did not detect the bursting of the switch open</i>
<u>Underlying cause(s):</u>	<ul style="list-style-type: none"> • <i>none</i>
<u>Recommendation(s):</u>	<i>none</i>

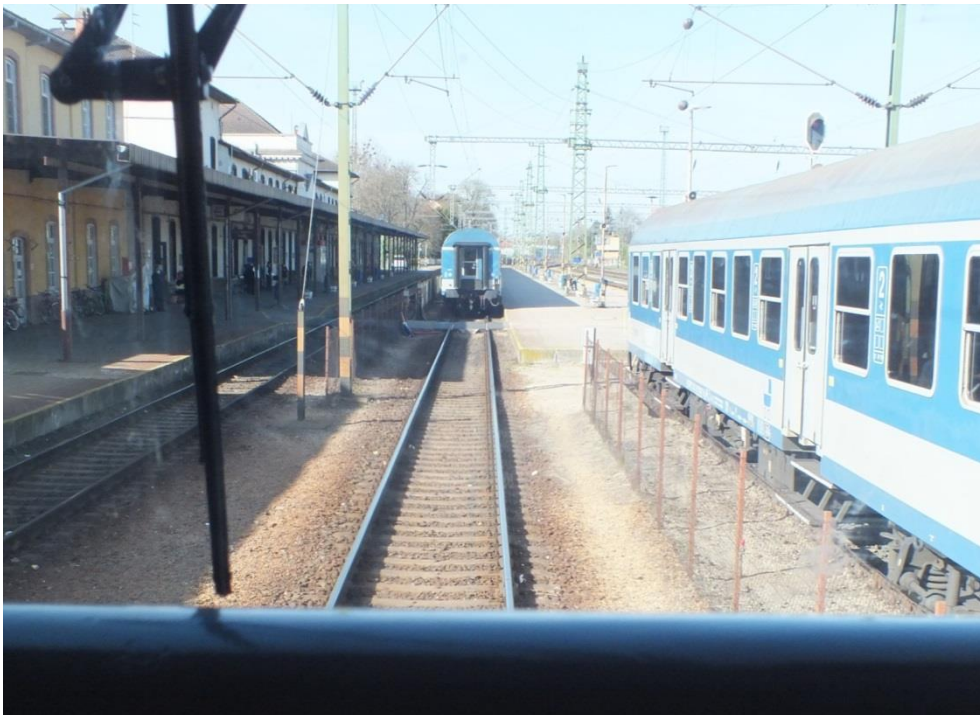
SUMMARY OF OCCURRENCE № HU-10048

Grade:	<i>Railway incident</i>
Date and time:	<i>7 April 2021 (17:35)</i>
Location:	<i>Rákosrendező (station)</i>
Occurrence type:	<i>Unauthorised train movement other than signal passed at danger</i>
Movement type:	<i>Regional passenger train</i>
Description:	<i>Train no. 2376 stopped at Rákosrendező station due to a technical malfunction. After turning away the malfunction, the train departed without permission. It trailed a point and harmed the locked route of train no. 2386. Train no. 2386 stopped immediately. No injuries occurred.</i>
Consequences:	<i>0 fatality / 0 serious injury No damage (0 EUR)</i>
Parties:	<i>MÁV Zrt. (IM) MÁV-START Zrt. (RU)</i>
<u>Direct cause(s):</u>	<ul style="list-style-type: none"> <i>the locomotive driver of the train No 2376, which had stopped at Rákosrendező station due to a technical fault, left without authorisation after the fault had been rectified</i>
<u>Contributory factor(s):</u>	<ul style="list-style-type: none"> <i>the communication between the parties directly involved in the resolution of the situation caused by the in-serviceability, i.e. the driver of the train No. 2376 and the traffic controller of the Rákosrendező station, was insufficient in terms of quantity and content</i> <i>due to his inexperience, the locomotive driver of the train No 2376 was too busy trying to rectify the fault and clear the track and</i>

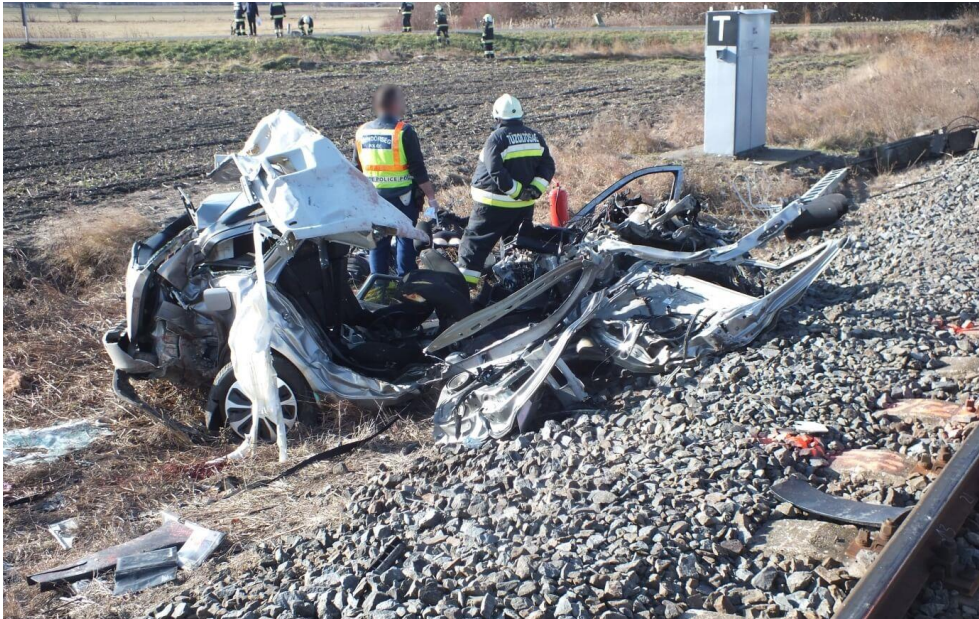
SUMMARY OF OCCURRENCE № HU-10178

<u><i>Underlying cause(s):</i></u>	<ul style="list-style-type: none"> • <i>psychological testing is not a compulsory part of the periodic medical fitness assessment of locomotive drivers, therefore any age-related mental performance deterioration of employees can be hidden</i>
<u><i>Recommendation(s):</i></u>	<i>The NIB recommends that the Ministry of Construction and Transport, as the technical preparatory body for transport legislation, to consider proposing an amendment to Government Decree 203/2009 (IX.18.) on the health requirements and medical examination procedure for employees performing railway transport safety-related tasks, so that psychological examinations are included in the periodic medical examinations of railway vehicle drivers (locomotive drivers) with a specified periodicity.</i>

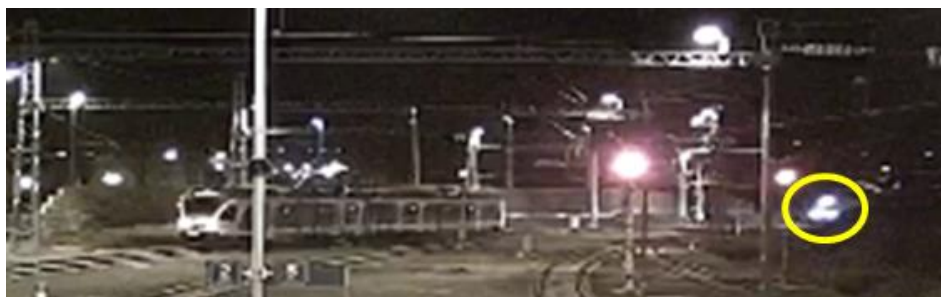
SUMMARY OF OCCURRENCE № HU-10177

<u>Contributory factor(s):</u>	<ul style="list-style-type: none"> • <i>the railway company did not provide the necessary staff to carry out the brake test properly</i> • <i>due to language difficulties, it was not possible to notify the Hungarian traffic management of the emergency in time</i>
<u>Underlying cause(s):</u>	<ul style="list-style-type: none"> • <i>the infrastructure manager did not ensure that, in accordance with the local contract in force, a traffic manager with the necessary language skills is assigned to border-crossing traffic management</i>
<u>Recommendation(s):</u>	<p><i>NIB recommends MÁV Zrt. to review the fulfilment of the expected staff competences in its safety management system to ensure that the language skills of the staff and the applicable language under the border transition contracts are in line.</i></p> <p><i>NIB recommends MÁV Zrt. ensure that the audio recording of the communication equipment (including service mobile phones) used at Hidasnémeti station is properly implemented, including the purpose of making their voice material available. NSA should, where necessary, oblige the infrastructure manager to provide adequate voice recording services.</i></p>

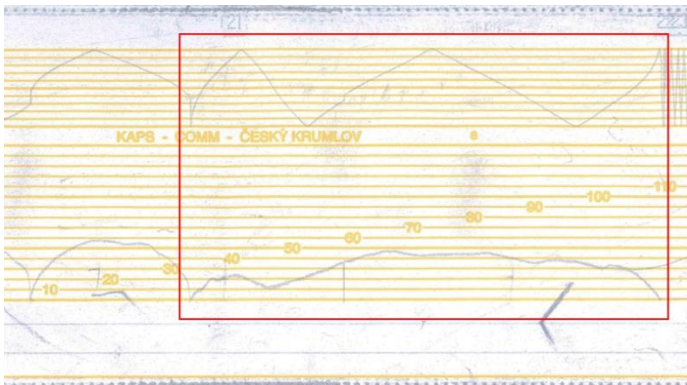
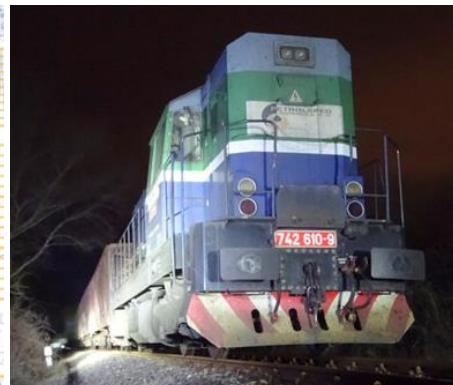
SUMMARY OF OCCURRENCE № HU-10184

<u>Underlying cause(s):</u>	<ul style="list-style-type: none"> <i>the locomotive drivers' valid knowledge of the vehicle type and their decades of driving experience do not necessarily reflect their confidence in handling vehicles, and knowledge is not always at a skill level</i>
<u>Recommendation(s):</u>	<i>none</i>
