# Railway Accident Investigation Unit Ireland

**Annual Report**  
**2020**

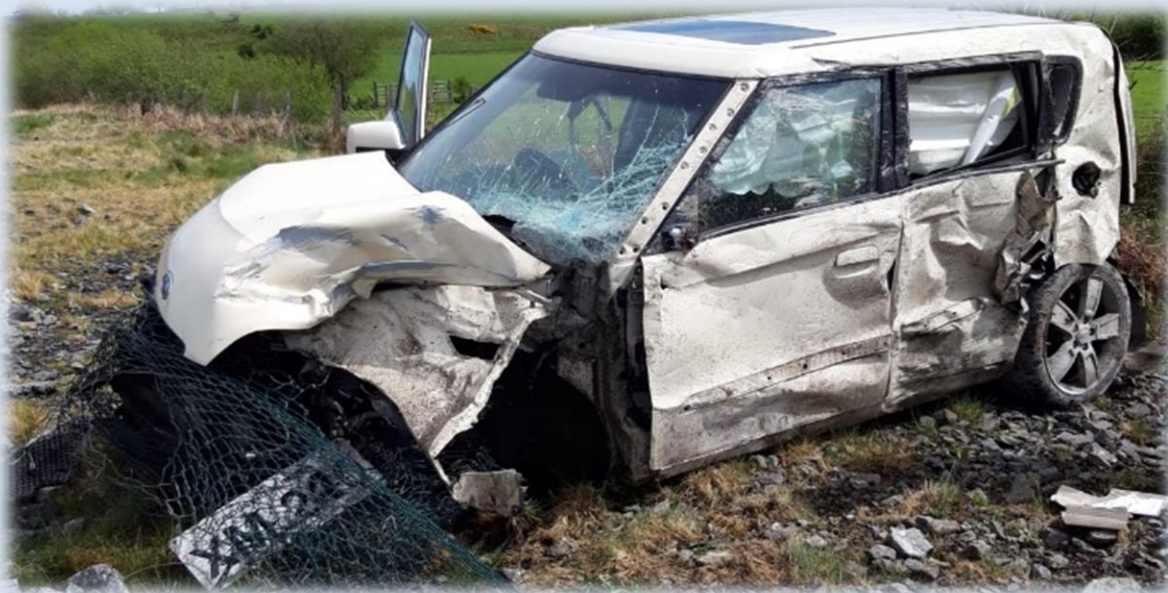
#### Collision between a car and a train at IÉ Kilnageer Level Crossing (XM240), Mayo, 29<sup>th</sup> April 2020

At approximately 13:40 hrs on the 29<sup>th</sup> April 2020, the 13:10 hrs passenger service from Westport to Dublin (Train A809) was approaching Kilnageer Level Crossing (LC) XM240, located approximately six kilometres (km) from Castlebar, County Mayo. At the same time a car approached LC XM240 with the gates open (left open by a previous user) and began travelling through LC XM240. When the driver of Train A809 saw the car, he made a full-service brake application; however, the train could not stop in time and struck the car.

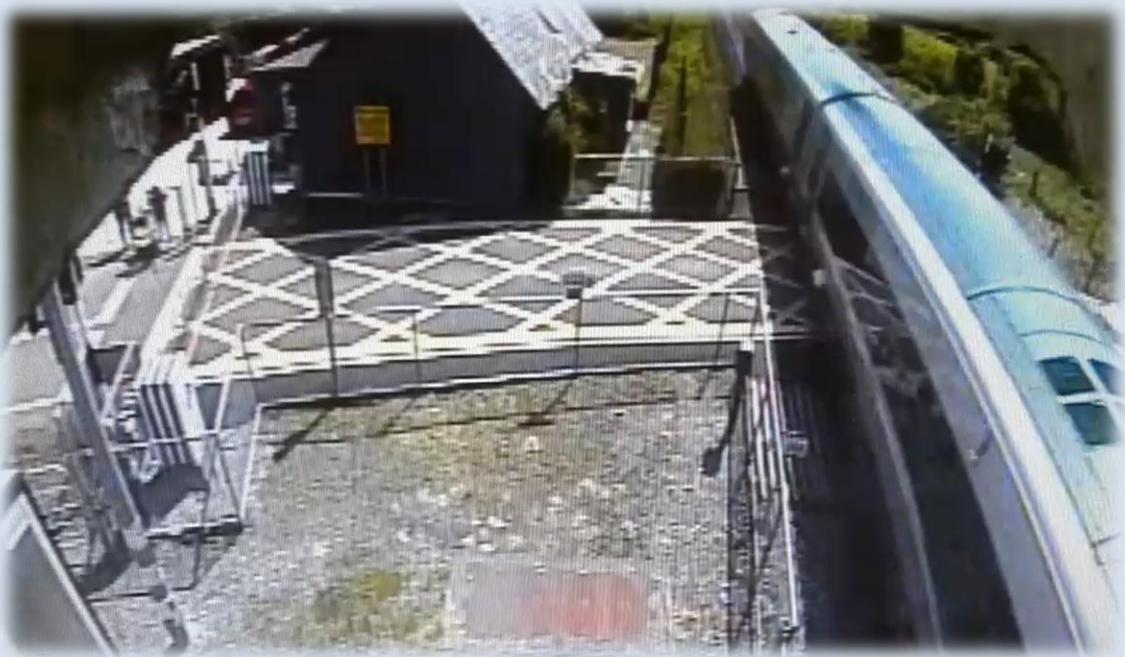
At approximately 12:13 hrs on the 24<sup>th</sup> May 2020, a Level Crossing Control Operative (LCCO), located at Athlone Local Control Centre (ALCC) cleared Closed-Circuit Television (CCTV) Level Crossing (LC) XA068, located in Ashfield, Offaly for the passage of the 11:00 hrs passenger service from Galway to Heuston (Train A703) while a member of the public (MOP) was inside the barriers of the level crossing.

The MOP had requested assistance from LCCO using the telephone provided at the level crossing. LCCO advised the MOP that they would raise the barriers and instructed the MOP to stand beside some level crossing equipment (clear of the tracks, but within the confines of the level crossing). LCCO did not raise the barriers and allowed Train A703 to pass through LC XA068. The MOP was uninjured as a result of this incident.

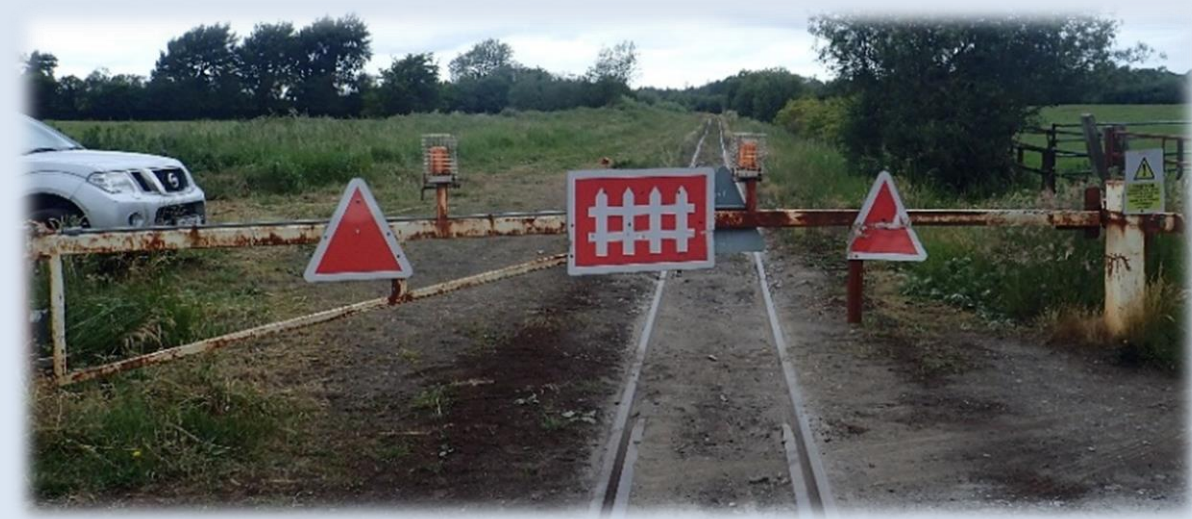
## Collision between a Bord na Móna Flat Wagon and Kilcolgan Level Crossing Gates, Offaly, 8<sup>th</sup> June 2020

At approximately 13:15 hrs on the 8<sup>th</sup> June 2020 a Bord na Móna (BnM) double rake system travelled through Kilcolgan Level Crossing, closing and opening the derailing points to allow passage through the crossing. At some stage after the passage of the double rake through Kilcolgan Level Crossing, the derailing points were placed in the closed position (possibly by trespassers).

Approximately two kilometres away, works were being undertaken at BnM Worksite 610A, Lemonaghan, in preparation for track renewal work. The works included the transport and unloading of ballast at Worksite 610A by means of a Locomotive, a Flat Wagon and an Excavator. During the ballast unloading, ballast fell from the Flat Wagon onto the track; which in turn resulted in the Flat Wagon derailing during a shunting manoeuvre. The Locomotive was uncoupled from the Flat Wagon to facilitate the rerailing and a lifting chain was placed around the excavator bucket and the Flat Wagon coupling. The Flat Wagon was then lifted, aligned with the track and lowered onto the rail. The chain was removed from the Flat Wagon coupling and the Flat Wagon rolled away towards Kilcolgan Level Crossing.

On approach to Kilcolgan Level Crossing, the Flat Wagon passed over the derailing points (in the closed position) allowing the Flat Wagon to continue towards the gates. The Flat Wagon collided with the first gate at Kilcolgan Level Crossing forcing the gate across local road, L70075, before colliding with the second gate forcing it open away from the road. The Flat Wagon came to a stop approximately 50 metre (m) past Kilcolgan Level Crossing.

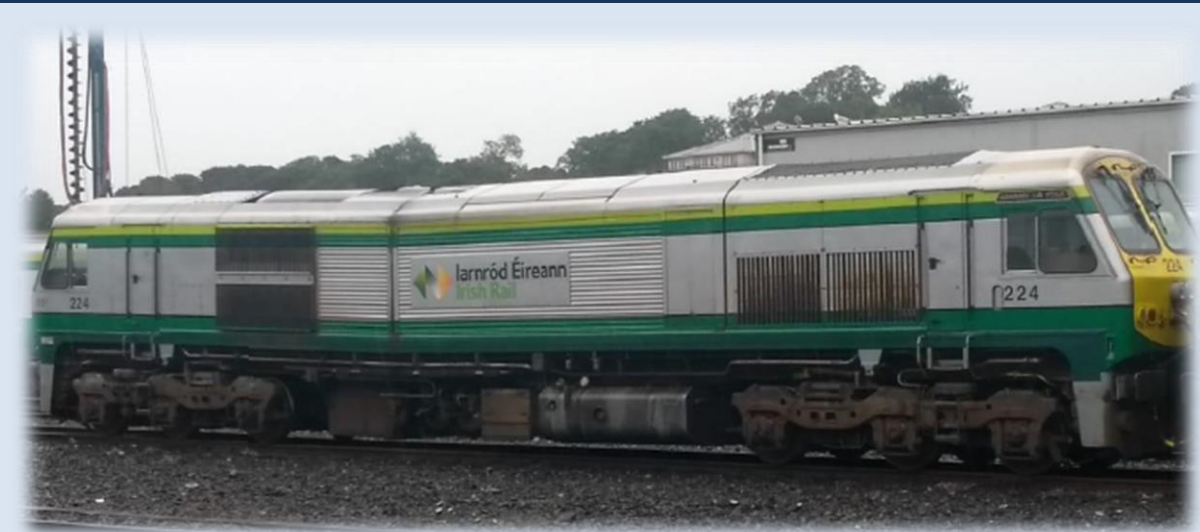
## IÉ Chassis Plate Fracture on General Motors Class 201, Locomotive 224, 7<sup>th</sup> July 2020

On 6<sup>th</sup> July 2020, the 14:25 hrs Cork Kent to Dublin Heuston passenger service operated with Locomotive 224 at the rear. Locomotive 224 experienced a coolant leak and electrical fault that caused the locomotive to shut down while approaching Limerick Junction. The train was deemed a failure and hauled to Heuston Station, Dublin.

On the 7<sup>th</sup> July 2020, while Locomotive 224 was at Heuston Station awaiting transfer to Inchicore Works, a driver observed the body of Locomotive 224 was sagging near the centre point and reported it to his supervisor who in turn alerted the relevant parties. On inspection, by the CME Department's maintenance staff a main frame crack was identified. Locomotive 224 was then shunted to Inchicore Works for a more thorough examination.

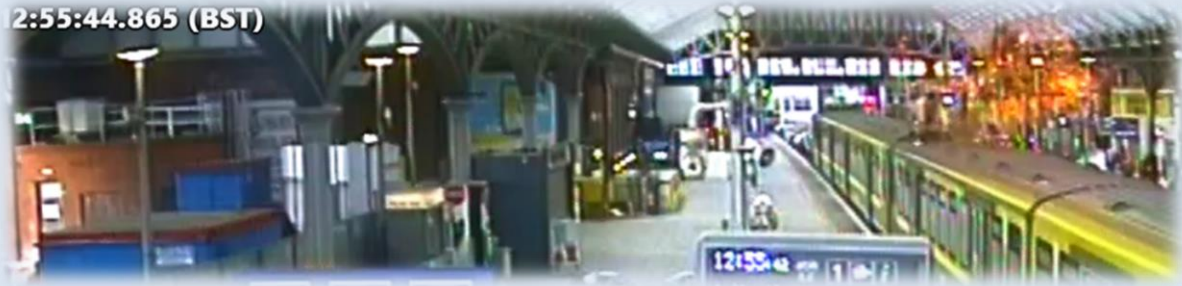
## IE Overhead Line detachment, Pearse Station, 1<sup>st</sup> October 2020

At approximately 12:55 hrs on Thursday 1<sup>st</sup> October 2020, the 12:04 hrs IE DART service from Greystones to Howth (Train E920) was coming to a stop in Pearse Station when the second pantograph (Pantograph 396) of the train set (Unit 8128) lost contact with the Contact Wire of the Overhead Line Equipment (OHLE). The Pantograph Head and Upper Arm lowered rapidly resulting in the Pantograph Lower Arm extending to its maximum reach and contacting the OHLE. This action caused the Pantograph Lower Arm to flip, driving the Upper Arm and Pantograph Head on to the roof of the train resulting a short circuit and a large flashover. The short circuit caused a loss of power to the OHLE in the section. Train E920 coasted before being brought to a stop, on Platform 1, by the driver (Driver E920).

Driver E920, having heard the noise from the flashover, stepped onto Platform 1 to check the train and after observing the OHLE vibrating, returned to the cab and pressed the "Pan Down" button. This resulted in the lead and rear pantographs lowering but the Lower Arm of the Pantograph 396 did not lower (which was later determined to be as a result of the failure of the pantograph chains).

The DART electrification system is fitted with an Auto Reclose function which allows a high speed circuit breaker to automatically reclose after a tripping event provided a successful Line Test has been passed. After the pantograph failure, and following a successful Line Test, the Auto Reclose restored power to the OHLE causing a second short circuit. This resulted in the Catenary Wire from the OHLE breaking and falling onto Platform 1. While the Catenary Wire was on Platform 1 a second Auto Reclose resulted in power been restored to the fallen Catenary Wire. The Catenary Wire remained live on Platform 1 for approximately forty-six seconds before the Electrical Control Operator (ECO) isolated the section. There were two passengers on Platform 1 at the time but not in the vicinity of the fallen Catenary Wire.

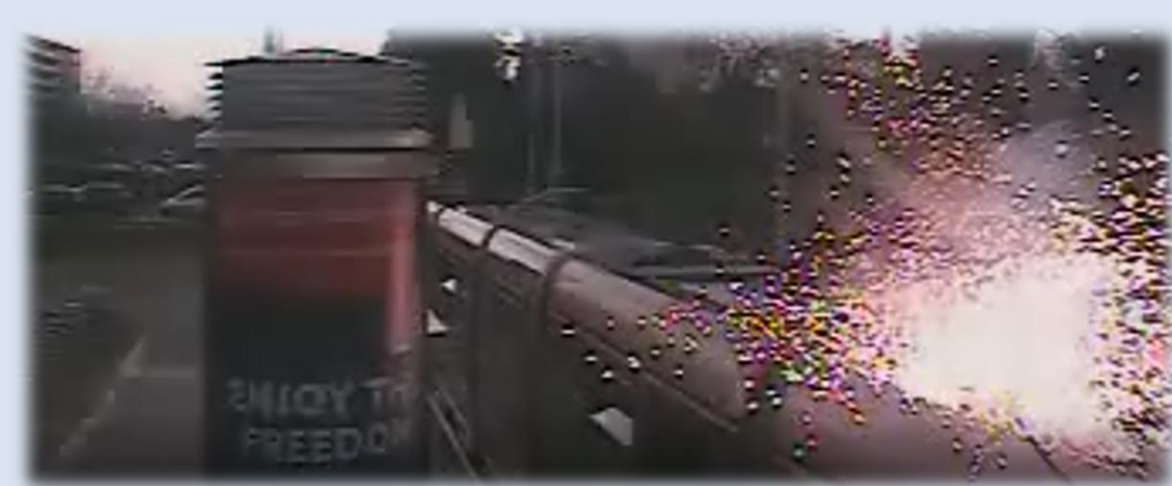
## Luas Overhead Line Failure, Stillorgan, 2<sup>nd</sup> November 2020

On 2<sup>nd</sup> November 2020 the 14:31 hrs Luas Service 65 (operated by Tram 5010) from Brides Glen to Broombridge served Stillorgan inbound platform before moving forward to Signal B11. The driver of Tram 5010 (Driver 5010) noticed the Main Circuit Breaker (MCB) had opened in the driving cab (the MCB opened due to its failure to detect 750 volts (V) Direct Current from the Overhead Contact System (OCS)). The loss of 750V DC was the result of the OCS Electrical Supply System, High Speed Circuit Breaker (ESS HSCB) L1 Sandyford opening automatically due to the OCS breaking and short circuiting against the roof of Tram 5010. Driver 5010 also noticed the OCS was sagging and advised the Traffic Supervisor at the LNMC.

The Traffic Supervisor viewed the images from the Close Circuit Television (CCTV) cameras located at the Stillorgan Stop and saw the OCS had broken and was lying across the top of Tram 5010, the outbound track and platform. The Traffic Supervisor instructed Driver 5010 not to open the passenger doors and to keep all passengers inside the tram until otherwise advised. The Supervisory Control And Data Acquisition (SCADA) system indicated that the section in the area of Stillorgan was de-energised.

The Traffic Supervisor identified other trams operating in the vicinity of Stillorgan and requested they stop; which they did. Shortly afterwards, the Traffic Supervisor then began to attempt to reform service and requested that Service 88, Brides Glen to Parnell, (operated by Tram 5003) continue to Sandyford Stop and stop there. At approximately 14:37 hrs, Tram 5003 passed the Insulated Overlap (two OCS contact wires from two electrical sections which provide a continuous supply of power to the tram when the tram passes from one section to the next and also allows for de-energising of one section at a time) between Sandyford and Central Park. As a pantograph head of Tram 5003 traverses the Insulated Overlap, the pantograph bridges both contact wires and electrically connects the two sections together, re-energising the section at Stillorgan where Tram 5010 was located. The re-energising of the section at Stillorgan resulted in a second short circuit between the OCS wire and the roof of Tram 5010. The second short circuit resulted in HSCB L2 (L2 signifies out of City Centre) Sandyford and HSCB L1 (L1 signifies in to the City) Glencairn also tripping out due to overcurrent.

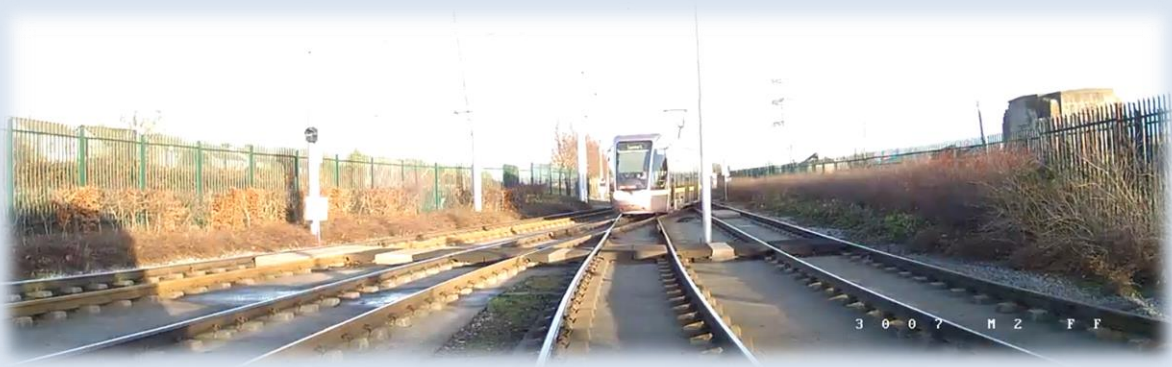
## Trend Investigation into Signals Passed at Stop (SPASs) on the Luas Network

In February 2020, the RAIU received the monthly occurrence notifications from Transdev in relation to incidents and accidents on the Luas network in January; here it was notified that there had been a signal passed at Stop (SPAS) at Cookstown Interchange, County Dublin, on the 3<sup>rd</sup> January 2020.

On Friday 3<sup>rd</sup> January 2020, the driver of Tram 3007 (Driver 3007), departed Cookstown Inbound Platform travelling to Belgard Stop. At approximately 15:08 hrs, Driver 3007 approached and passed Tram Signal S-2e at the Cookstown LSS area, when it was displaying a “Stop” aspect. At the same time, Tram 3025, travelling Outbound towards Saggart, entered Cookstown LSS on a “Proceed” aspect. On seeing Tram 3025, Driver 3007 stopped Tram 3007, and waited for Tram 3025 to pass before continuing his journey.

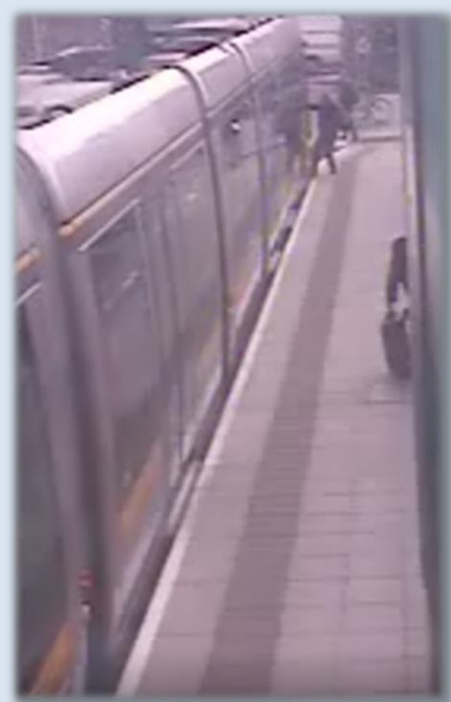
#### Passenger trap-and-drag occurrence on Luas tram at Heuston Stop, 26<sup>th</sup> March 2019

On the 26<sup>th</sup> March 2019, at approximately 14:22 hrs, a male passenger attempted to board inbound Luas tram, Tram 3011, at Heuston Stop. The passenger placed his hand between the door leaf and the door pillar of the rear most entrance door as the door was closing. The passenger's hand became trapped in the door seals. The door obstacle detection system did not detect the presence of the hand as it was less than 10 millimetres (mm); the door operation mechanism allows 10 mm obstacle detection to facilitate door closing.

The tram departed Heuston Stop nineteen seconds after the doors were closed with the passenger's hand trapped in the door. Two security staff came to the passenger's assistance, with one of the security staff communicating with the driver by radio.

The immediate cause of the passenger hand being trapped in the door of Tram 3011 was the passenger placed his hand in the door opening, as he attempted to board the tram, during the door closing sequence.

- CF-01 – The Driver did not conduct an adequate visual check, using rear view monitors and mirrors during or after the door closing sequence; this, in part, may be as a result of deficiencies in the mirrors (absent from Heuston Stop) and ineffective in-cab monitors (older black and white monitors);
- CF-02 – There were no labels warning the passenger of the risk of attempting to board or exit a tram while the doors are closing;

- Safety Recommendation 2020001-01 – Transdev should update their suite of document for driver training (SM 017 Driver Training Plan), operations (TSI Manual) and competence assessment (SM 018 & SM 019 Competence Assessment) to include a requirement for drivers to conduct a thorough final visual check (using CCTV and mirrors) after obtaining doors closed and locked indications and before moving the tram to confirm that nothing is trapped in the doors;

- Safety Recommendation 2020001-02 – Transport Infrastructure Ireland (TII) should conduct a riskbased review on whether CCTV platform monitors should be installed at high-use tram stops;

- Safety Recommendation 2020001-03 – TII should conduct a risk-based review on whether the tram fleet operating on the Red Line should be upgraded with coloured rear view monitors;

- Safety Recommendation 2020001-04 – Transdev and TII should develop new labels, for the application on tram doors, which warn passengers of the dangers of closing doors;

- Safety Recommendation 2020001-05 – Transdev, as part of the update to the SMS 018 Competence Assessment, should formally include the assessments that should be conducted every quarter;

- Safety Recommendation 2020001-06 – Transdev should brief drivers on the operation of the door mechanism, and specifically explain the removal of obstacle detection for the final 10 mm of door travel; this briefing should then be incorporated into their suite of training and competence management documents;

- Safety Recommendation 2020001-10 – Transdev should update their Chain of Care Procedure mandating that drivers are subject to appropriate developmental supports (such as assessment, monitoring and supervision) post incident/accident. Depending on the type of incident/accident, and whether the actions of the driver contributed to the incident/accident, specified periods of time of continuing developmental supports should be set.

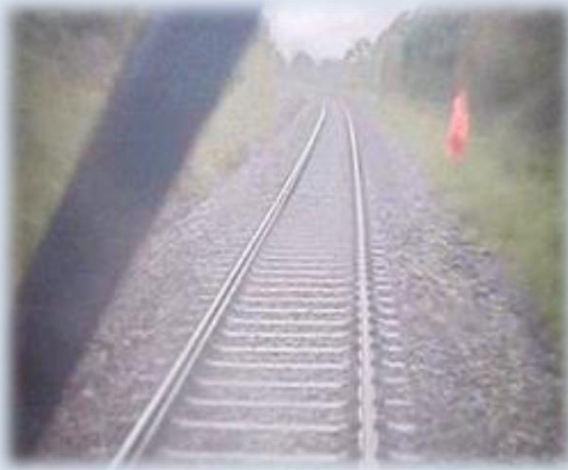
## Near miss with an Iarnród Éireann Patrol Ganger near Woodlawn, Galway, 4<sup>th</sup> June 2019

At approximately 10:04 hrs on the 4<sup>th</sup> June 2019, the 09:30 hrs passenger service from Galway to Heuston train departed Woodlawn Station. On route to Ballinasloe Station, on a curved section of track, the driver saw a person in high visibility clothing walking on the line in the five foot with his back to the oncoming train. The driver placed the train brake in the emergency position and sounded the train horn to warn of the train's approach. The person identified was an IÉ-IM Patrol Ganger who then stepped off the

track into the cess, approximately four seconds before the train passed. The driver brought the train to a stop and reported the incident. The weather at the time of the incident was raining with high gusts.

The immediate cause of the incident was that Patrol Ganger was in a position of danger as the requirements of the IÉ Rule Book could not be met in full for his patrol length. Contributory factors to the incident were:

- Safety Recommendation 202002-01 – IÉ-IM should review its track inspection methods to see if technological/ mechanised systems and/ or other safety measures could be implemented to eliminate/ minimise track worker exposure to railway hazards whilst undertaking the task of track patrolling;
- Safety Recommendation 202002-02 – IÉ-IM should, through their risk assessment process, conduct a review of the patrol lengths, with the objective of identifying all patrol lengths with associated risks, and introducing adequate mitigation measures to eliminate these risks. Consideration should be given to the introduction of technologies (such as anti-collision devices) for use by patrol gangers, with the objective of warning patrol gangers of oncoming trains.

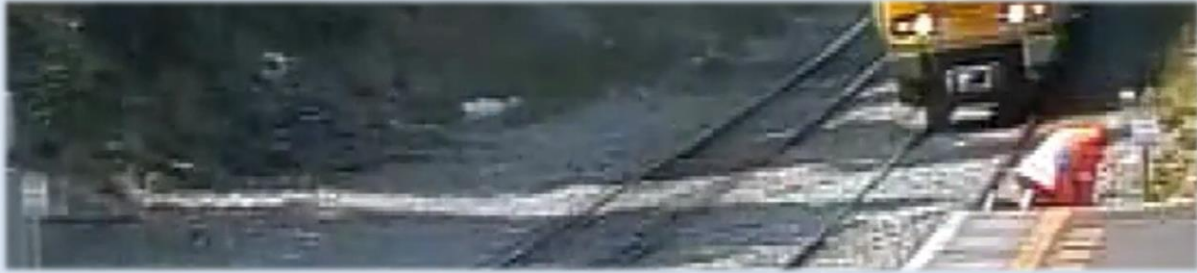
#### Near-miss collision between a train and an IÉ-IM staff member, at Rush and Lusk Station, 20<sup>th</sup> June 2019

At approximately 09:50:31 hrs, on the 20th June 2019, a member of IÉ-IM's SET Department's staff (to be referred to as SET Worker) accessed the railway line at Rusk and Lusk Station and began walking on the railway line (Up Line). The SET Worker was accessing the railway line to inspect electrical equipment associated with a nearby SET location case.

Seven seconds later the SET Worker sees the 08:00 hrs Belfast to Connolly passenger train approaching on the Up Line and starts to walk towards the other railway line (not occupied by the train, the Down Line). At 09:50:42 hrs, while standing in the middle of the Down Line, he raises his hand above his head to acknowledge the presence of the train, he is not in a position of safety. Two seconds later (09:50:44 hrs) the SET Worker walks across to the Down Platform and leans his elbow down on the platform and raises his other hand to acknowledge the train for a second time, he is not in a position of safety.

- Safety Recommendation 2020003-01 – The IÉ-IM SET Department should develop a formalised process, through their SMS suite of documents, for IÉ-IM SET staff walking/ working alone, which should be completed prior to any member of SET staff going on or near the line; at a minimum consideration should be given to:
  - Whether it is necessary to go on or near the line to conduct the walk / work;
  - What local knowledge is required to walk /work safely;
  - Whether all the requirements of the IÉ Rule Book / SSOW can be met;
  - What special protection arrangements are required either at night or during the day.
- Safety Recommendation 2020003-02 – IÉ-IM should brief all staff of their requirements, under the IÉ Rule Book, to wear their high visibility clothing correctly.

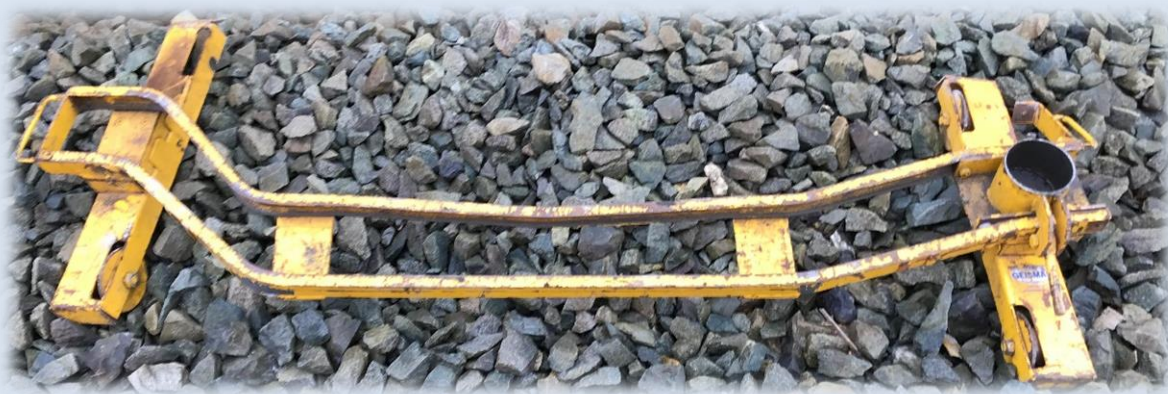
**Collision between an Iarnród Éireann passenger train and rail-mounted maintenance equipment,  
Rosslare, Wexford, 11<sup>th</sup> January 2020**

On 11<sup>th</sup> January 2020, T3 Possessions were granted between the 112 Mile Post (MP) 880 yards and the 112 MP 1320 yards (Rosslare Strand to Rosslare Europort) for IÉ-IM CCE Department in relation to the Rosslare Coastal Erosion Project.

The work being undertaken in the T3 Possessions included the erection of viewing distance marker boards (sometimes referred to as V Boards) on the north and south sides of a newly re-opened level crossing, adjacent to Hayesland IÉ-IM compound. There were four members of CCE staff, working in pairs, erecting the V Boards on the north and south sides of the level crossing. The pair working on the south side included the Person In Charge Of Possession (PICOP)/ Engineering Supervisor (PICOP/ES) and the other pair, working on the north side, included the Acting Permanent Way Inspector (APWI).
