STATE COMMISSION ON RAILWAY ACCIDENT INVESTIGATION

ANNUAL REPORT 2023

ON THE ACTIVITIES
OF THE STATE COMMISSION
ON RAILWAY ACCIDENT INVESTIGATION

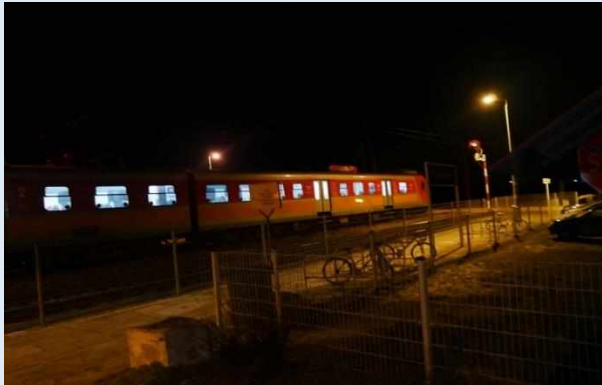
Photograph 1 – A view of the occurrence site at night from the passenger stop Krzcięcice (own material of PKBWK)

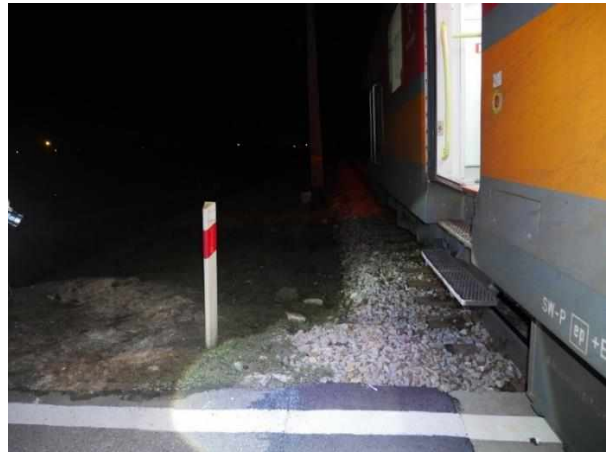
Photograph 2 – A view of the occurrence site at night from the passenger stop Krzcięcice (own material of PKBWK)

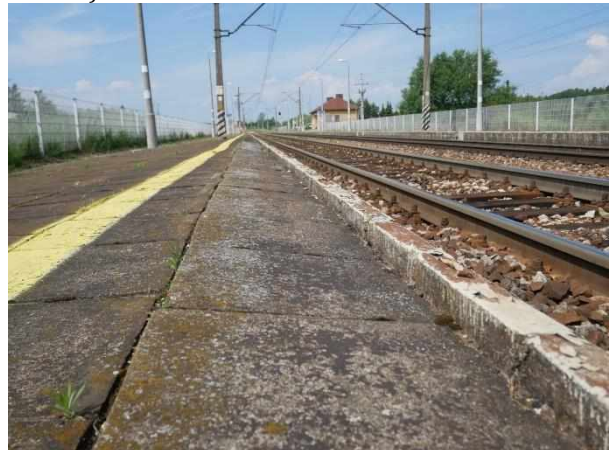
Photograph 3 – A view of Platform 2 with uneven pavement (own material of PKBWK)

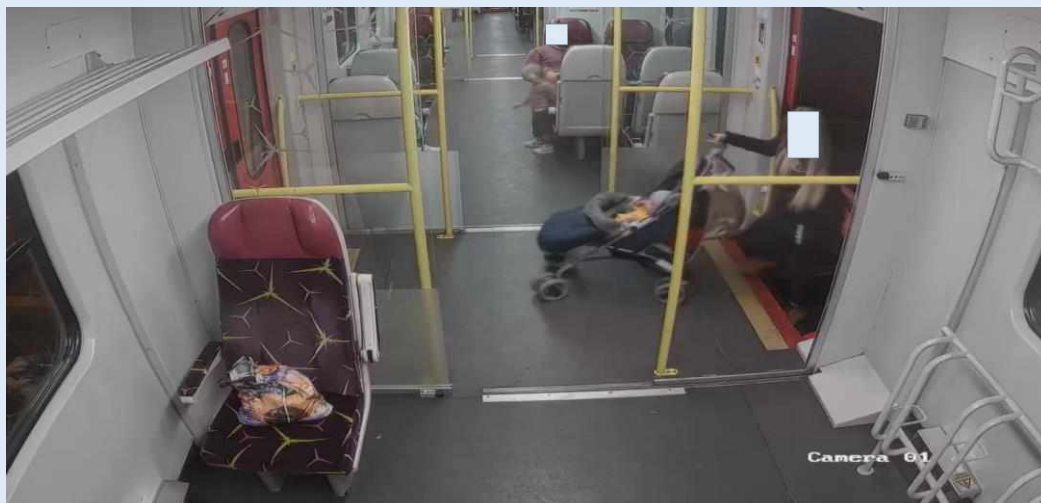
Photograph 4 – An image of the passenger disembarking from the train (vehicle CCTV)

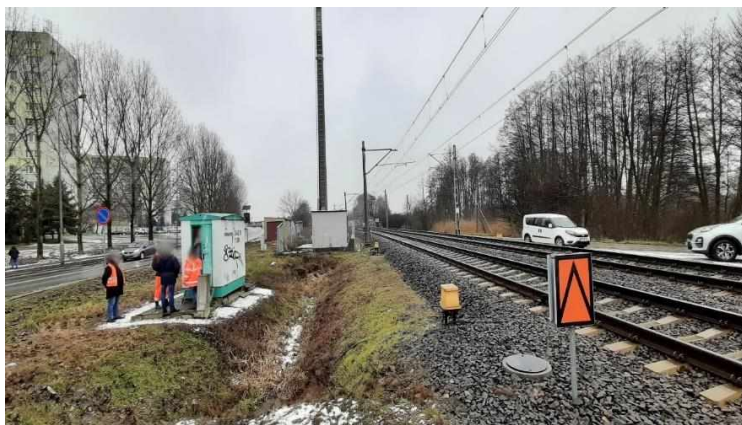
Photograph 5 – A view of track no. 2 from the road from the distance of 5 metres from the outermost rail (own material of PKBWK)

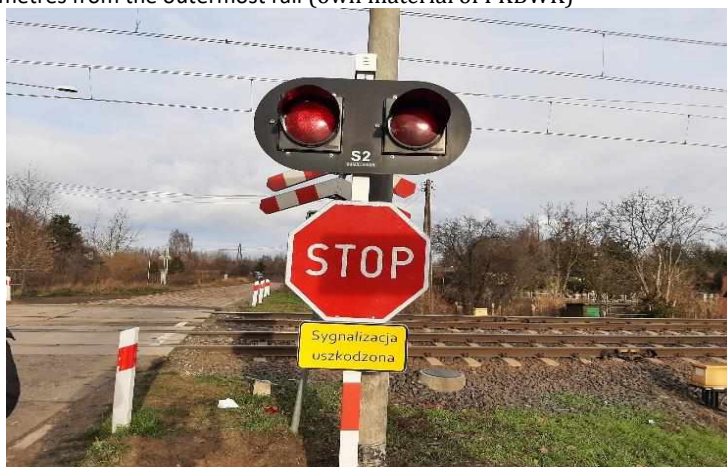
Photograph 6 - Marking of the crossing after the arrival of representatives of PKBWK (own material of PKBWK)

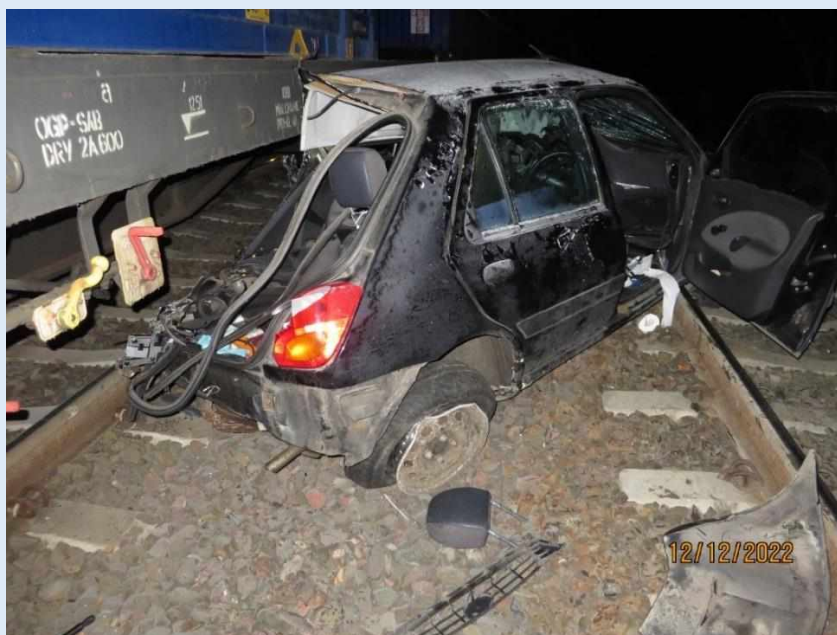
- the passenger car driver sustained injuries and was taken to hospital
- the Ford passenger car was damaged
- electric locomotive ET22-1082 was damaged
- the train did not derail

Photograph 7- Consequences of the occurrence (source: material provided by the railway commission)

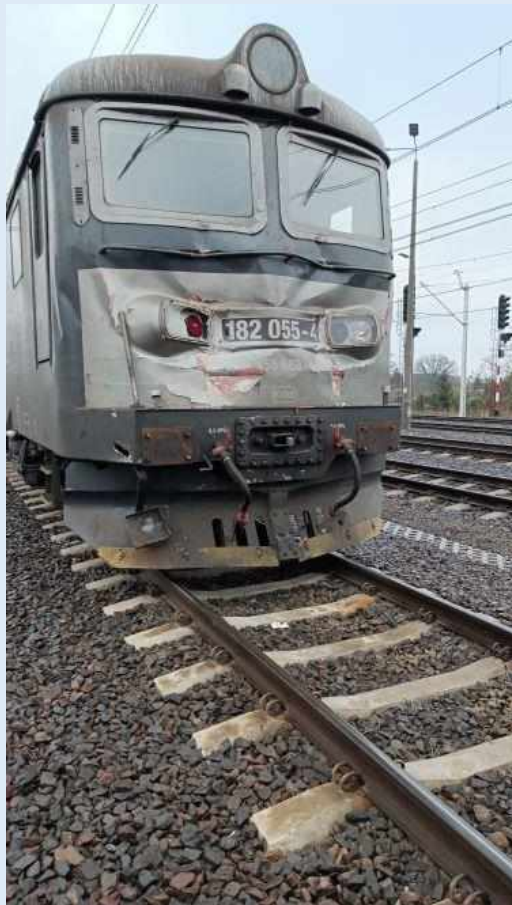
- locomotive E182-055-4 leading train LTE 785009 of the carrier CTL Logistics Sp. z o.o. was damaged
- the last wagon no. 84 51 594 4675 - 4 (loaded with stone) in train TME 684013 of the carrier POL-MIEDŹ TRANS Sp. z o.o. was damaged

Photograph 8- Consequences of the occurrence (source: material provided by the railway commission)

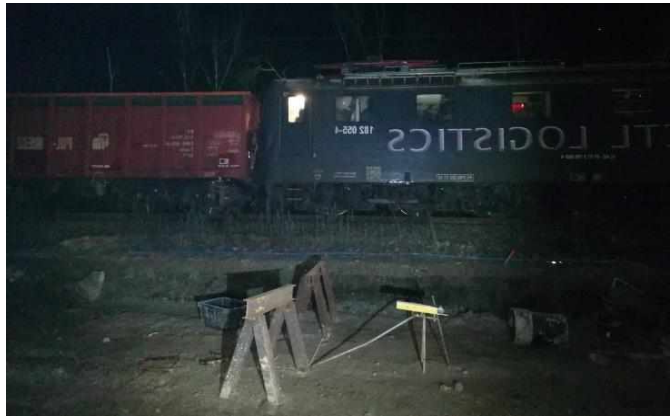
Photograph 9 - A view of the occurrence site (source: materials provided by the railway commission)

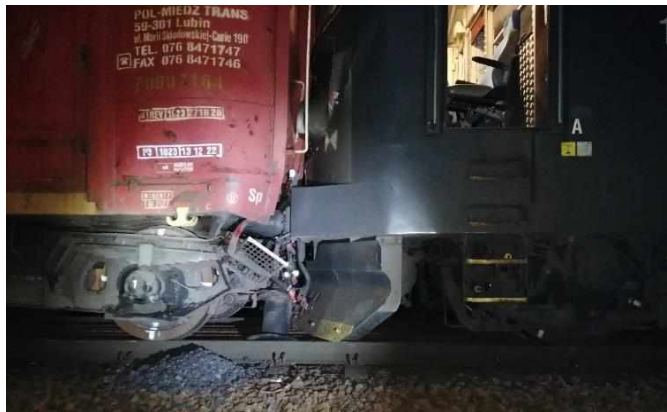
Photograph 10 - A view of the occurrence site (source: materials provided by the railway commission)

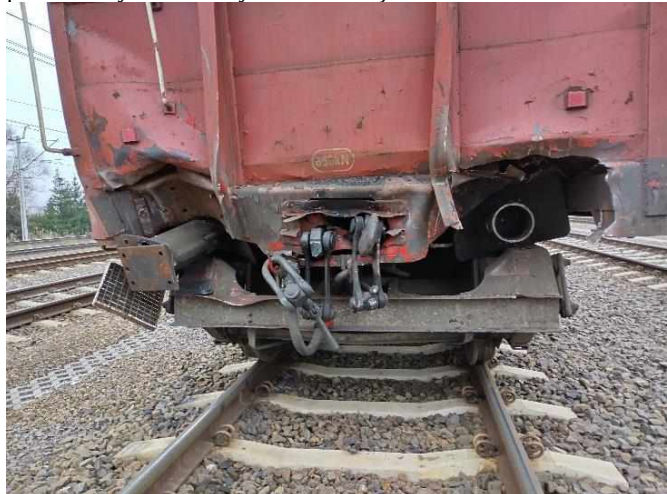
Photograph 11- Consequences of the occurrence (source: material provided by the railway commission)

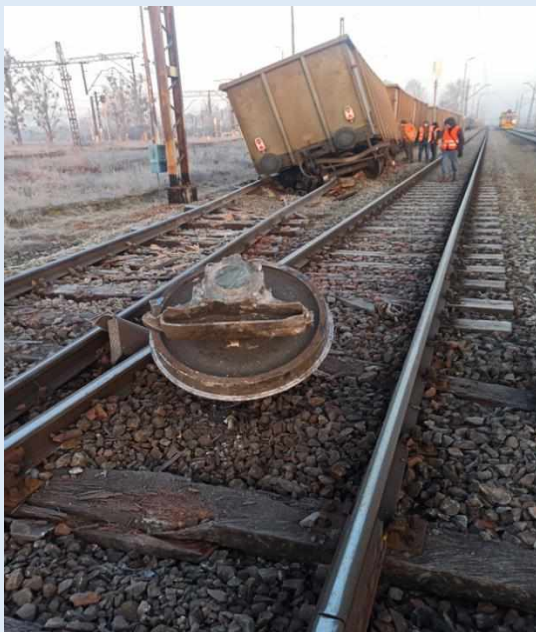
Photograph 12 – A view of the occurrence site (source: materials provided by the railway commission)

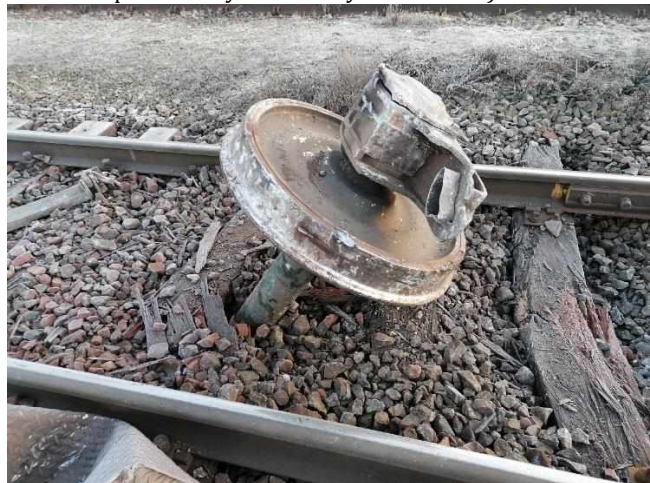
Photograph 14 – Consequences of the occurrence (source: material provided by the railway commission)

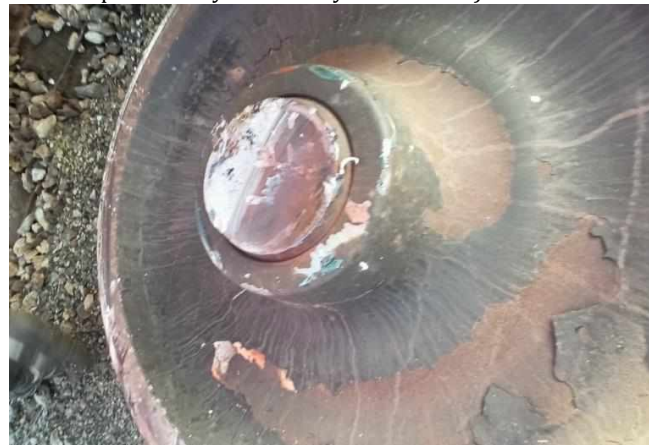
Photograph 15 – Consequences of the occurrence (source: material provided by the railway commission)

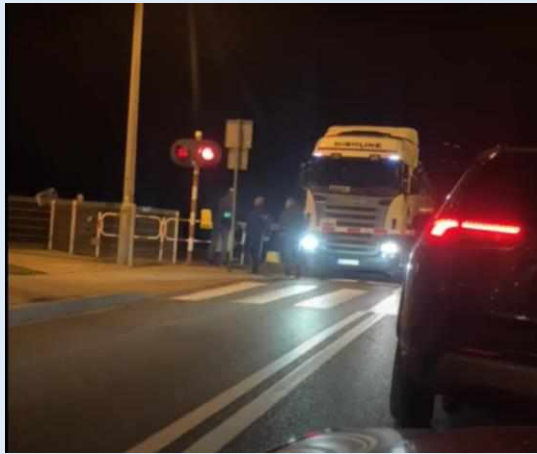
Photograph 16 – Attempts to lift the barrier bar undertaken by the witnesses (source: YouTube)

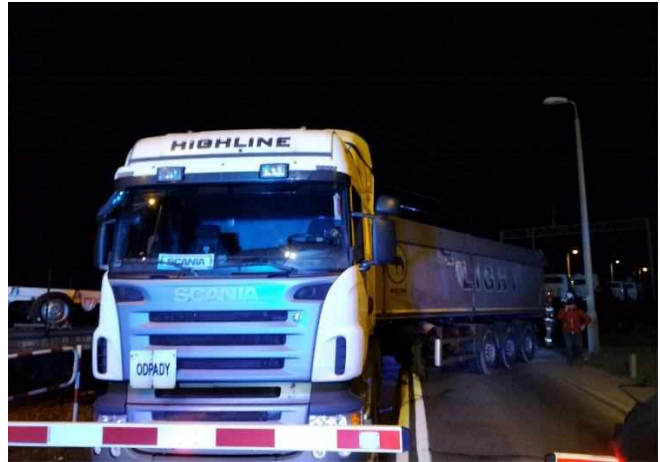
Photograph 17 – Consequences of the occurrence – the place where the head of the road tractor stopped after the collision (source: material provided by the railway commission)

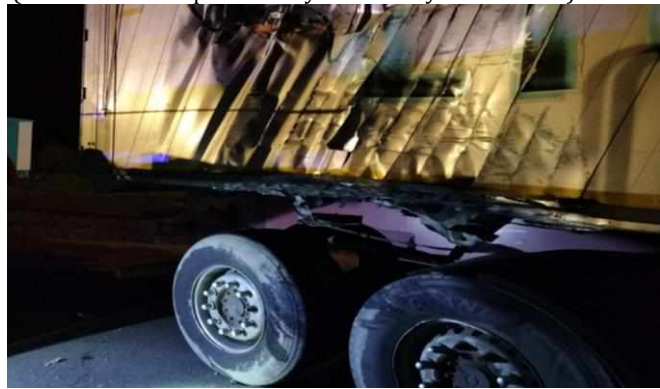
Photograph 18 – Consequences of the occurrence – damage sustained by the road tractor's semi-trailer (source: materials provided by the railway commission)

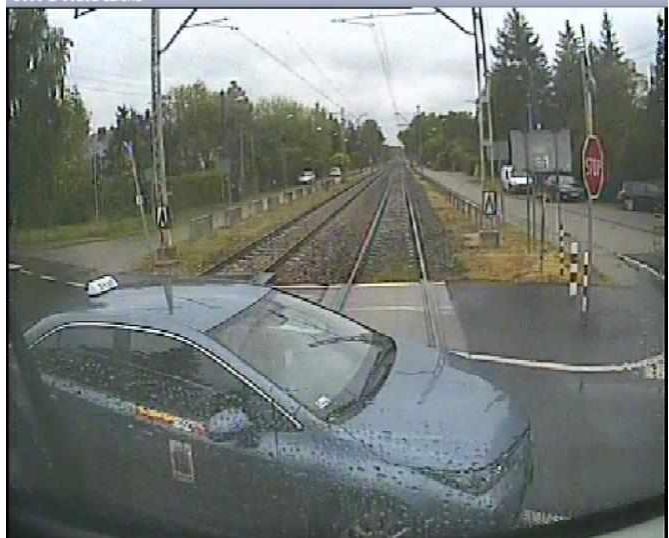
Photograph - A view of the foreground at the moment of the accident recorded by the rail vehicle's camera (source: materials provided by the railway commission)

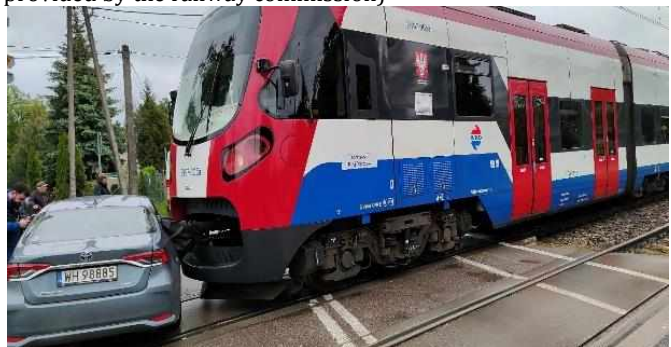
Photograph 21 - A view of the collision site (source: materials provided by the railway commission)

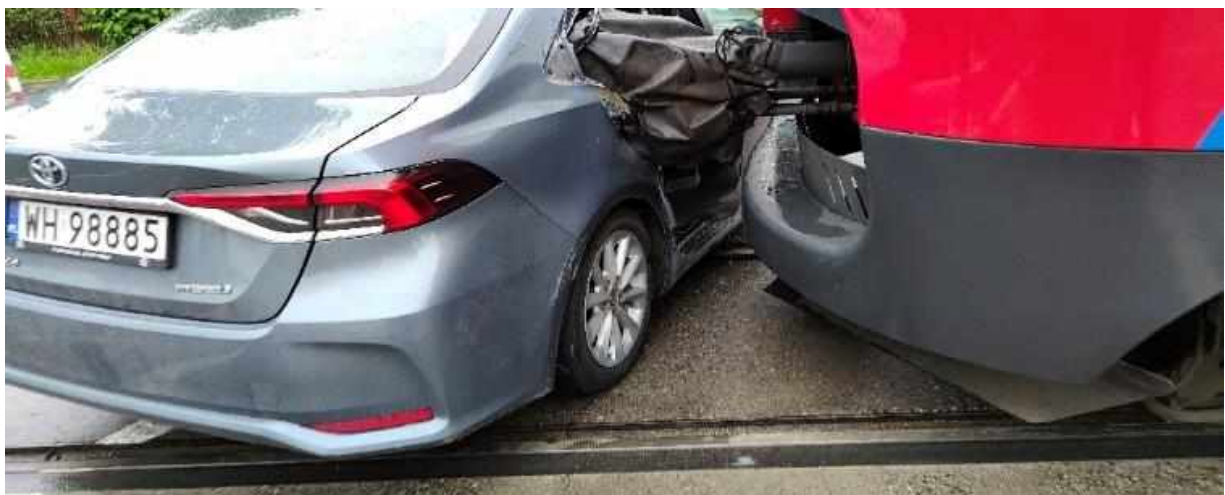
- damage to a Toyota Corolla passenger car
- damage to electric multiple unit EN97-005
- no injuries

Photograph 22 - Consequences of the occurrence (source: materials provided by the railway commission)

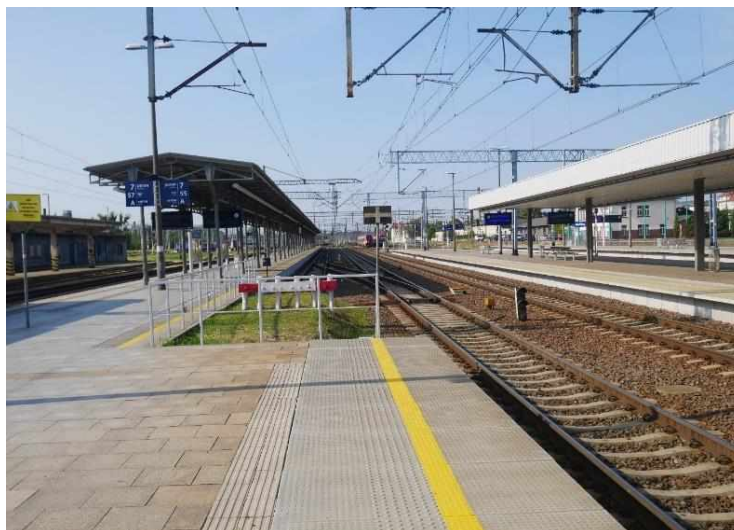
Photograph 25 – A general view of the occurrence site (source: own material of PKBWK)

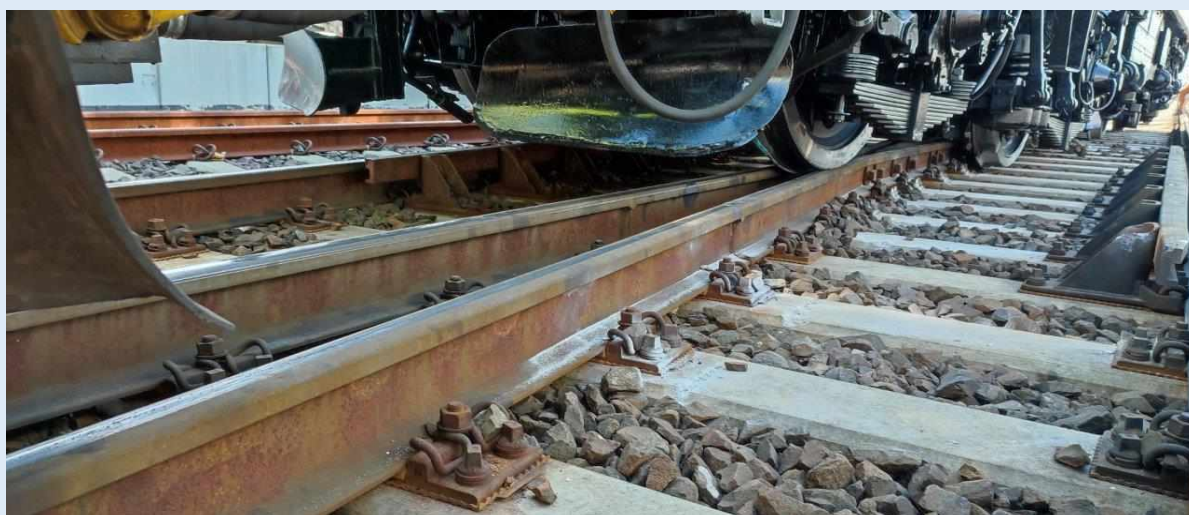
- damaged turnout No. 140 and station track no. 51 from the shunting disc Tm60 to the fouling point of turnout no. 140
- derailed and damaged locomotive EU07-1529

Photograph 26 – Consequences of the occurrence – derailment of locomotive EU07-1529 (source: own material of PKBWK)

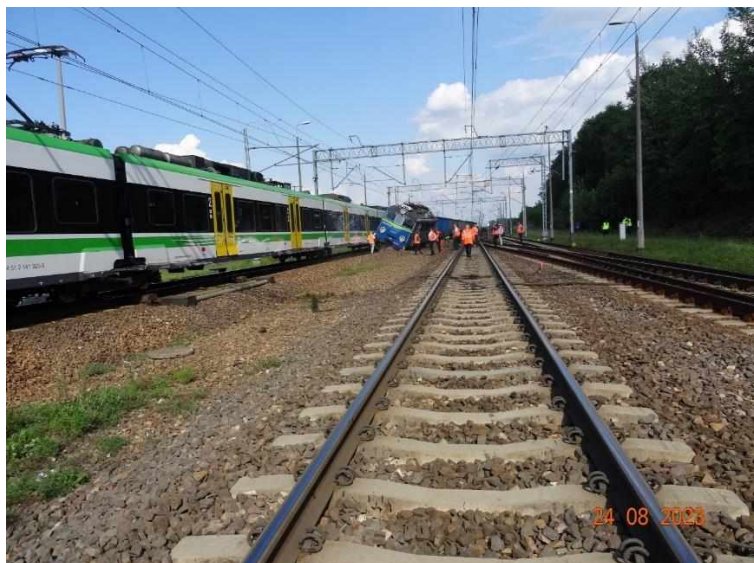
Photograph 27 – A general view of the occurrence site (source: materials provided by the railway commission)

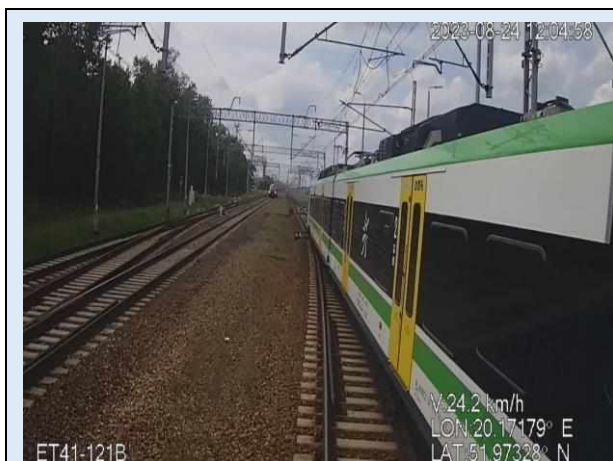
Photograph 28 – A view from the front view camera of train no. 524009 at the time of the collision (source: materials provided by the railway commission)

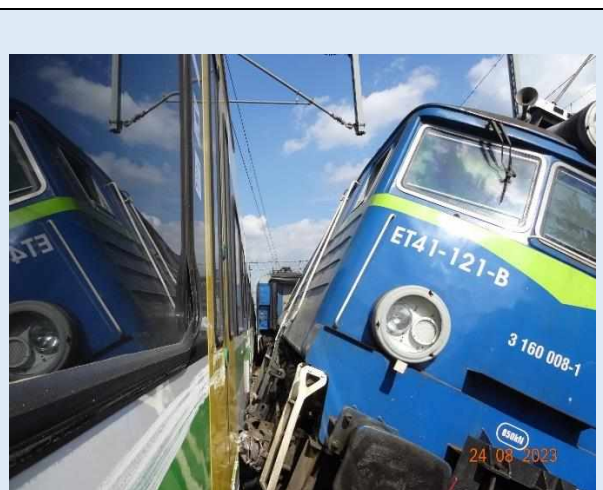
- all bogies of the first section and one bogie of the second section of the ET41-121 derailed, and section B and the gangway between the locomotive sections were damaged
- elements of the structure and body skin of electric multiple unit ER160-22 were damaged
- the drive of turnout no. 13 and turnout sleepers were damaged

Photograph 29 – Consequences of the occurrence (materials provided by the railway commission)

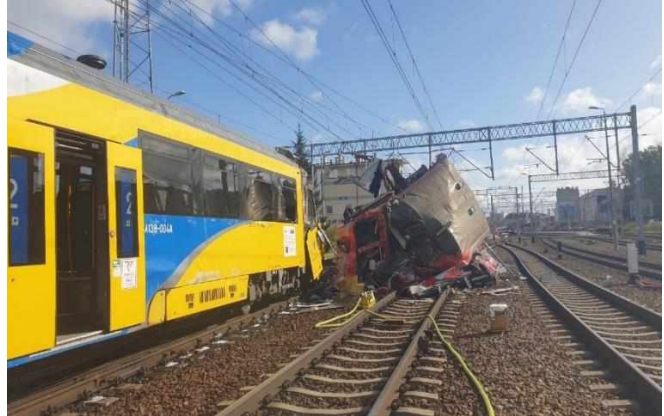
Photograph 31 – A general view of the occurrence site (source: materials provided by the railway commission)

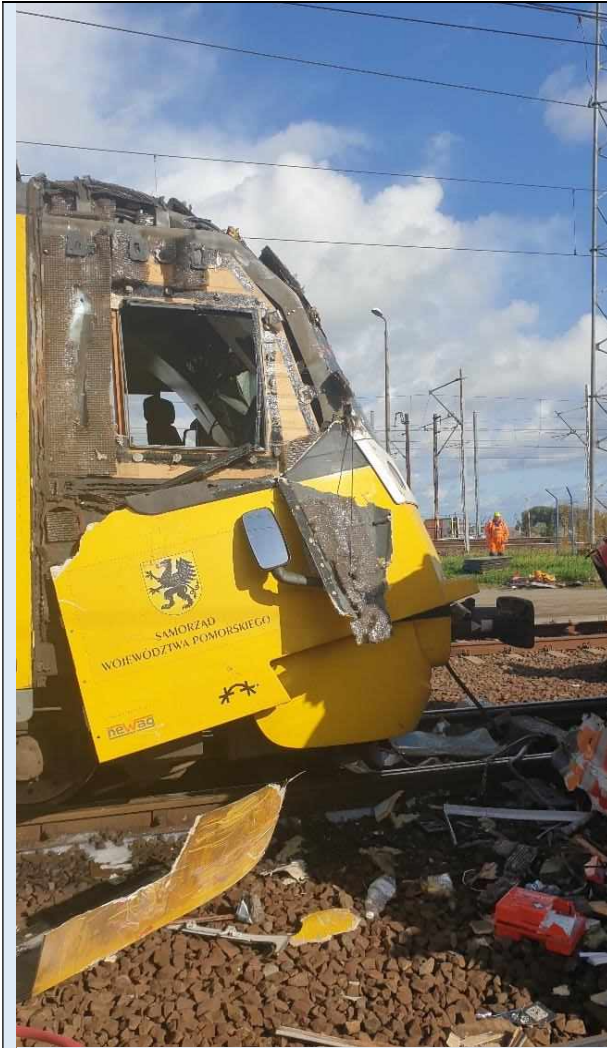
Photograph 30 - Consequences of the occurrence - damage to SA138-004 (source: own material of PKBWK)

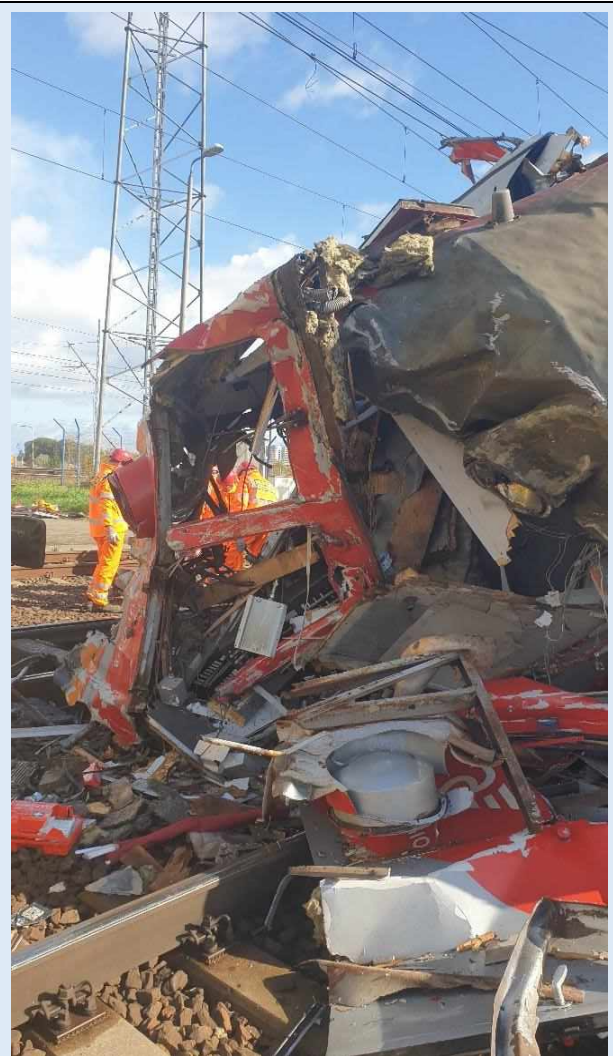
Photograph 32- Consequences of the occurrence - damage to EMU EN57-1248 (source: own material of PKBWK)
