AIR, MARITIME AND RAILWAY ACCIDENT AND INCIDENT INVESTIGATION UNIT

Number: 010-15/2021/22

ANNUAL REPORT OF THE INVESTIGATION BODY FOR RAIL TRANSPORT OF THE REPUBLIC OF SLOVENIA 2020

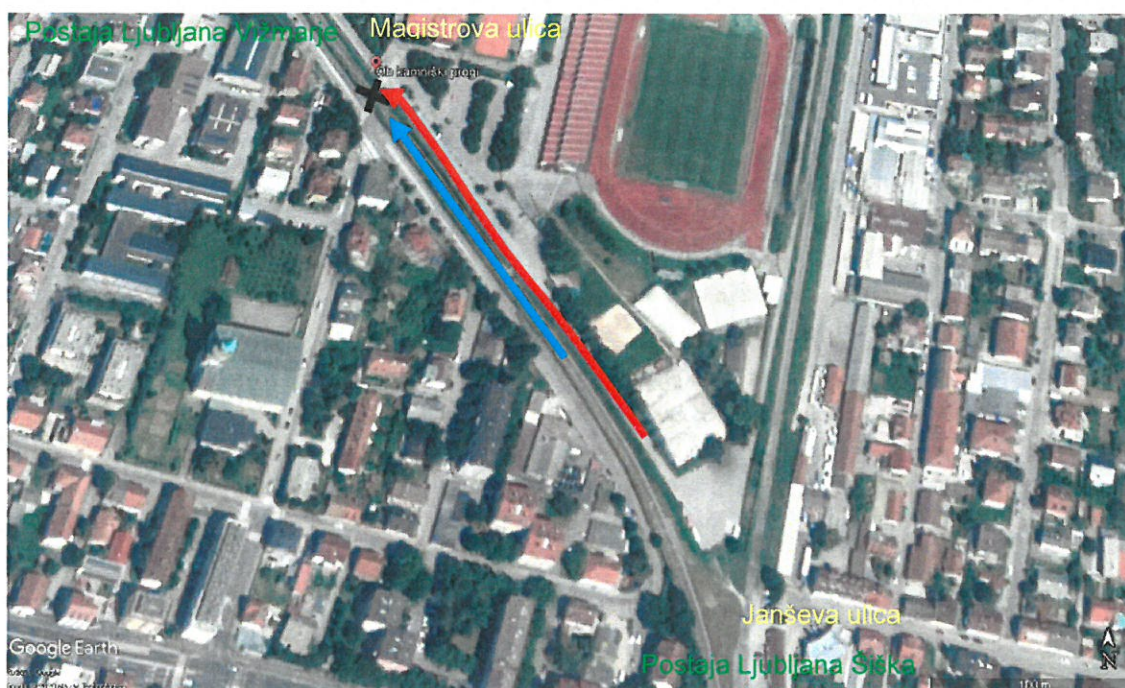
The engine driver of passenger train No. 2408 could not have avoided striking the cyclist at level crossing NPr 567.8, at km 567.774. The cyclist was on the railway line at the moment when the EMU pilot was 23 m ahead of the level crossing. Train No. 2408 stopped 177 metres from the point of collision with the cyclist. The railway line was closed between 12:53 a.m. and 4 p.m.

Picture No. 1: direction of travel of the local train is marked by a blue arrow, direction of travel of the cyclist by a red arrow, and location of the collision by a black cross

The direct cause of the collision of local passenger train No. 2408, on 10 November 2019, at 12:53 a.m., with the cyclist is the lack of attention paid by the latter, who failed to acknowledge the blinking light signals on the traffic sign which, in addition to the ringing of the safety device, warn road traffic participants about incoming trains, and who failed to stop before the level crossing, and instead cycled onto the railway line at the moment when the train was approaching from his left side.

An indirect cause for the collision of the train with the cyclist was the earphones that the cyclist wore while riding the bicycle. An indirect cause can also be attributed to the abundant vegetation along the railway track, which absorbs the noise generated by track vehicles during travel exceptionally well. Electric EMUs generate very little noise by default due to their technical characteristics.

Recommendation No. 1 has been accepted and realised after the collision of local passenger train No. 2408 with a cyclist on 10 November 2020.

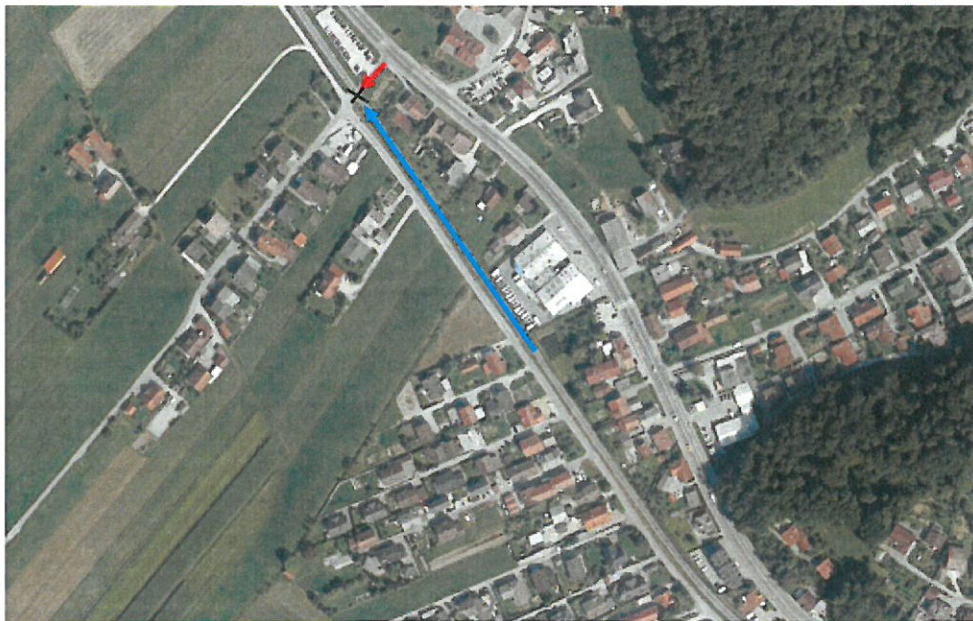
Picture No. 1: A red arrow shows the direction of travel of the goods road motor vehicle from the direction of the Dolenjska cesta Road on the local Pod Strahom Road, a blue arrow shows the direction of travel passenger train no. 3212 which was travelling from Metlika to Ljubljana, and a black cross marks the site of collision.

From the moment when the emergency brake was applied until the stopping of the train, train No. 3212 travelled approximately 280 m. The train hit the rear left wheel of the cargo part of the goods road motor vehicle, type Volvo 280 Euro 5, with an automatic coupler and left corner of the pilot of EMU 715-122 in the direction of travel of the train.

The direct cause of the collision of local passenger train No. 3212 with the goods road motor vehicle that drove onto the crossing of the local road and single-track railway line at the moment when the train was approaching the level crossing is insufficient visibility of the railway line from the road in the direction of the Škofljica station due to vegetation that grows on the right side of the railway line and blocks the view.

On the right side of the railway line, goods road motor vehicles are parked 200 m before the level crossing at a parking lot of the Pečjak bakery, reaching into the railway line strip, which reduces visibility already at that distance. This is an indirect cause of the accident.

1. the road infrastructure manager, the Municipality of Škofljica:
 - to ban traffic of motor vehicles longer than 4 m at the level crossing 143.033 until an arrangement is made with Pečjak d.o.o. that the company parks goods road motor vehicles outside the railway line strip;
2. to the railway infrastructure manager, SŽ – Infrastruktura, d.o.o.:

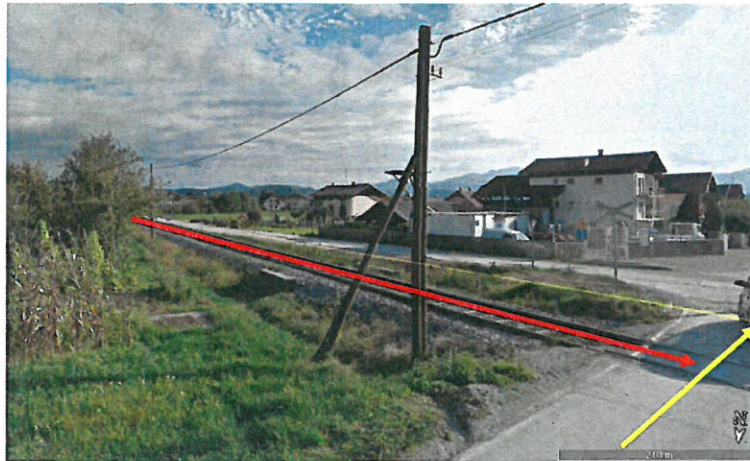
Picture No. 2: A red arrow shows the direction of travel of train No. 3212 and a yellow arrow the direction of travel of the goods road motor vehicle.

An analysis of road traffic at the level crossing and the existing road and railway infrastructure showed that the trees and tall shrubbery in the immediate vicinity of the level crossing pose a very high risk for road traffic participants who cross the railway line. Goods road motor vehicles longer than 4 m are especially exposed to the risk.

- removal of trees and tall shrubbery in the railway line strip between the house at the address Dolenjska cesta 432 and the railway line.

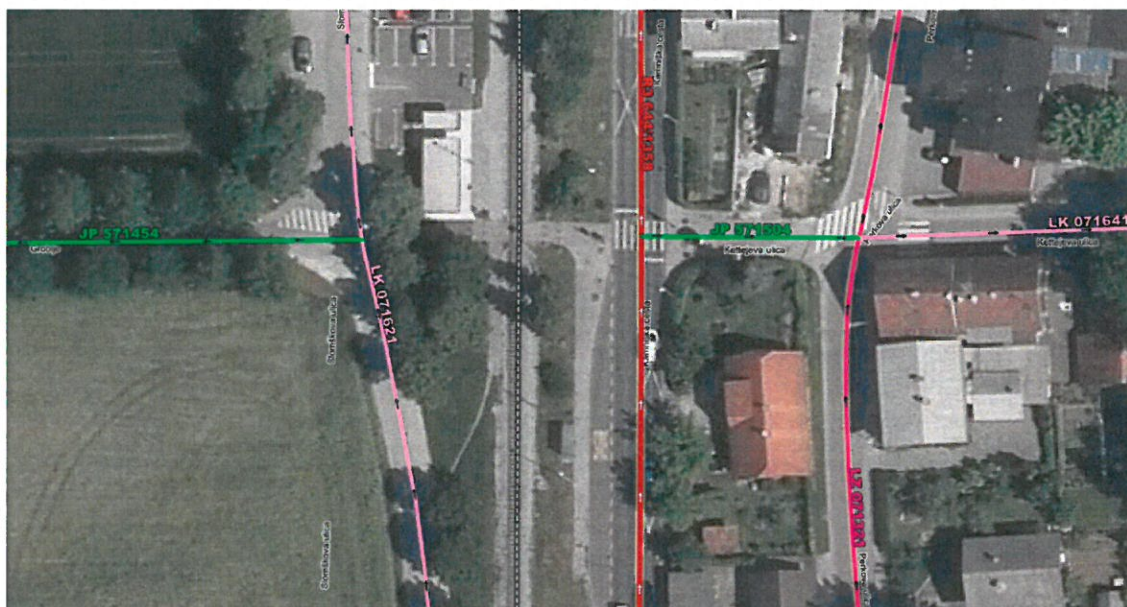
Picture No. 1: Traffic infrastructure in the area of the accident (green line - the Kettejeva ulica Street, black-white line - railway line, red line - the Kamniška cesta Road, violet line - local roads)

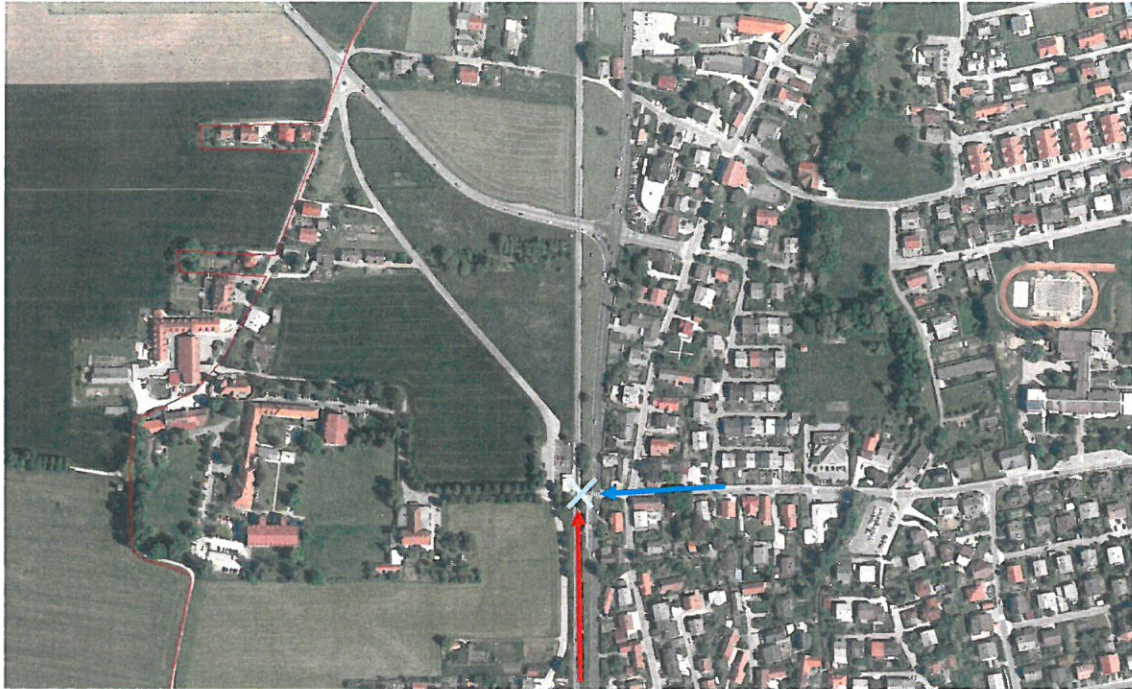
Picture No. 2: a grey cross marks the spot of collision, a red arrow marks the direction of travel of the train, and a blue arrow marks the direction in which the pedestrian was walking

The pedestrian did not stop before the railway line despite the incoming train. The train was approaching from her left side. The pedestrian entered the hazardous area of the railway line directly in front of the pilot of the diesel engine. The train hit the girl with the right corner of the control unit 715-120, diesel engine 713-120. After the collision, the victim was left lying along the railway line on the right side, 3.80 m from the right track and 11.5 m from the point of collision in the direction of travel of the train.

The direct cause for the collision of the passenger train – empty passenger unit, No. 9620, on 10 February 2020 at 09:25 a.m., at the regulated level crossing for pedestrians of the Rodica station, marked with road signs, between the stations Domžale and Jarše Mengeš, at km 14.117, is the lack of attention paid by the 20-year-old girl, who did not make sure whether a track vehicle was approaching the level crossing before entering the hazardous area of the railway line at the crossing.

It is recommended that all vegetation on both sides of the railway line from the direction of Rodica station in the direction of Domžale station that blocks the view of the railway line for road traffic participants is removed within the railway line strip.

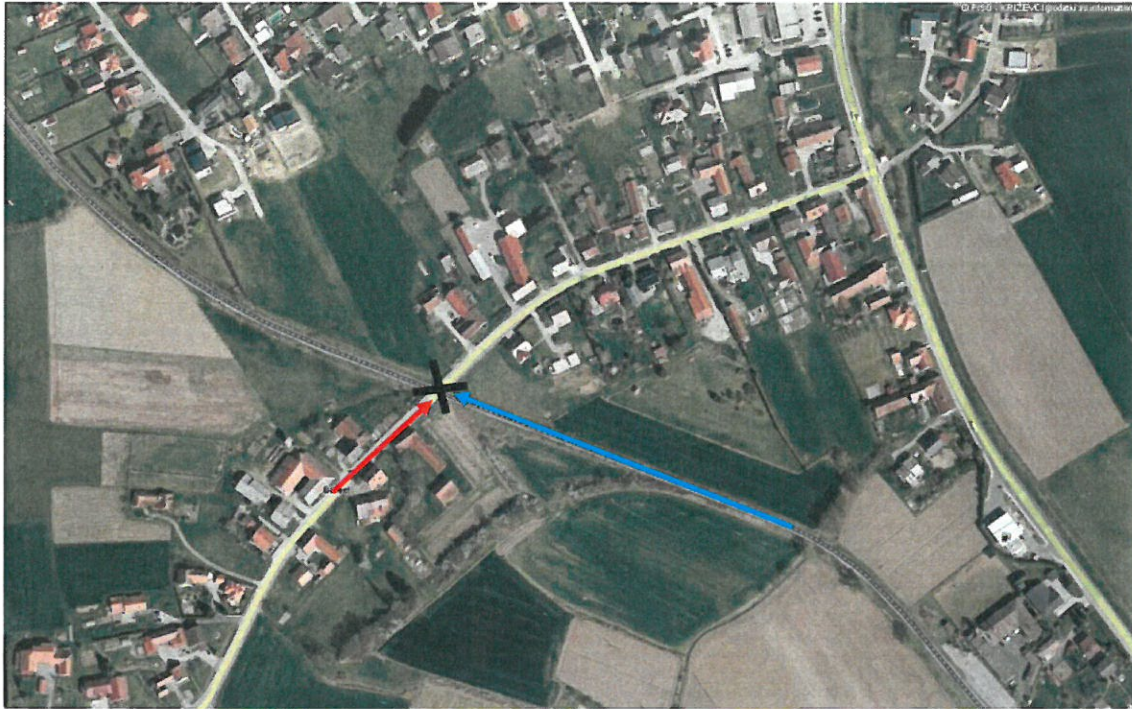
Picture No. 1: A red arrow shows the direction of travel of the road motor vehicle in the direction of the village of Boreci on the local road, a blue arrow shows the direction of travel of goods train no. 56490, which was travelling from Ljutomer towards Gornja Radgona, and a black cross marks the site of collision.

Train No. 56490 collided with the road motor vehicle at a speed of 40 km/h. After the collision, the front of the train stopped at km 5.288,6. From the point of collision with the road motor vehicle to the point of stoppage, the train travelled 95.6 m.

The direct cause of the collision of goods train No. 56490 with the road motor vehicle that drove onto the crossing of the local road and single-track railway line at the moment when the train was approaching the level crossing was insufficient visibility of the railway line from the road in the direction of Ljutomer station due to the vegetation that grows on the left side of the railway line and blocks the view. 274 metres before the level crossing, the railway line turns left and then goes straight. For the entire length of the curve, the left side of the railway line is overgrown with shrubbery that continues straight all the way to the area, 70 m before the level crossing, which blocks the view of the railway line to road traffic participants.

1. the road infrastructure manager, the Municipality of Križevci:
 1. Warning transverse lines – sound signs to be installed on the road before level crossing 5.2 at km 5.193 from both sides of the level crossing, to warn road traffic participants that they are nearing the level crossing. These are additional means to bring to the attention of road traffic participants that they are nearing the hazardous area of the level crossing. Transverse warning lines are drawn so that their frequency increases as the road approaches the level crossing.
2. to the railway infrastructure manager, SŽ – Infrastruktura, d.o.o.:
 1. removal of vegetation, shrubbery and tall overgrowth from the railway line strip along the left curve all the way to the level crossing.

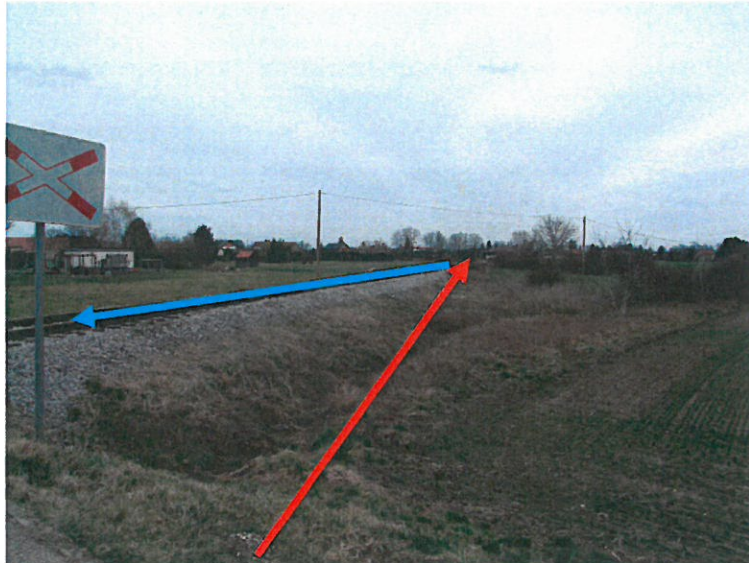
Picture No. 2: A red arrow shows the view of the railway line from the direction of the level crossing for road traffic participants, and a blue arrow marks the direction of travel of goods train No.56490, which collided with the road motor vehicle on 2 March 2020.

An analysis of road traffic at the level crossing and the existing road and railway infrastructure showed that the trees and tall shrubbery in the immediate vicinity of the level crossing pose a very high risk for road traffic participants who cross the railway line.

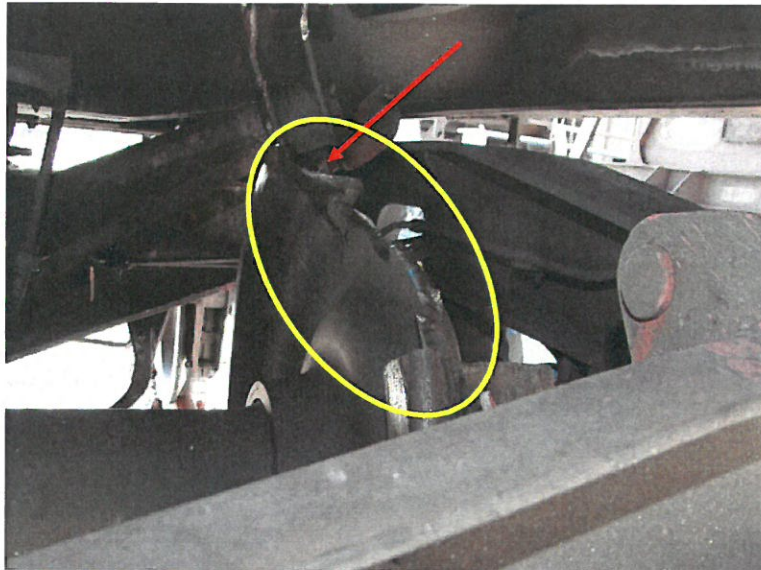
During a more detailed inspection of the wagon in daytime, it was then found that while the train was heading towards Divača station, a piece of the left wheel of the first axle of the second bogie had broken off in the direction of travel of the train. At the point where the part of the wheel broke off, the brake triangle had then jammed into the brake shoe. The wheel then pulled the brake triangle along the right wheel under the wagon floor, where the brake shoe was stuck between the structure of the bogie and the floor of the wagon, thereby blocking the rotation of the whole axle.

Picture No. 1: A red arrow shows the point where the brake shoe became stuck in the edge of the fractured wheel, and a yellow rhombus shows the area of the wheel fracture.

The direct cause of the incident – a fracture of the left wheel of the first axle of the second bogie of the 17th wagon No. 31 81 537 5060-5 during the operation of goods train No. 53202, on 31 March 2020 was material fatigue as a result of monobloc overheating caused by the previous blocking of the brake system.

The wheel fracture resulted in the jamming of the left brake block of the left brake shoe of the brake triangle behind the rim at the broken part of the monobloc, causing a blockage of the entire first axle of the second bogie at wagon No. 31 81 537 5060-5, in the direction of travel of the train.

For the investigation of the incident – wheel fracture on the 17th wagon during travel of goods train No. 53202, on 31 March 2020, an analysis of the wheel fracture was made. The analysis was made by the Institute for Metal Structures. The analysis showed that the fracture of the wheel (monobloc) was largely a consequence of the fissure advancing from the flange towards the wheelset axle due to fatigue. At the place where the fissure occurred, microfissures were also detected, running parallel to the traction surface, which most likely led to the wear of material on the traction surface of the wheel. It was established with electron microscopy that the fracture was ductile.

- the following recommendations are issued to the operator SŽ –Tovorni promet, d.o.o.:
- 1. update the diagnostic system for the thermal overload of running gears of the railway rolling stock in operation;
- 2. lay down procedures for handling wagons in which a thermal overload of running gears of the railway rolling stock is detected during operation;
