AIR, MARITIME AND RAILWAY ACCIDENTS AND INCIDENTS INVESTIGATION UNIT

Number: 010-15/2022/23

ANNUAL REPORT OF THE INVESTIGATING BODY FOR RAIL TRANSPORT OF THE REPUBLIC OF SLOVENIA 2021

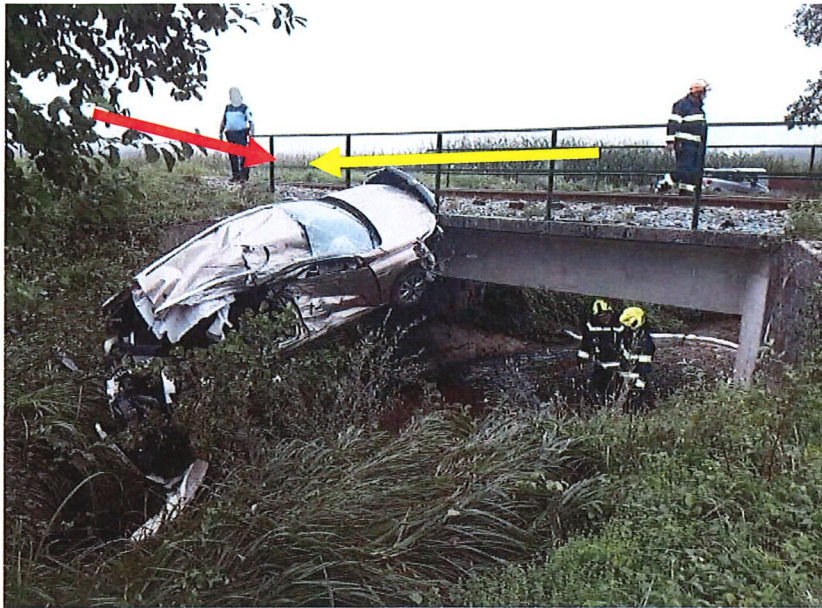
The inspection of the accident revealed that train No. 3375 from Sevnica to Trebnje collided head-on with the rear right door of the passenger road motor vehicle, a Renault Megan Grandtour, driving from Martinja vas to Gorenje Jesenice. Due to the collision, the road vehicle was knocked to the bank of the Jeseniščica stream.

Image 1: The red arrow shows the direction of the train and the yellow arrow shows the direction of the passenger road motor vehicle.

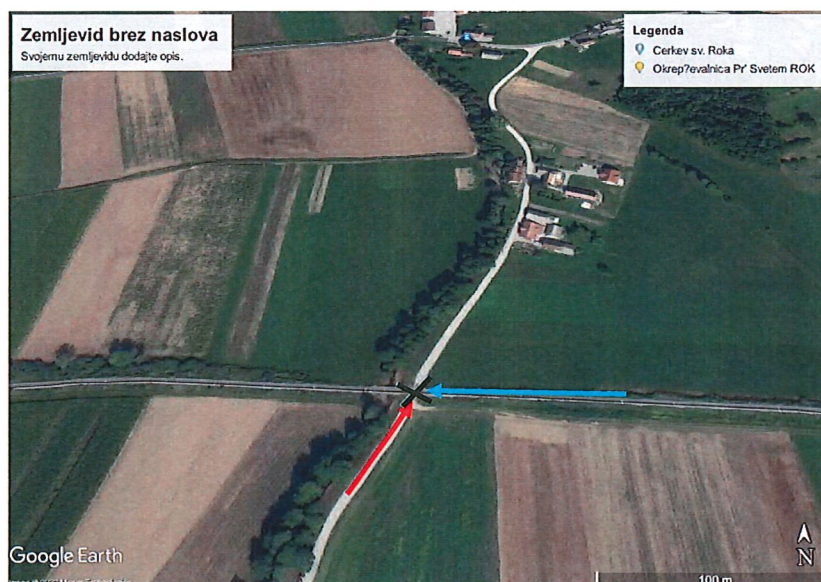
Image 2: The black cross shows the point of collision, the blue arrow shows the direction of the train, and the red arrow shows the direction of the passenger road motor vehicle.

The inspection revealed that the road users' view of the track from the road in the direction of the train involved in the accident was blocked by high vegetation and a cornfield with crops 2.2 m high. At the time of the accident, the corn crops growing along the left side of the track were 11 m away from the level crossing and the vegetation on the bank of the track was 65 m away. At a certain point during the train's journey from the Tržišče station to the Mokronog loading station, the vegetation on the bank of the track before the level crossing concealed the entire DMU 713/715-125.

The direct cause of the collision of regional passenger train No. 3375 on 3 September 2020 at 07:01 at the regulated level crossing 17.0 with traffic signs between the Tržišče station and the Mokronog loading station at km 17.032 was the high vegetation growing along the track and the cornfield that blocked the view of the track just before the level crossing.

The indirect cause can be attributed to the noise-reducing properties of the vegetation along the track, which was at its thickest at the time of the accident. The vegetation dampened the sound of the train whistle that the driver sounded 500 m before the level crossing at signal mark 206: "Attention, level crossing", with signal 63: "Attention", to warn road users of an oncoming train approaching the level crossing.

- immediately after the accident, was advised to remove all vegetation in the visibility triangle of the level crossing along the railway track in the immediate vicinity of level crossing 17.1 between the Tržišče station and the Mokronog loading station. The vegetation blocking the road users' view of the track should be removed on a regular basis so as not to exceed the height of the track ballast;
- during the vegetation growth cycle, the growth rate should be monitored.

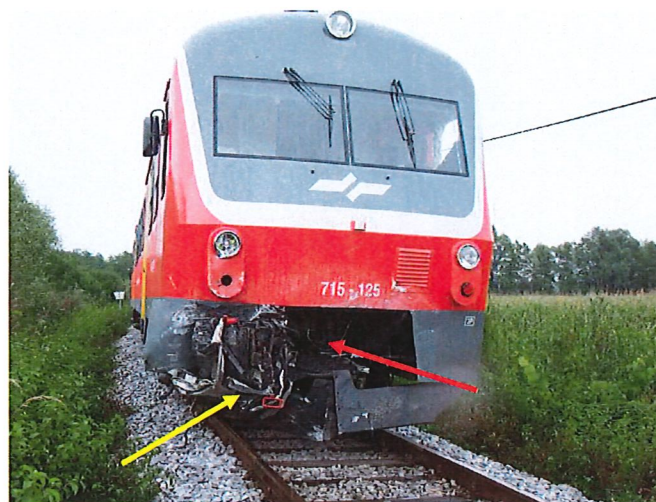
- damage to the front of the control unit of the DMU 715-125 (a completely destroyed automated coupler, a heavily damaged bottom right side of the front, minor damage to the right side of the control unit of the DMU 715-125, the stair of the right-hand passenger doors, scratched front passenger doors, a scratched right bearing cover on the first axle of the first bogie in the direction of train movement);
- A completely destroyed road passenger motor vehicle, a Renault Megan Grandtour.

Image 3: The red arrow shows the completely destroyed automated coupler of train No. 3375 and the yellow arrow shows the front right side of the control unit of DMU 715-125.

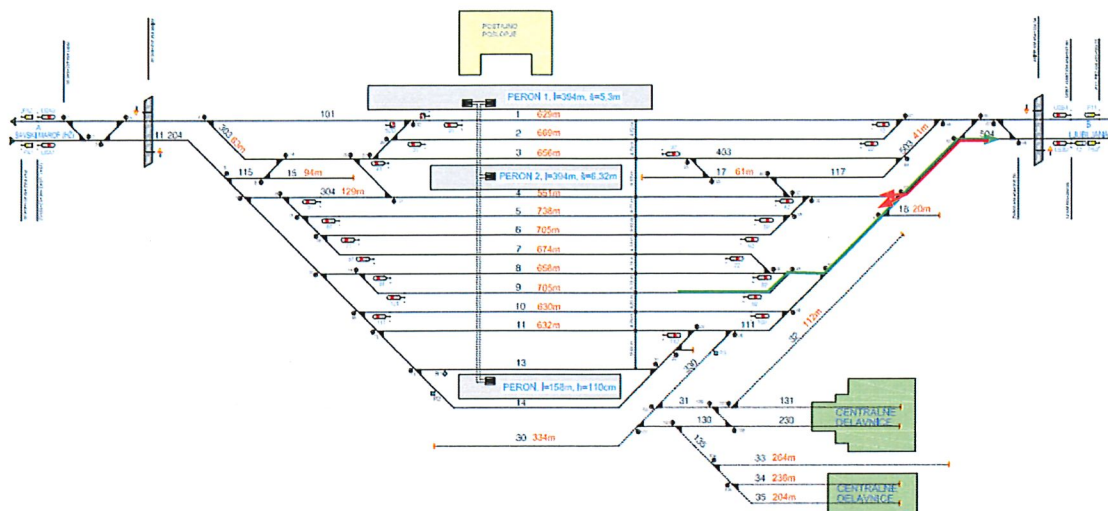
The inspection of the accident revealed that locomotive No. 91 81 1293 001-4 of the undertaking RCC-Ljubljana, d.o.o., was pushing locomotive No. 9181 1116 025-8 of the undertaking RCC-Croatia, d.o.o., from track No. 504 in the direction of track No. 4. During shunting at switch No. 60, the first axle of the first locomotive in the direction of movement of train composition No. 9181 1116 025-8 of the undertaking RCC-Croatia, d.o.o., diverged in the direction of track Nos 7 to 11, and the second axle of the first bogie forked with both wheels between the switch rails and the stock rails. The pushed locomotive, No. 9181 1116 025-8, of the undertaking RCC-Croatia, d.o.o., then derailed with its right wheel in the direction of the rolling stock at km 454.021,6 and with the left wheel at km 454.018. The point of derailment of the right wheel was established based on the signs of damage to the spacer between the switch rail and the stock rail above the 19th sleeper of the switch, and the point of derailment of the right wheel based on the signs of damage to the spacer between the switch rail and the stock rail above the 14th sleeper of the switch, viewed from the top of the switch rails.

Image 1: The green arrow shows the shunting from track No. 9 in the direction of track No. 504 and the red arrow shows the shunting from connecting track No. 504 towards switch No. 60.

The direct cause of the accident – the derailment of the pushed E-locomotive 91 81 1116 025-8 A-ÖBB of the undertaking RCC-Croatia, d.o.o., during shunting with coupled E-locomotive 91 81 1293 001-4 A-ÖBB of the undertaking RCC-Slovenia, d.o.o., at switch No. 60, Dobova station, on 10 January 2021 at 10:21 was the forking of the second axle of the first bogie of E-locomotive 1116 025, which means that movement over the switch happened at the moment when the switch rails of switch No. 60 switched from a diverging to a straight line (the switching of switch rails from tracks Nos 7 to 14 in the direction of track No. 4).

The indirect cause of the accident can be attributed to poor communication between the personnel of the infrastructure manager – the signalman at the Dobova station – and the personnel of the undertakings – the E-locomotive drivers.

- The Undertaking SŽ – Infrastruktura, d.o.o., should:
 - 1 draft a plan of the risks involved in shunting at the Dobova station, which should include monitoring the set shunting paths and carrying out shunting operations, particularly where visibility is reduced due to the specific conditions of the area;

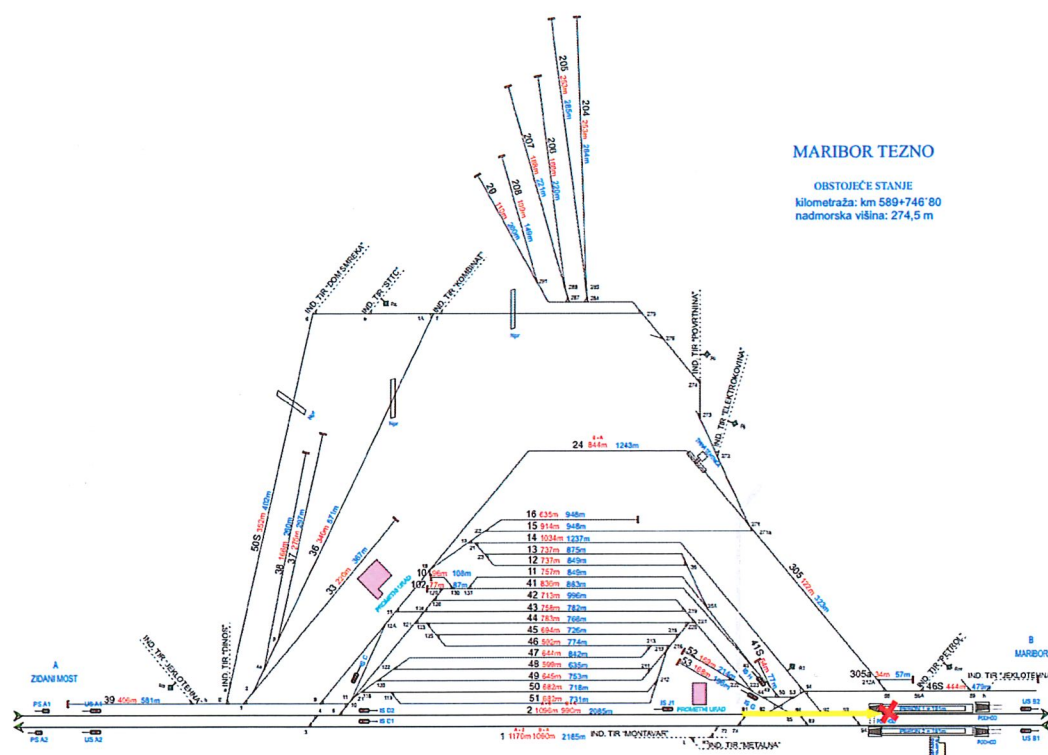
Image 1: The yellow arrow shows the direction of movement of IC regional train No. 518 on the left, station, side of the tracks and the red arrows shows the point of collision with the minor girl.

The direct cause of the accident – the collision of IC train No. 518 with a minor girl on the left, station, side of the tracks, at the Maribor Tezno station in the area of the Maribor Tezno stop on 12 January 2021 at 15:08, was the tempting of fate by the two young girls, who were standing between the left and right tracks at the time of the movement of the train.

The indirect cause of the accident can be attributed to teenage frolicking, recklessness and unfamiliarity with the various characteristics of moving trains, which led to the wrong assessment of the speed of the oncoming train. It is reasonable to assume that the girls were surprised by the speed of the approaching train.

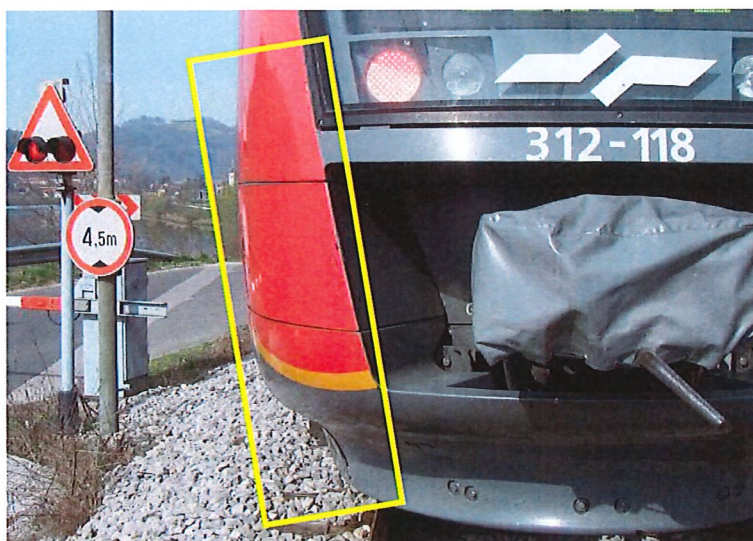
Image 1: The yellow square shows the marks and minor damage to the sheet metal

and paint on the front of EDMU 312-118 caused by the collision of train No. 2807 with the 72-year-old man.

The direct cause of the accident – the collision of regional passenger train No. 2807 with an elderly man on the left track between the Sevnica and Blanca stations at km 484.218 on 29 March 2021 at 09:32 – was an unfortunate set of circumstances that occurred when the man was walking his dog. The man's dog was pulling the leash with such force that the man could barely keep up. As the bank near the track was well-trodden, it is safe to assume that the man used this path daily to walk his dog. It is likely that, upon noticing the train, the dog started pulling the leash even harder and, as the man did not let go, the dog pulled him into the path of the train.
