Directorate for Aircraft, Maritime and Railway Accident Investigation

Railway Accident and Incident Investigation Unit

ANNUAL REPORT

2009

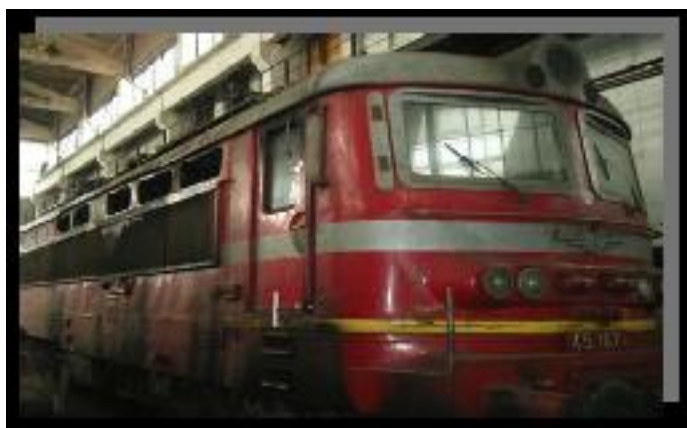
- Technical investigation of railway accident: fire in electric locomotive No. 45-167.4 of train composition No. 3601 Sofia – Burgas at 142+580 km, in the Stamboliiski-Todor Kableshkov inter-station section, on road No. 1, which occurred at around 17:55 on 30.11.2009

Locomotive No. 45-167.4 is shown in Figure 1

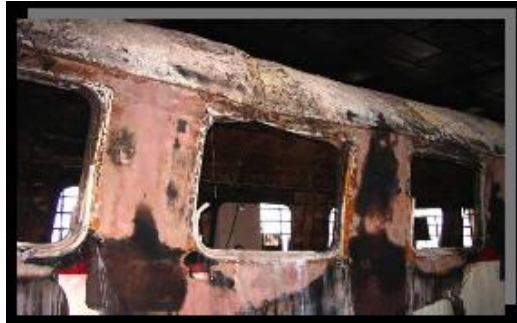
- Explanation of the occurrence of smoke in rail car No. 505229741713 of train composition No. 8626 during travel, which happened on 04.02.2009, at around 22:33 h. The car was detached from the train. It was found that there was a damaged rubber jacket between the electric motor and the turbine causing the gas mixture to enter the car.

Figure 2 shows the couchette-car after the fire

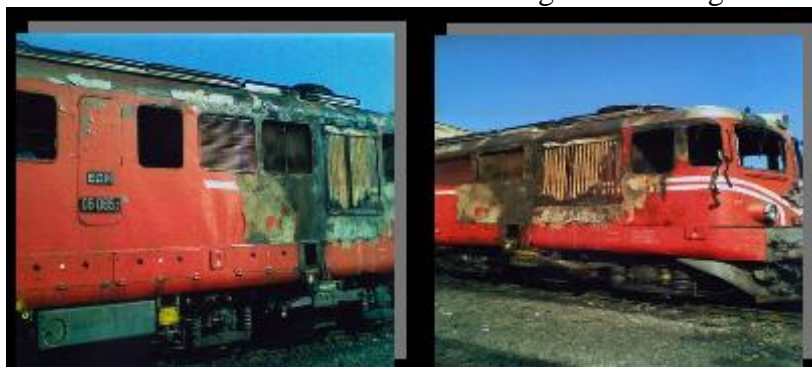
- Participation (without being members of the technical investigation commission) in the investigation of the accident which occurred on 20.10.2009, at around 18:00 h, involving train No. 50506, powered by locomotive No. 06 – 065, in the inter-station section Kalotina-Stanyantsi, resulting from fire in the locomotive. The accident was caused by fire in the fourth and fifth driving engines of the locomotive. The damages incurred amounted to BGN 53 543 (EUR 27 387.7).

Locomotive No. 06-065 is shown in Figure 5 and Figure 6

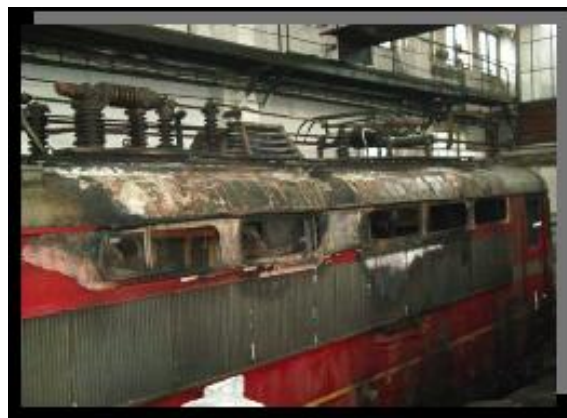
Locomotive No. 45-167.4 is shown in Figure 7

The accident has caused damages to locomotive No. 45-167.4 – fire in the first horizontal fan and the engine compartment.

- the reason for the fire in Locomotive No. 45-167.4 cannot be unambiguously determined; it can be clearly seen, however, that the lower section of the rectifier unit of Group 1 of the first horizontal fan – the section accommodating the rectifiers for the auxiliary equipment – was most severely affected by the fire, and on this grounds it can be assumed that **the fire in the locomotive was most probably caused by a breakdown of a capacitor of the R-C groups used to protect the auxiliary 220V rectifier from internal commutation over-voltage.** The over-voltage occurring during switching of the rectifiers is generated concurrently with the transition of the P-N junctions of silicon elements (diodes and transistors) from ON to OFF state as a result of the negative bias (U_{rev}) of the sinusoidal voltage wave (i.e., regular switching). The circuit contains a R-C group (capacitor and resistor in series) connected in parallel with each semiconductor rectifier. The capacitor is charged during the half wave causing negative bias voltage at the rectifier P-N junction, which is followed by a period of discharging via the resistor (during which energy is transformed into heat) while there is a conducting bias voltage applied at the rectifier (ON state of the rectifier). During the past 27 years of continuous operation, the nominal performance (capacitance) of the of the capacitors have gradually deteriorated as a result of aging, which is a reason to conclude, with high degree of probability, **that at a certain unpredictable moment there was an explosion (blow-up) of a capacitor caused by an over-voltage pulse, and the resulting sparks caused self-ignition of the capacitor electrolyte. The compact size of the rectifier cabinet (small spacing between the elements) created conditions for a process of avalanche expansion of the fire and ignition of the cables within the rectifier unit, thus causing subsequent blow-up of adjacent capacitors.** The confined design of the rectifier cabinet and the cooling method based on the generation of negative pressure in the air duct by the under-basket fan caused the air to be sucked into the engine department, flowing through the heat sinks of the semiconductor rectifiers and R-C groups in the downward direction to the area under the locomotive. This is the reason why the engine-drivers did not see fire and smoke in the engine department. Then the fire expanded from the rectifier cabinet to the fan via the air duct, causing ignition of its power supply cables, and this was the fire first seen by engine-driver No. 2 when he stuck his head out of the side window and looked back. While the efforts of the locomotive crew were directed at putting out the fire under the locomotive, the fans were put out of operation, as a result of the disconnection of the main air-break disconnecter and the power supply, and the fire expanded inside the engine compartment, filling it with thick asphyxiating smoke from the burning insulation and capacitor electrolyte. This also explains why the engine-drivers' efforts to take out the handheld CO₂ fire extinguishers were unsuccessful. The rapid intensification of the fire and its spreading to the oil-cooling system (oil cooler, pump and oil tubes) of the power transformer and the subsequent melting and burning of the rubber fixtures and seals caused leakage of oil with ignition temperature of 135°C. The ignition of the oil, rubber seals, cable insulation and insulating boards in the rectifier unit under the conditions of intense flow of air caused a rapid rise of the temperature in the engine compartment and intense release of smoke. The breaking of the side windows with the aim of putting the water hoses inside the engine compartment caused inflow of oxygen and subsequent intensification of the fire in the interior.

This fire was not caused by violations or omissions in the maintenance (performance of scheduled and emergency repairs) or operation (depot inspections, etc.) of the locomotive, or deviation from the regulatory provisions concerning the condition of the electric circuits (control measurements), or improper actions of employees.

2. BDZ EAD shall give directions for inspection of the condition of the fire-alarm and fire-extinguishing systems of all electric locomotives being currently used, and find a

3. BDZ EAD shall give directions for the provision of new type of fire-safe dry capacitors for the R-C over-voltage protection units of the rectifiers, in view of their replacement during the next scheduled repairs (hoist-assisted repair, mid-life repair, major repair).
