## Investigation Report 2011-R005

**Person struck at level crossing XE039, County Clare,**

**27<sup>th</sup> June 2010**

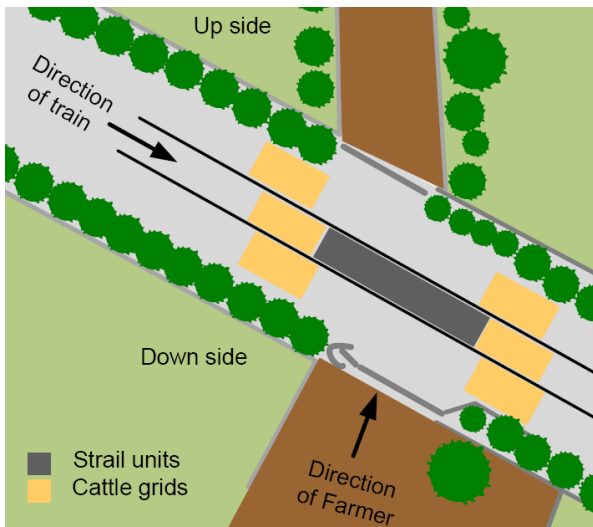
Figure 2 – Layout of XE039

XE039 has a skewed crossing route and is at an acute angle to the railway line, see Figure 2. The surface of the road approach on both sides of the LC is unpaved. The surface on both sides of the track is ballast. The surface between the rails consists of Strail units, which are made of rubber. There are cattle grids the full width of XE039 on the railway approaches to prevent cattle straying along the railway line.

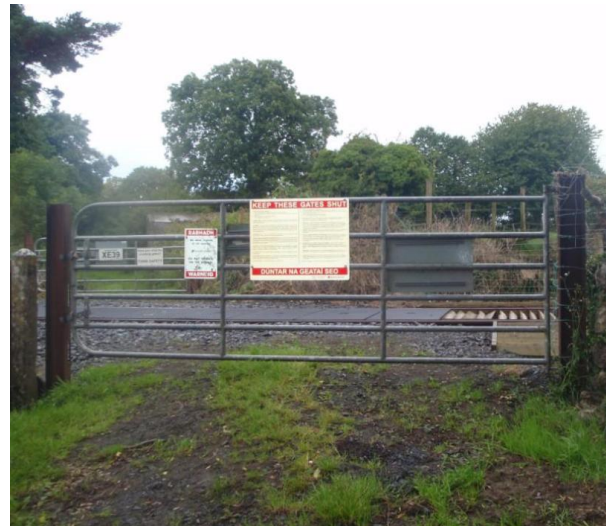
Photograph 1 – XE039 from Down side

There are metal gates positioned on both the *Up* and *Down sides* of XE039, see Photograph 1. The gates are positioned approximately 3.18 m from the nearest rail on the *Up* side of XE039 and 2.91 m from the nearest rail on the *Down* side of XE039. There is a wicket gate on the *Down* side of the LC gate on the *Down* side of the track to allow pedestrians cross without opening the LC gate on the *Down* side of the railway line. The surround of the wicket gate is made of concrete and the wicket gate is made of timber. The gates at XE039 are fitted with padlocks. The two LC users were both provided with keys to the padlocks and the gates were normally kept closed and padlocked.

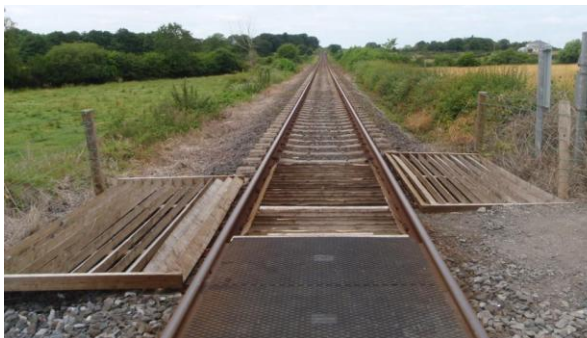
Photograph 2 – Approach from Down direction

- The vegetation at XE039 may have affected the Farmer's ability to see the train.

Photograph 2 shows the approach from the Down direction, which is the direction the train travelled from. The vegetation along the Down side of the railway is shown in Photographs 2 and 3.

- Iarnród Éireann to develop and implement a vegetation management programme that addresses vegetation management on a risk basis, prioritising high risk areas.

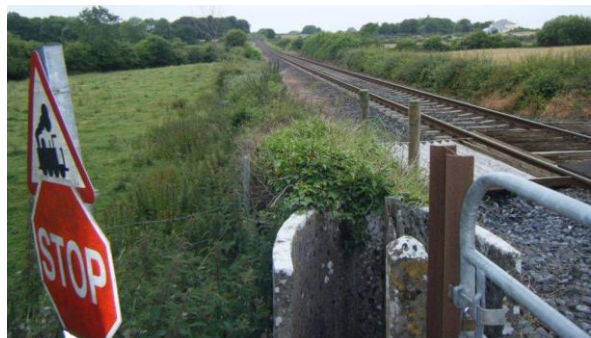
Photograph 3 – Vegetation on Down side

The vegetation at XE039 was found to have provided restricted views that could have been improved through vegetation management, leading to the reiteration of the following safety recommendation from RAIU investigation report 'Report into the collision at level crossing XN 104 between Ballybrophy and Killonan on the 28th of June, 2007' published in June 2008 (RAIU, 2008):

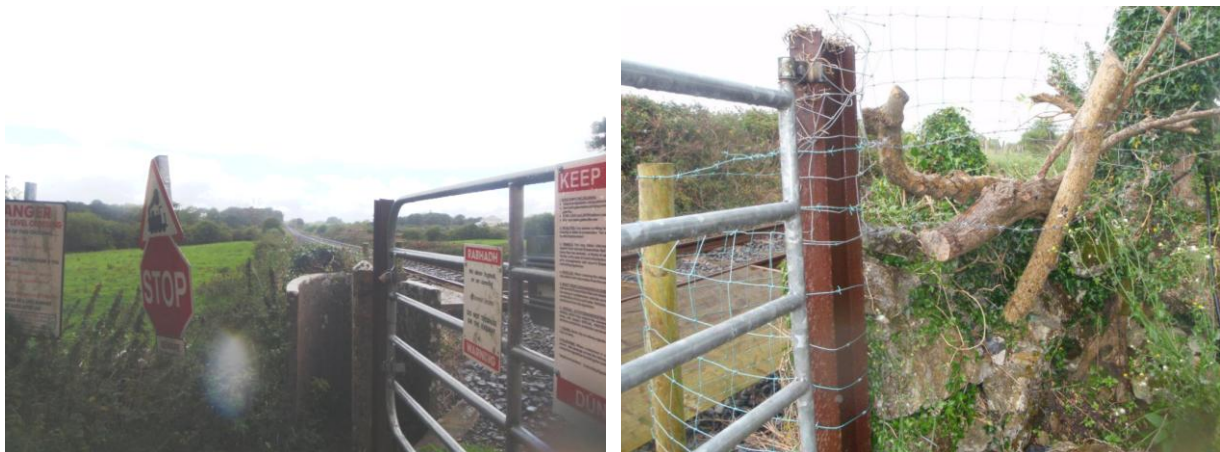
Photograph 4 – Down side view in Down direction      Photograph 5 – Down side view in Up direction

The views at XE039 on the side the Farmer approached from were photographed from the viewing position specified in MW50, at 3.66 m from the nearest rail at a height of 1.22 m, see Photographs 4 and 5. Photographs 4 and 5 were taken following cutting back of the vegetation after the accident.

Photograph 5 shows that the viewing distance looking in the Up direction from the Down side of the railway at the viewing distance of 3.66 m would not meet the 250 m required by MW50.

The viewing distances for XE039 were found to have been measured at less than the 3.66 m from the nearest rail specified in MW50 for three of the four views as shown in Table 4. This meant that in order to view trains approaching from both directions, the Farmer would have had to be positioned 2 m from the nearest rail. As the Farmer was moving a cow across the railway line in front of him this meant that the cow would already have been within the swept path of an approaching train by the time the Farmer could make the determination of whether or not it was safe to cross the railway line in accordance with clause 11.7 of the user booklet (IÉ, 2006). This meant that an accident involving the cow would have been inevitable. Depending on the position of the Farmer when he became aware of the train, the impending accident with the cow may have affected the Farmer's decision to continue forward across the railway line or go back towards where he came from in order to move to a position of safety.
