# Summary - Safety Investigation

## Collision between 2 SNCB/NMBS passenger trains

### Binche - 13 January 2016

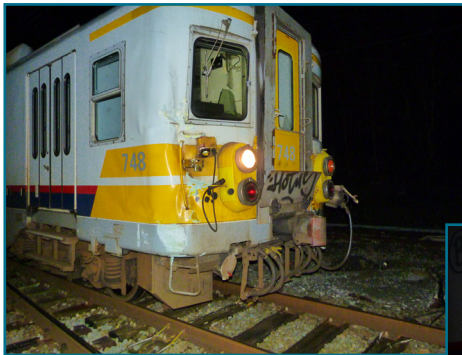
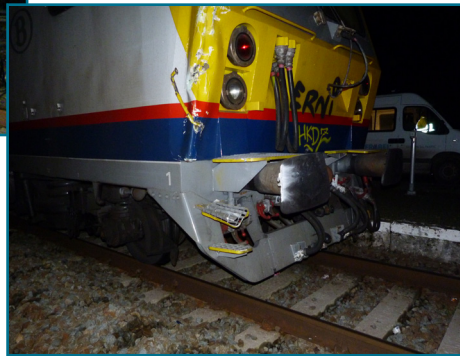
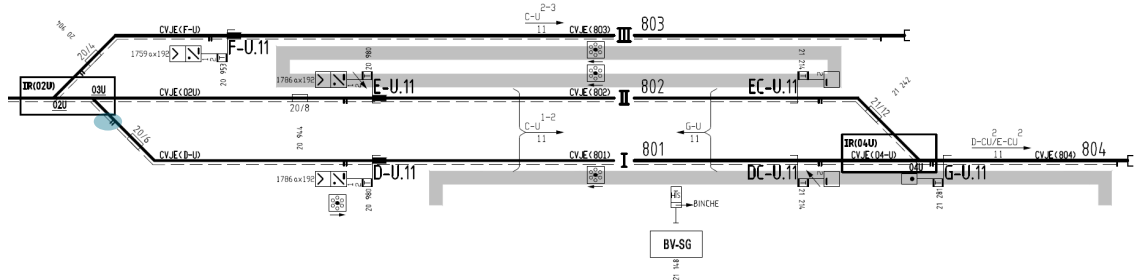
On Wednesday 13 January 2016 at around 20:53, the SNCB/NMBS empty passenger train ME3421 struck the rear of the SNCB/NMBS train E3440 when entering Binche station. There were no victims in the collision and the damage, which was only to the rolling stock, was relatively limited.

The collision between the two passenger trains was made possible due to the position of an insulated connection on a track circuit ensuring the detection of trains: while the train E3440 had released one part of its route by passing this connection, the train was still in the track gauge of the adjacent track II.

The track circuit being released, the movement of the train ME3421 onto track II was authorised: the front of the train ME3421 collided with the rear of the train E3440.
