REPUBLIC OF BULGARIA
NATIONAL AIR, MARITIME AND RAILWAY ACCIDENTS
INVESTIGATION BOARD

FINAL REPORT

**Investigation of railway accident – fire in electric locomotive № 44094.8,
occurred while servicing fast train № 3621 between the stations Chernograd –
Aytoz on 28.09.2020**

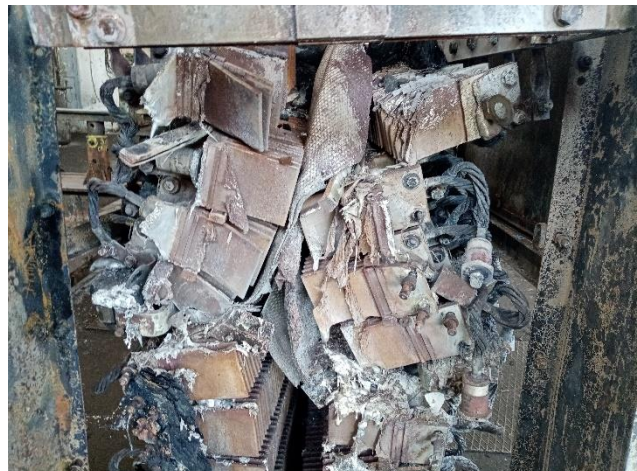
Fig. 2.1

- Severely damaged insulation pads of the rectifier elements of rectifier group 020 (rectifier of the first traction group). Molten diode coolers at the bottom of the rectifier group (Fig. 2.1);
- Terminal board of the second traction motor (TM) - badly burnt, including the cable insulation of the second traction motor (Fig. 2.2);
- The connecting rubber pipe of motor pump 238 has been burnt but not destroyed. Most likely from a secondary fire flame in rectifier group 020;

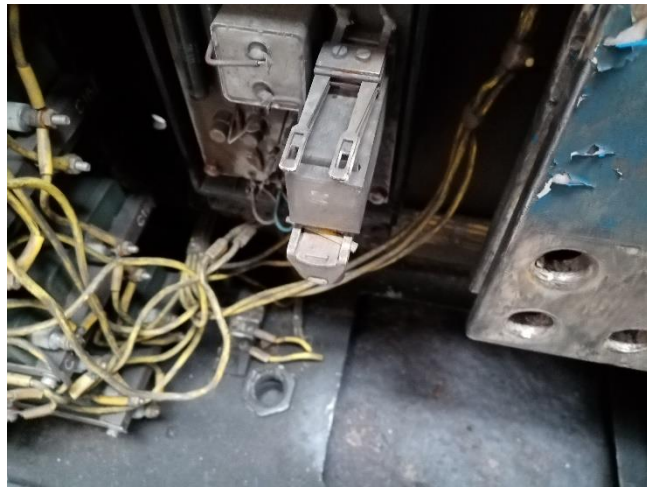
Fig. 2.4

- The check for the serviceability (by insulation resistance, for circular fire) of the horizontal fan - 230 - upright;
- Disassembly of the bogies, inspection of the body shell floor and inspection of traction engines 1-2. After drying the locomotive, the insulation resistance of the armature winding and the additional poles were measured - in good condition;
- Download and decoding of the locomotive tape information;
- The Commission received all the collected materials and the report from the Task force according to the requirements of art. 73 para. 3 and para. 4 of Ordinance № 59, reviewed and analysed in detail the collected documentation.

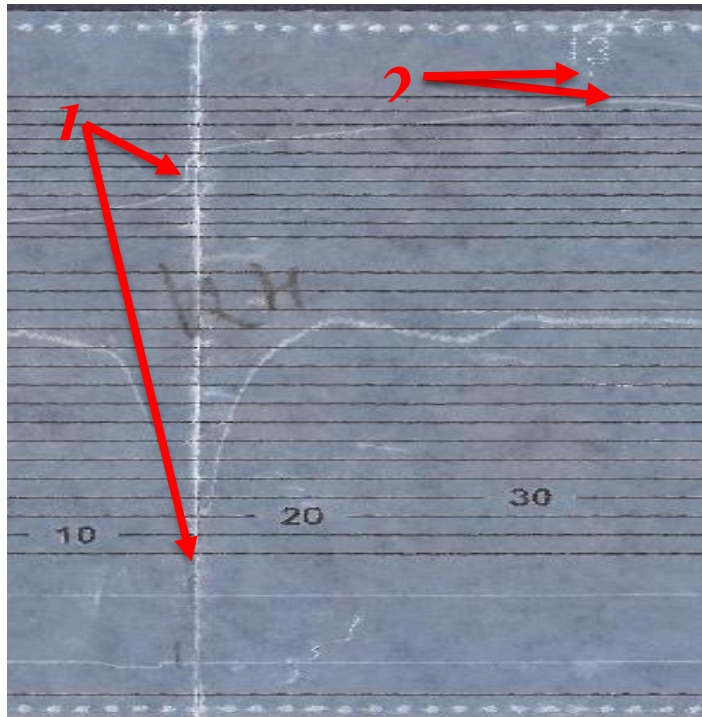
Fig. 4.1

FT № 3621 arrives at Karnobat station at 12:54 p.m. on the registration of the time line on the speedometer tape

(Fig. 4.1, pos. 1). After a standstill of about 1 minute and 10 seconds, the train departs, accelerates to 22 km/h, after which the speed stays at this value for about 40 seconds - a time during which it travels about 250 meters, then begins to accelerate again (Fig. 4.2, pos. 1). In this mode it travels 1900 meters in 1 minute and 20 seconds to reach a speed of 125 km/h at km 235⁺²⁰⁰ (Fig. 4.2, pos. 2). At this point, the locomotive driver switches off the traction mode of the locomotive and prepares it for the passage of the neutral insert. The train travels 1800 meters by inertia from km 235⁺²⁰⁰ to km 237⁺⁰⁰⁰ in 1 minute. In this interval, the speed decreases to 113 km/h (Fig. 4.2, pos. 3).

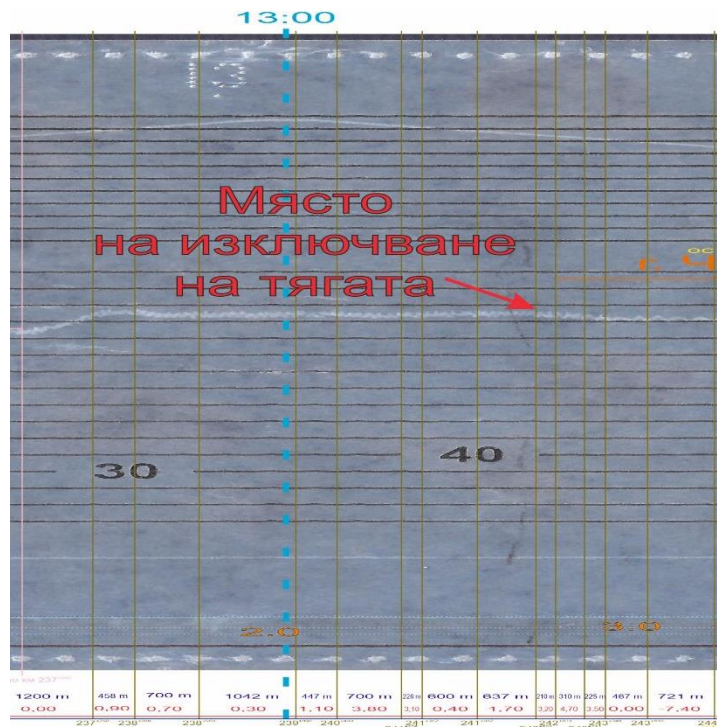
Fig. 4.3

During the movement in this interval of km 242⁺⁸¹⁵ the train enters in Chernograd station at a speed of 120 km/h at 13:02 p.m. At this speed, the train moves for 1985 meters from km 243⁺³⁴⁸ to km 245⁺³³³ for 1 minute (Fig. 4.3).

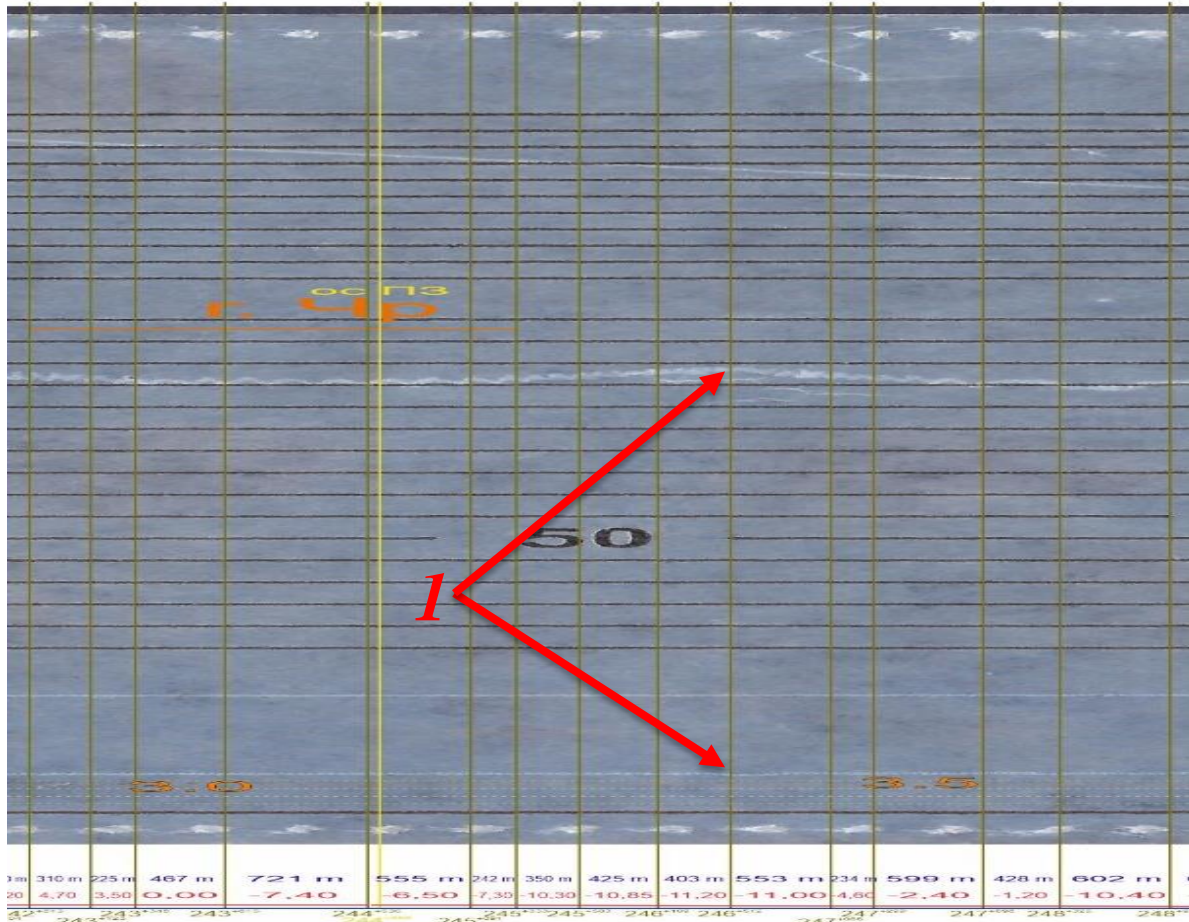
Fig. 4.4

From km 245⁺³³³ at 13:02:50 p. m. the train moves by inertia, but the speed starts to increase due to the increase of the longitudinal slope of the road. The speed reaches 128 km/h at km 246⁺⁵¹² at 13:03:30 p.m. At this point, the locomotive driver applies the automatic train brake to prevent the section from exceeding the maximum permissible speed by reducing the pressure in the main air conduct by 0.4 bar to 4.6 bar for about 10 seconds, then loosens the brake and restores it up to 5.0 bar (Fig. 4.4). The speed starts to decrease, reaching a value of 117 km/h at 13:05 p.m. from km 246⁺⁵¹² to km 250⁺⁰⁰⁰ for 3.5 km in 1 minute and 40 seconds. From km 249⁺⁶⁶⁰ to km 252⁺⁸⁰⁰ the speed fluctuates between 117 and 120 km/h when driving by inertia, traveling about 660 meters

in 1 minute and 20 seconds (Fig. 4.4, pos.1).

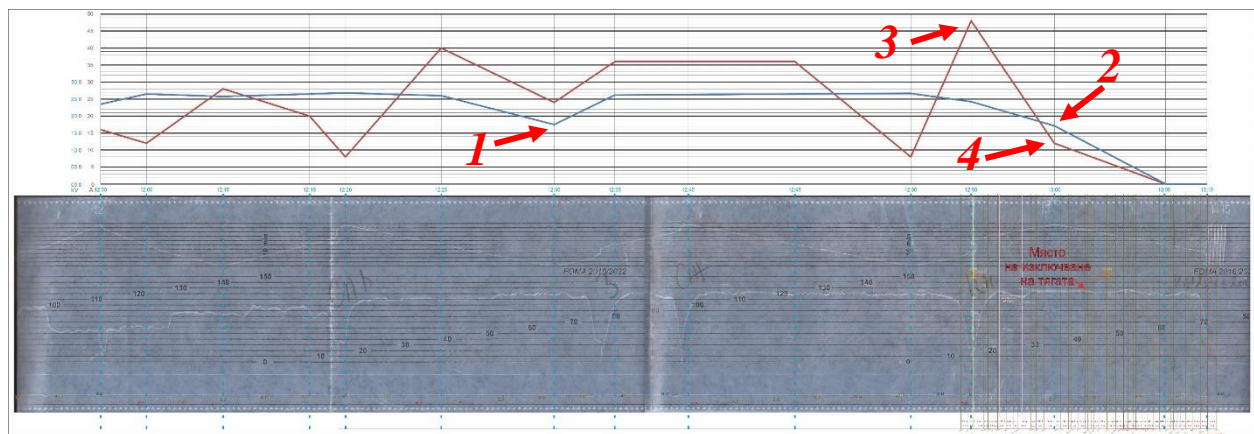
Fig. 4.6

The maximum measured **average** value of the current consumed by the locomotive is 48.0 A at 12:55 p.m. (Fig. 4.6, pos. 3), which corresponds to the moment of departure of the train from Karnobat station. Then the second lowest **average** current value of 12.0 A was measured for the second time (Fig. 4.6, item 4) when the train is already in the area of TS Karnobat, terminal Chernograd, track № 1. This can be explained by the fact that the train is moving at high speed and the values of the traction current are low, after which it switches to inertia mode and logically the traction current decreases even more. At the same time, the auxiliary machines (especially the compressors) continue to operate and load the rectifier units. Reduced voltage values lead to increased current during the operation of auxiliary machines, which increases their operating time, combined with the lack of cooling. This mode of operation has led to an increase in the temperature in the rectifiers of the auxiliary machines and to their ignition. At the end of the

An important factor for raising the temperature is the operation of the locomotive with reduced voltage in the catenary (Fig. 4.6), which leads to increased operating currents, which are known to cause intense heating of the wires and devices through which they flow and worsen the conditions for operation of auxiliary machines and devices, in other words, the parameters of the voltage in the catenary at 13:00 p. m. at the time of the fire in the locomotive were violated.

Recommendation 3 proposes SE NRIC to inspect the facilities and devices for traction power supply, related to the detection and elimination of faults leading to low supply voltage in the catenary during the movement of trains in the section Zimnitsa - Aytos.

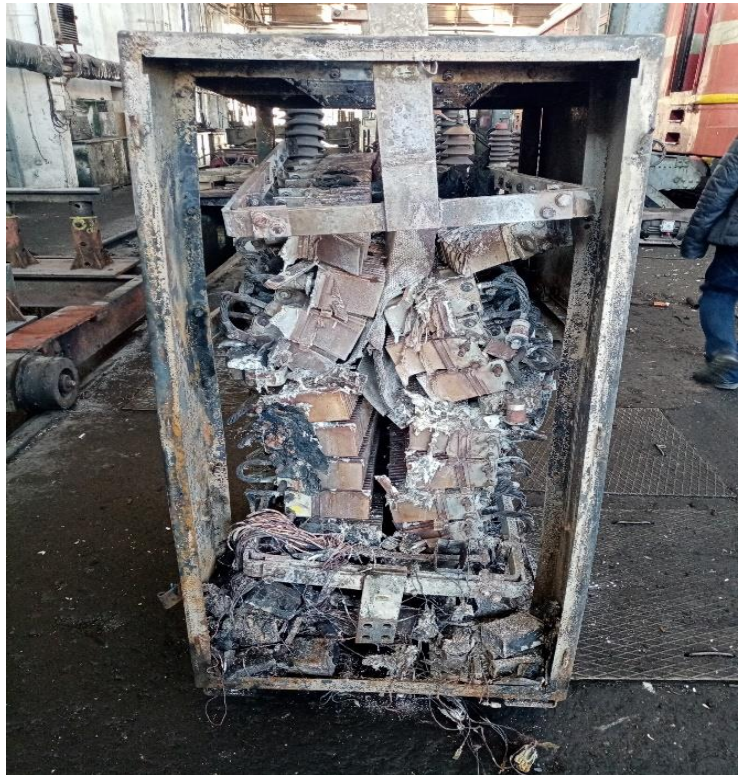
Fig. 5.1

It was found that the rectifier unit of the first group was almost completely burned, as the traction rectifier has fused diodes and cooling radiators to them. The Commission also found that the initial ignition source was located at the lower end of the rectifier cabinet, where the rectifiers of the auxiliary machines are located, and more precisely on the rectifier side of the compressor motor of the same group (Fig. 5.1). The conductors were with burnt insulation and in a brittle condition, proving the presence of temperatures of 800÷900°C (Fig. 5.2). The condensers had swollen and broken housings, apparently due to high pressure inside them, caused by self-ignition due to the developed high temperature (Fig. 5.3). It was obvious that the fire occurred and developed in the lower part of the rectifier unit, on the rectifier side of the motor-compressor.

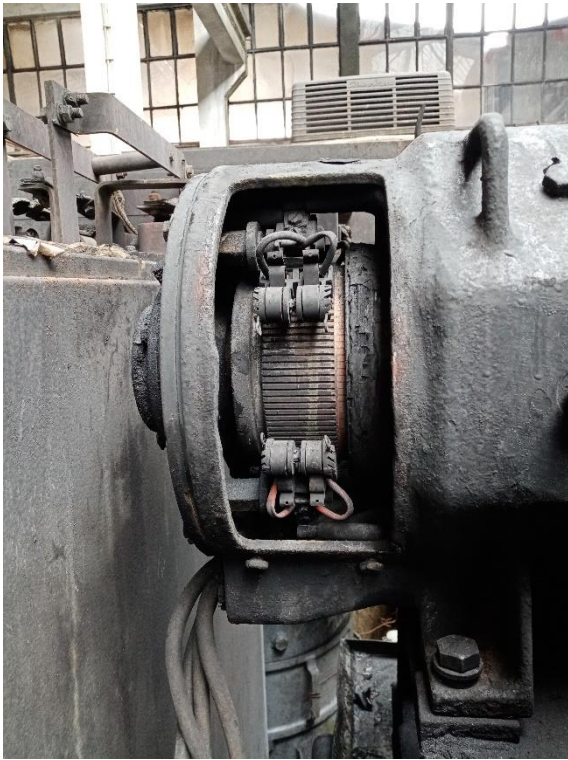
Fig. 5.5

The Commission also carried out in-depth inspections of the other units of the locomotive's engine compartment. It was found that the engine-compressor of the first group is unusable, but recoverable, with a smoky manifold/collector. The compressor was removed from the locomotive for further inspections. During the additional inspections performed on this unit, it was found that the damage was due to the high temperature during combustion and due to the water, by

which was put out the fire. There were no signs of a short circuit or ignition source on the compressor motor (Fig. 5.5). The commission also inspected the horizontal hopper fan cooling the rectifier unit of the first traction group and found that it was also undamaged due to the timely actions of the locomotive crew and the impossibility the fire to spread on this unit (Fig. 5.6).

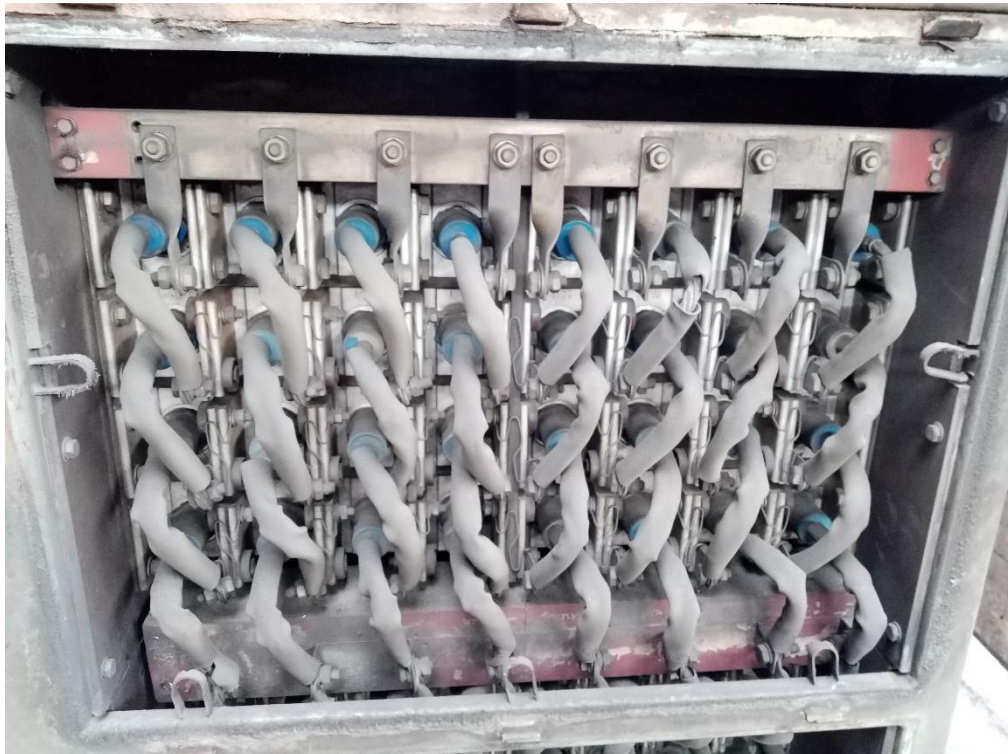
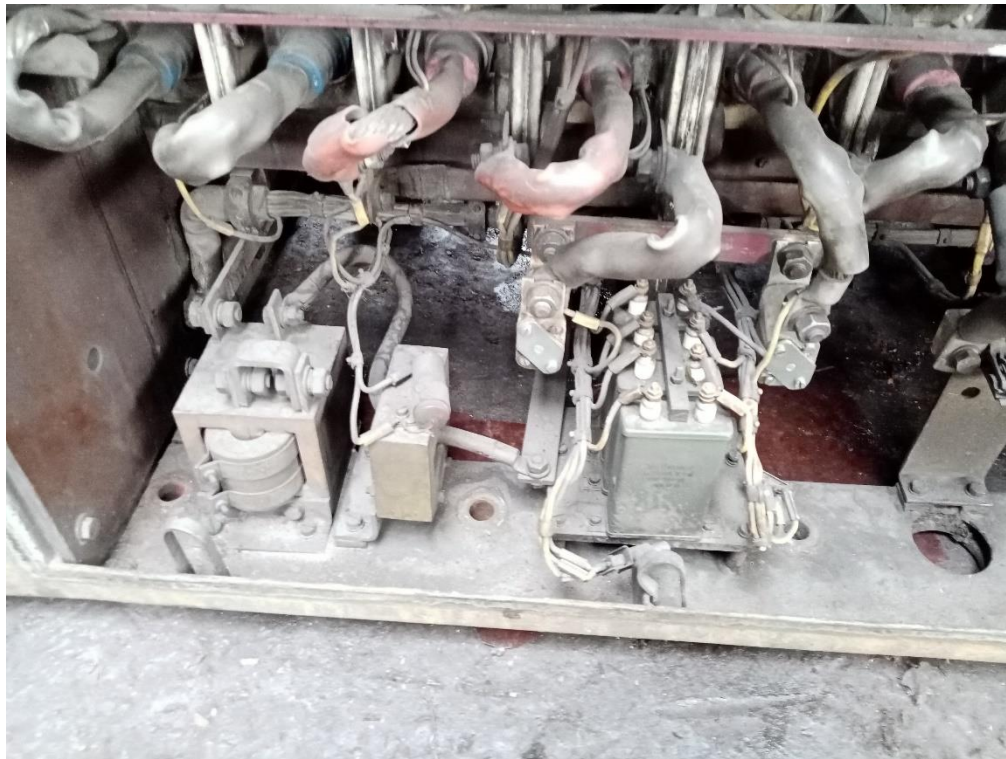
The Investigation Commission carried out a detailed and in-depth inspection of the rectifier unit of the second traction group. It was established that there were no damages on this rectifier unit - the locomotive crew found the fire that occurred early and took measures to limit it, thus preventing even greater damage to the locomotive. At the same time, keeping in good condition the rectifier unit of the second group allowed the Commission to inspect and analyse its condition and the causes that led to the ignition of the locomotive (Fig. 5.7 and 5.8).

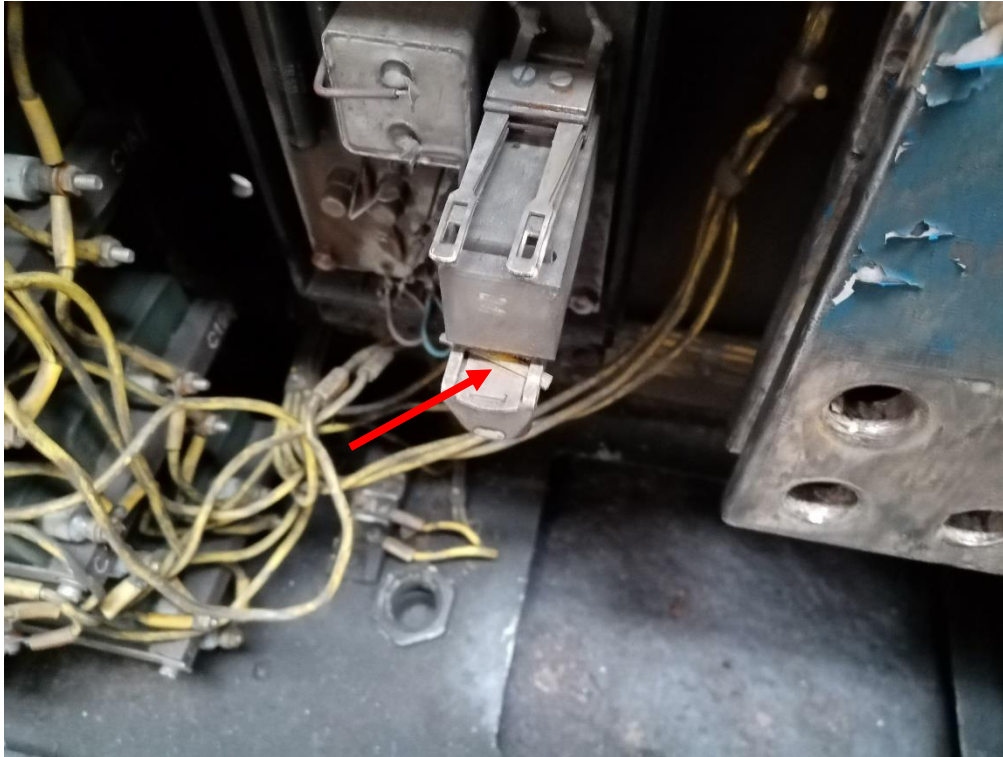
Fig. 5.9

In the course of the investigation, the Commission also found a breach of the safe operation of the locomotive - the exclusion of important protection, which ensures that the locomotive does not remain without cooling during operation. It was found that on the coil of the control relay Y3 is placed an object - which keeps the relay on, regardless of the signals it receives. Relay Y3 is a control relay that receives voltage from the auxiliary rectifiers of the fans. It turns off the traction mode of the locomotive below (143V) and participates in the cooling control circuits of electrical machines and rectifier groups (Fig. 5.9). In this way, the relay remains switched on continuously, regardless of whether the cooling is normal, and this creates a precondition for the locomotive to operate without sufficient or even without any cooling of electrical machines and apparatus. The operation of the locomotive without the necessary cooling leads to an excessive increase in temperature in the individual units and in the engine compartment as a whole, which leads to melting of the cable insulation, damage to the capacitors, leakage of their electrolyte, which in turn becomes a catalyst for ignition of the rectifier unit.

In this regard, it is necessary to emphasize that in this series of locomotives the cooling fans of the electric machines are switched on automatically during the traction mode of the locomotive, but are switched off manually by means of a button on the control panel, i.e. the subjective factor (the locomotive driver) is the one that assesses

the degree of cooling and whether further operation of the fans is necessary when switching off the traction mode.

It is very common practice for locomotive drivers to switch off the fans immediately after switching off the traction mode of the locomotive in order to prevent the gust of strong air current and increase the noise level in the control cabin. Violation of the working conditions of locomotive drivers is a precondition for the deterioration of their health, which is the main reason for their actions. However, this shutdown is accompanied by a further increase in temperature in the cooled machines and appliances, and especially in the rectifier units, which have so far operated at full capacity, their heating is very intense and at the time of shutdown they continue to radiate heat. This heat is distributed in the closed cabinet of the rectifier unit, including the rectifiers of the auxiliary machines. The above leads to intense heating of the rectifiers of auxiliary machines and the rectifier unit as a whole and in certain circumstances the capacitors do not withstand the high temperatures, burst and the spilled electrolyte ignites from the heated surfaces of the cabinet walls, igniting the wire insulation, which is in it.

Recommendation 1 proposes that BDZ PS Ltd. revise the control scheme of the fans in the locomotive in order to exclude interference of the subjective factor (the locomotive driver), observing the requirements of the Regulations for depot repair and maintenance of electric locomotives of BDZ (LS 0103 / 01.01 .1979) - §13 and of the Regulations for factory repair of electric locomotives series 44.000 and 45.000 (PLS 127/05) -§13.

Recommendation 2 proposes that BDZ PS Ltd. limit the access for forced “impact” of an electronic relay for voltage control of the Y3 fans, by obligatory sealing and performing periodic scheduled control for serviceability and functionality.

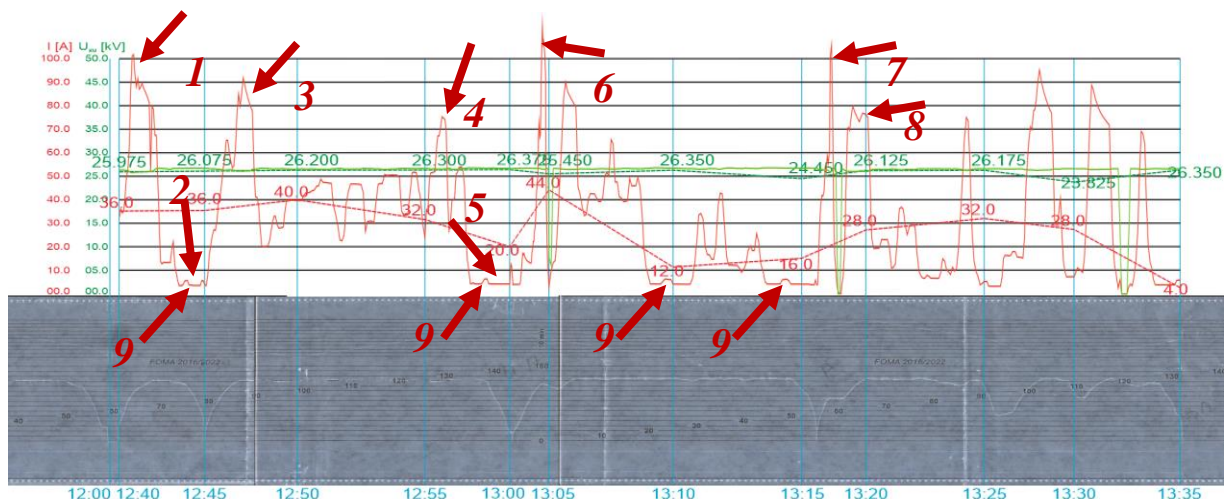
Fig. 5.10

On 12.02.2021 an experimental trip was made along the route of FT № 3621 with a locomotive № 44198. In the locomotive were installed devices measuring the voltage in the catenary and the current consumed by the locomotive during its movement, all data were recorded after which were analysed in depth and detail. The measurement of the values of the alternating voltage in the catenary was performed with a certified multifunction device "Fluke 430 Series SN": DM9311111, which also performs harmonic analysis of voltage and current in one phase, scanning with a frequency of 4 kHz, applying a computational algorithm - fast conversion of Fourier. The device allows digital recording of current and voltage curves with a scanning frequency of 2.5 Hz, which is determined by high accuracy (<0.5%). The recordings made by the devices are at every 5 seconds and give a clear and detailed picture of the change of the above-mentioned parameters. The data were taken and recorded using the software product Power Log Classic 4.6, after which they were processed and compared with the speedometer tape of the locomotive, which provides accurate information about current and voltage data both in time and in location and speed of FT № 3621. Due to the large volume of data, only the data from 12:40 p. m. to 13:35 p. m. were analysed - time during which the train is in the same section where the accident with locomotive 44094 was realized on 28.09.2020, namely the section of Zimnitsa station to Vladimir Pavlov station (Fig. 5.10).

In the interval from 12:00 p. m. to 12:25 p. m. the average values of the voltage in the catenary is over 26 000 V at **average** values of the consumed current for the same interval from 4 to 28 A (Table 2). At 12:30 p. m. the **average** value of the consumed current is 24 A at an average value of the voltage in the catenary 25 950 V. In the next moment of measurement at 12:35 p. m. was reported the lowest one.

During the movement of the train in some places local current peaks are observed, caused by the operation of the motor-compressors, and the consumption does not fall to zero value due to the fact that the train heating is constantly switched on (Fig. 5.10, pos. 9).

Throughout the movement in the observed section, the voltage in the catenary is maintained in the range of 26 to 27 kV, except for the values measured at 12:35 p. m. (15 350 V) and at 13:45 p. m. (2 625 V) (Table 2). The average values of current and voltage read by the locomotive electricity meter for intervals of 5 minutes generally show the same trend with voltage values slightly lower than those measured with the help of the device.
