REPUBLIC OF BULGARIA
NATIONAL AIR, MARITIME AND RAILWAY ACCIDENTS
INVESTIGATION BOARD

FINAL REPORT

**Investigation of railway accident – derailment of locomotive № 46041 of
direct freight train № 30682 while entering in Kostenets station on 15.07.2020**

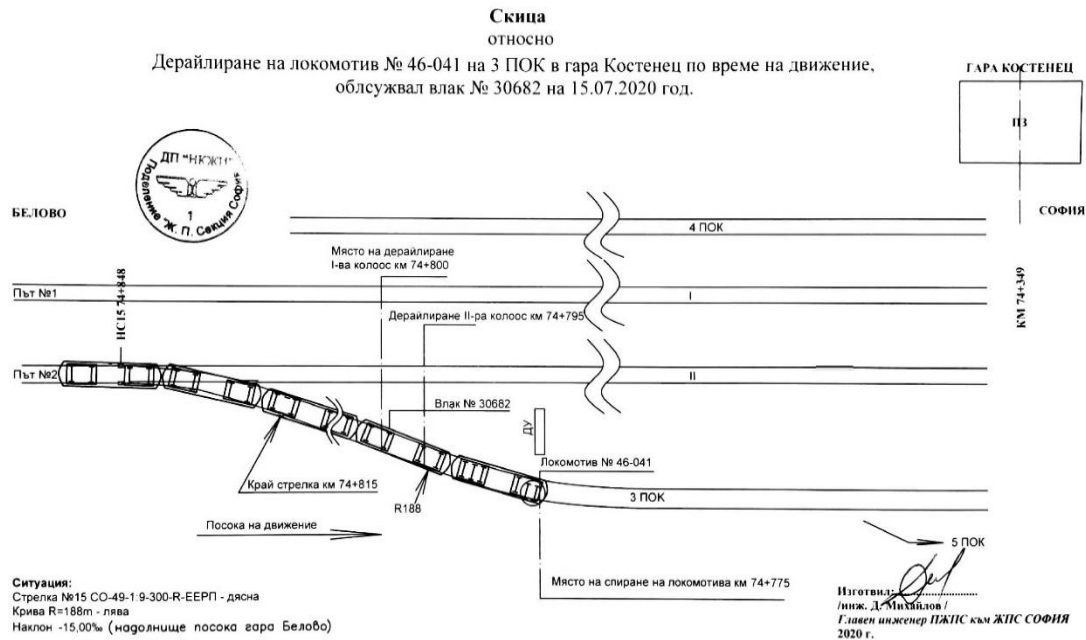
Fig. 1.2.

Immediate cause for the accident occurrence (derailment of the first two wheel-sets of locomotive No 46041 in the curve after switch No 15 of third acceptance-departure track in Kostenets station). The immediate cause is in combination with discrepancies of the inter-bogie coupler of the locomotive and additionally occurred lateral transverse horizontal force from the external leading right wheel of the first wheel-set in direction of the movement (sixth for the locomotive), caused by inadmissible differences of the track alignment in the left curve with radius $R=188$ m (fig. 1.2).

- By recommendation 4 it is suggested SE NRIC to adjust third track in Kostenets station in accordance with the requirements of item 3.3.6 and item 3.3.12.7 stipulated in Instruction on the layout and maintenance of the rail track superstructure and rail switches (for counter-curves without cant without transition curves and without intermediate line).

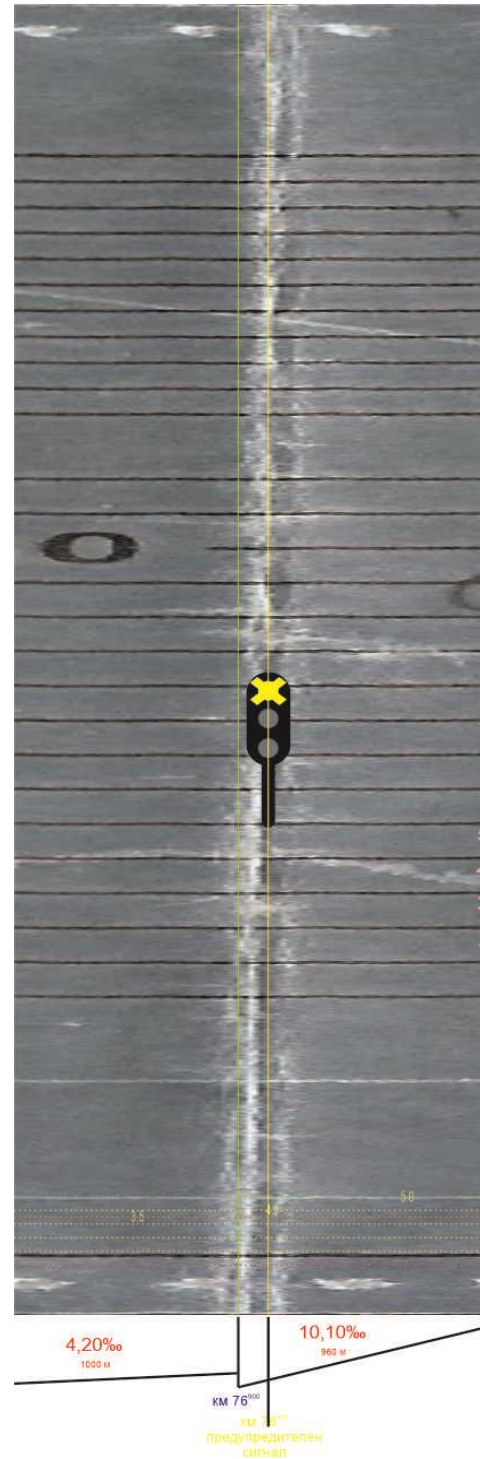
Fig. 4.1.

The train departed from Septemvri station at 09:23 a.m., and kept the admissible speed along the section. At 09:46 a.m. passed by the warning signal at Kostenets station with speed 42 km/h in traction mode (fig. 4.1). At 09:48 a.m. the train passed by the entrance signal at Kostenets station with speed 35 km/h with clear trend to

reduce the speed. After passing 200 meters (from the entrance signal at km 75⁺³³⁰ to km 75⁺¹³⁰) the speed reached 31 km/h and from that moment the reduction rate increased – the locomotive turned off the traction mode and started to move by inertia. The train moved in that mode to km 74⁺⁸⁰⁰ for 330 meters and at the same place with speed 25 km/h was registered long vertical line by the pen, which registers the movement speed (fig. 4.2, pos. 1). The registered was a result from the derailment of the locomotive sixth wheel-set, which was first in movement direction. It shall be noted that the Tacho converter of locomotives series 46000 is located on sixth wheel-set, i.e. in the case was the first derailed wheel-set. The conclusion is that the locomotive derailed at km 74⁺⁸⁰⁰ within 25 km/h speed with the first in movement direction (sixth for the locomotive) wheel-set. Only five meters after the derailment of the first wheel-set, derailed the second in movement direction wheel-set (fifth for the locomotive) at km 74⁺⁷⁹⁵ (fig. 4.2, pos. 2). The registered of the passed distance between the derailment of the sixth and fifth wheel-set is not is not proportional to the passed distance, because in that moment the sixth wheel-set was not in contact with the rail track and did not report it correctly. At the moment of derailment of the second wheel-set, the engine driver activated the automatic train brake as he performed complete official retention, decreasing the pressure in the main air conduct to 3,5 bars, as a result the speed was decreased to zero, and the locomotive stopped over at km 74⁺⁷⁷⁵ (fig. 4.2, pos. 3), calculated as per the location of the front locomotive buffers, which means that the track actually passed by the locomotive from the moment of derailment of the second wheel-set until its final stopping was 2,5 meters shorter, i.e. its first wheel-set location was at km 74^{+772,5}.

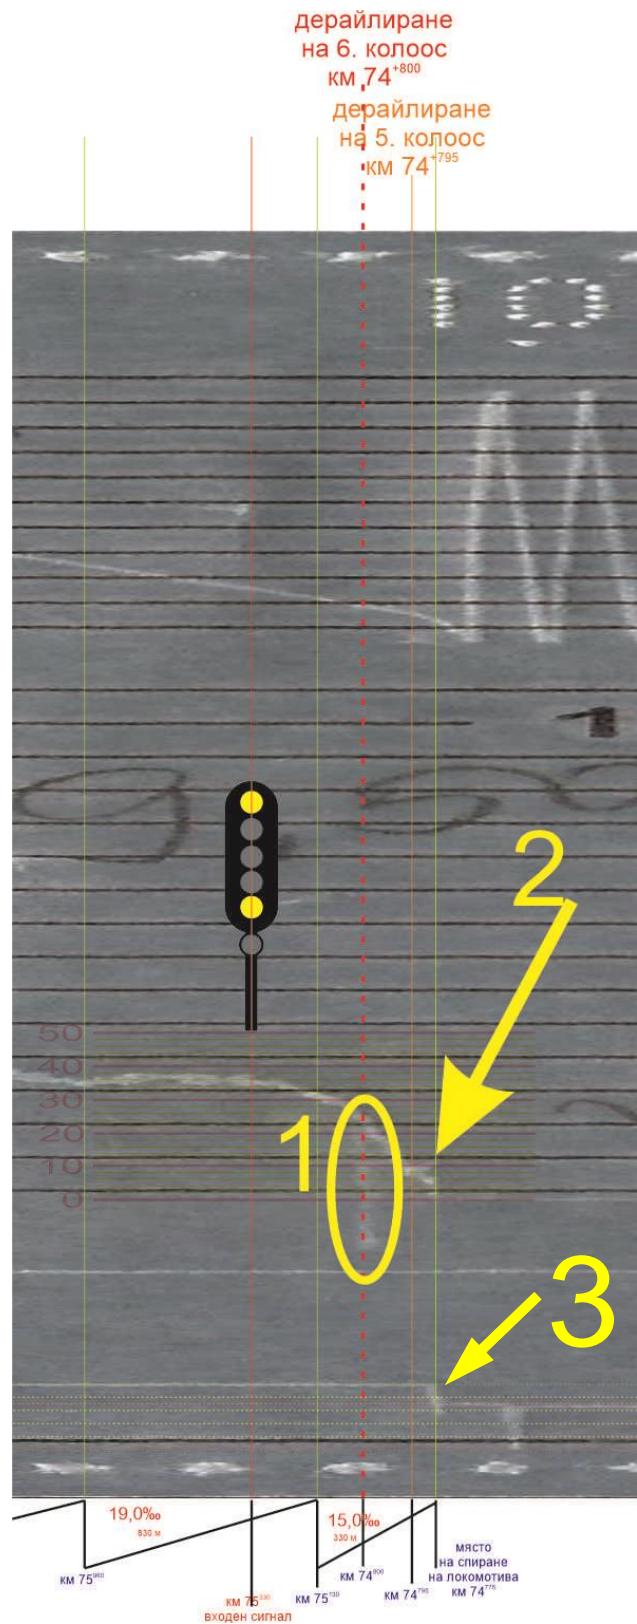
Fig. 4.2.

During the train acceptance on third acceptance-departure siding track in Kostenets station at approximately 09:50 a.m., the locomotive derailed with the first two wheel-sets in the left curve area after right switch No 15, S 49, deviation 1:9, radius R=300 m, as the locomotive took a position, within which the front buffers were against the remote indicator, and the leading first wheel-set stopped at 2 m before the indicator. The traces that the first and second derailed wheel-sets left were the following:

- The right leading wheel of the first wheel-set went on the crown of the right leading rail in the curve at a distance of 15,77 m from the end of switch No 15 and slid from the external part of the rail.
- After 0,85 m followed also sliding from the left wheel of the internal side of the left rail.
- At 21,40 m after the end of switch No 15, followed rising of the right wheel of the second wheel-set that left a trace with 0,15 m length on the crown of the right rail and slid to the right from its external side.
- Then followed sliding of the left wheel of the same wheel-set from the internal part of the left rail in the curve.

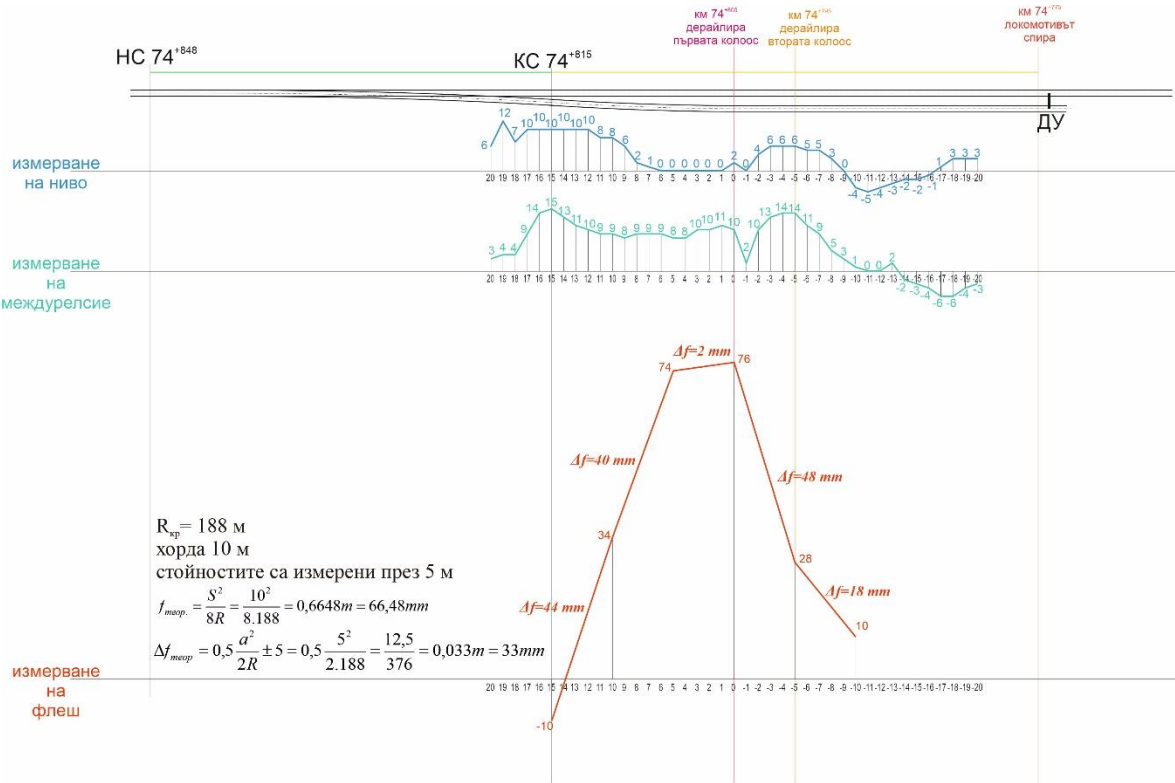
Fig. 4.4.

- Evident from the written values for the alignment in the circular curve, the alignment differences are from 34 mm, after 5 m to 74 mm in the rise point 76 mm, and after 5 m – 28 mm and after another 5m fell to 10 mm (Fig. 4.4).

• By recommendation 4 is suggested SE NRIC to arrange third track in Kostenets station as per the requirements of item 3.3.12.7 and item 3.36 for counter curves without cant without transitional curves, and without interim straight line of the Instruction for rail track and rail switches planning and maintenance.

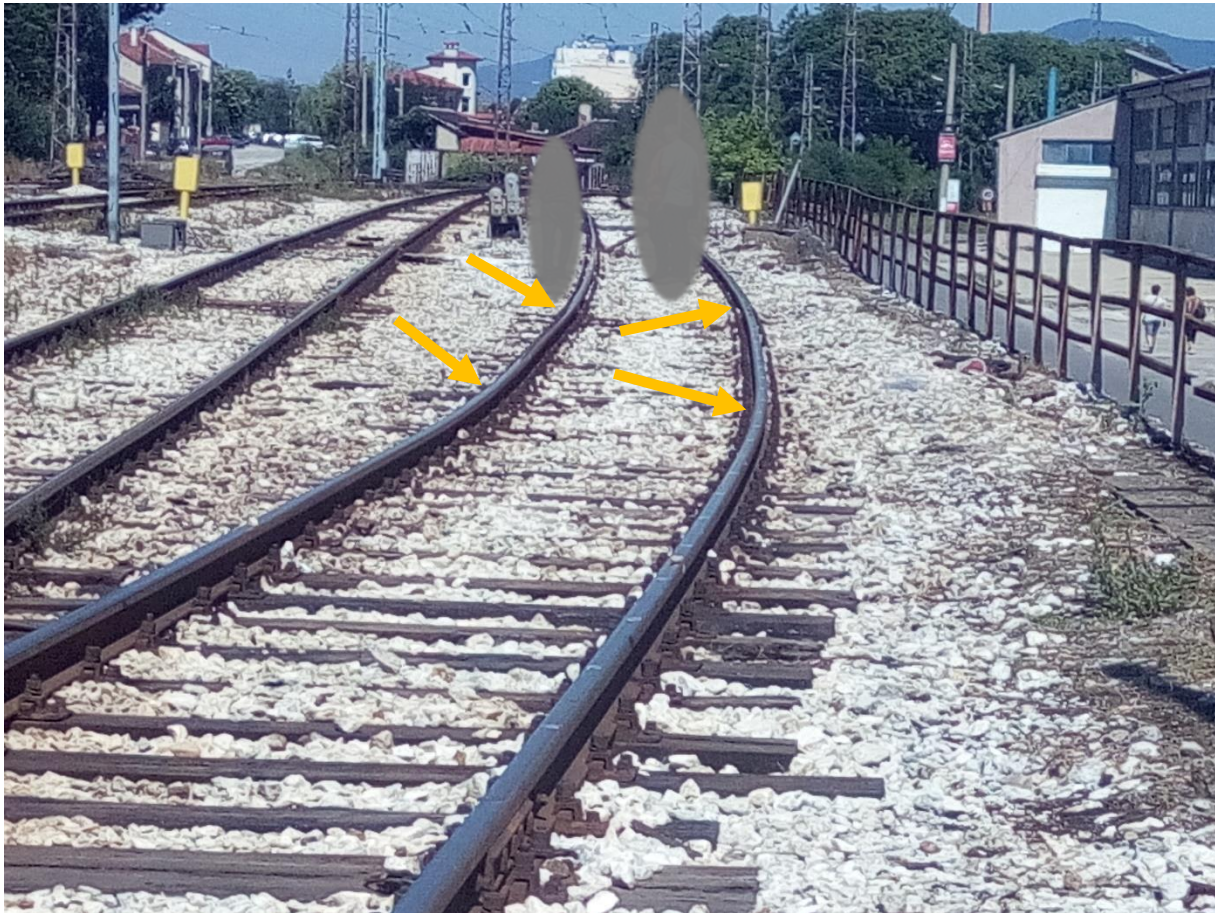
Fig. 4.5.

According to the data from the Statement of Findings of the Task Force on the condition of the rail track, it is not in norms. It is evident that the measured alignment differences in and around the derailment point further complicated the entry of the locomotive bogies, increased the steering force and the angle of attack of the driving wheel, which led to the derailment of the first and then the second in direction of the train movement wheel-sets (fig. 4.5).

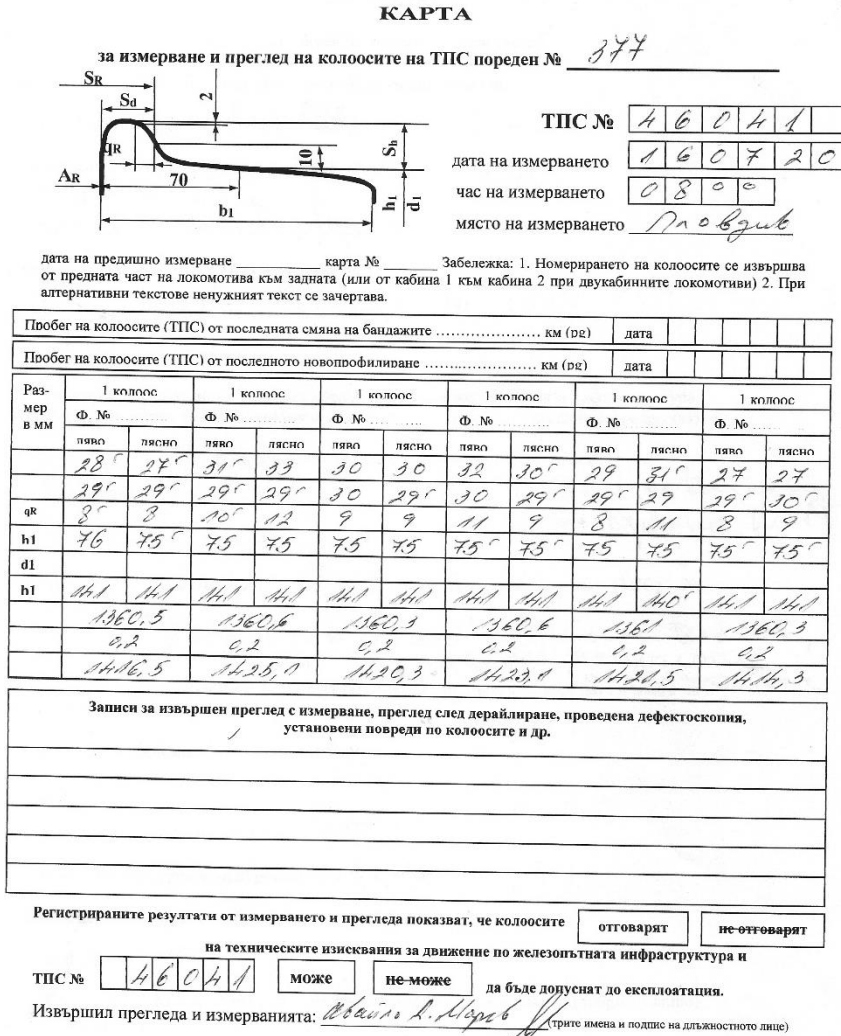
Fig. 4.7.

On 16.07.2020 in Plovdiv locomotive depot were performed measurements of the controlled dimensions of the wheel-sets of locomotive No 46041. All the controlled dimensions

are regular and respect the requirements of the normative documents (Fig. 4.7).

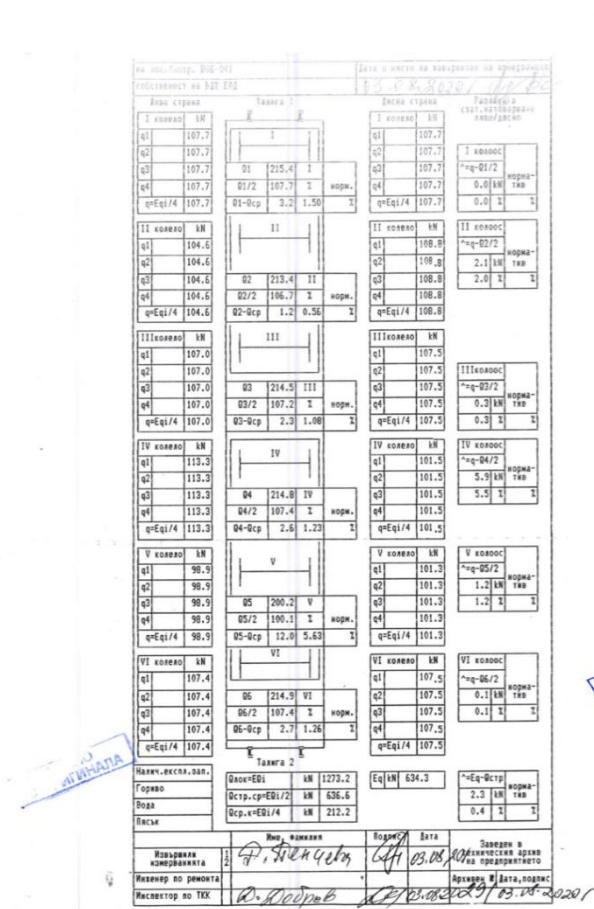
Fig. 4.13.

- In the load of the 4th wheel-set of the locomotive there were deviations to the left/right wheel from 5,5 % (the admissible difference is 5 %). All the rest 5 axles on that indicator are within the admissible field;
- In the load of the 5th wheel-set of the locomotive there were deviations to the left/right wheel from 5,63 % (the admissible difference is 2 %). All the rest 5 axles on that indicator are within the admissible field;

These deviations are minimal and insignificant; they were found after the accident and cannot be considered as a cause for its occurrence.

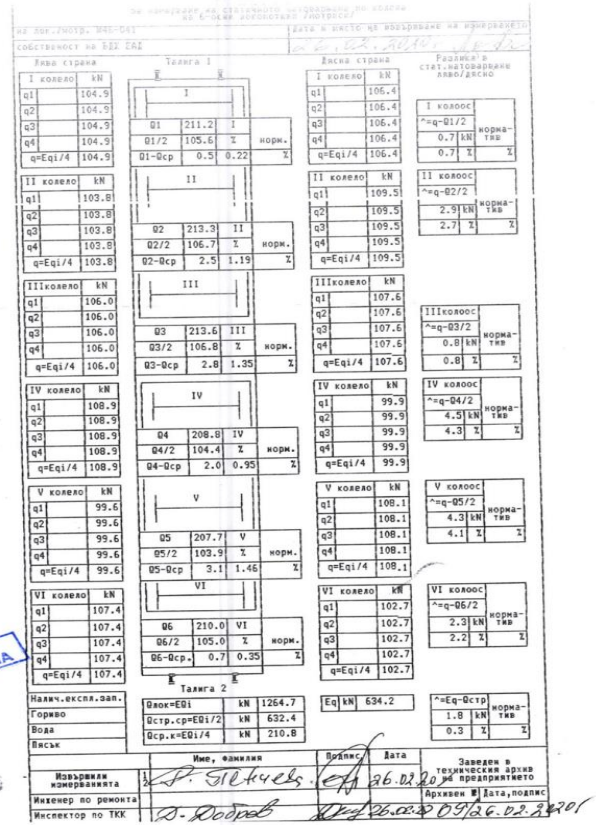
Fig. 4.14.

In the locomotive passport are conserved Maps for measurement of the static load of the wheels and adjustment of the spring system. Data on the measured static load in the wheels of locomotive No 46041-dated 26.02.2020 (**last measurement before the accident**) are displayed on the Map on fig.4.14.

From the displayed on the figure results was found that **all the differences in the load of the wheels** (left/right wheels of one axle, on wheelsets against the average load of wheelset and amount of loads of all left against the amount of loads of all right wheels) **are within the admissible normative thresholds.**

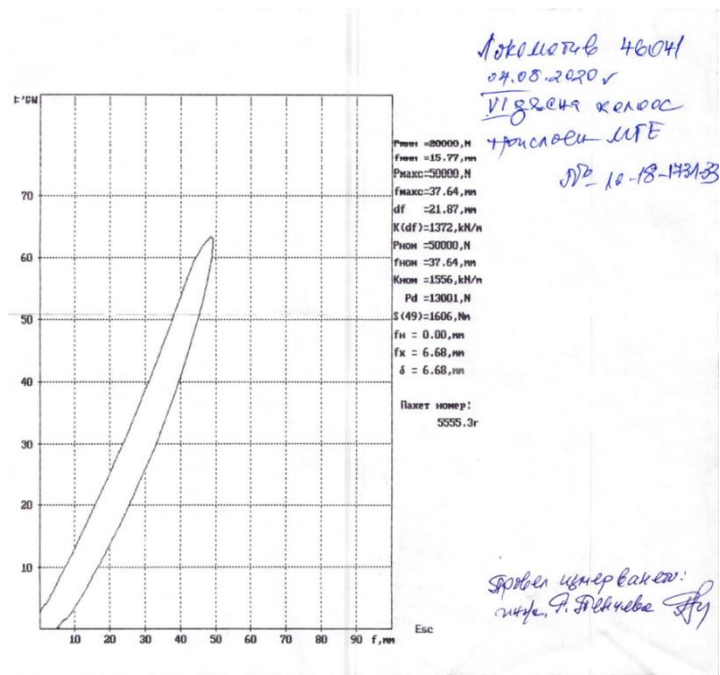
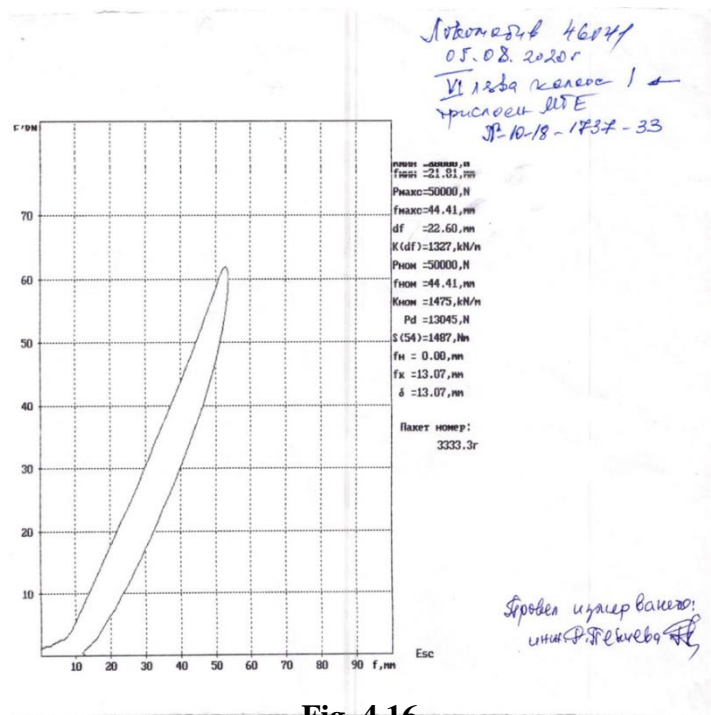
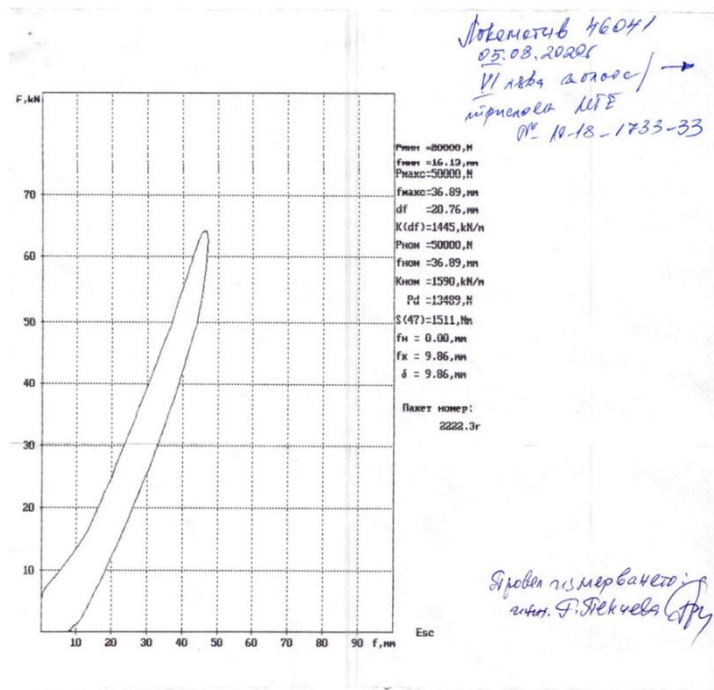
The main parameters of the metal-rubber pack No 10-18-1737-33 are displayed to the right from the force-deformation diagram on fig.4.16 with the registered and calculated results from the measurement:

The main parameters of the metal-rubber pack No 10-18-1733-33 are displayed to the right from the force-deformation diagram on fig. 4.17 with the registered and calculated results from the measurement:

The results are displayed graphically on figures 4.15, 4.16 and 4.17. The parameters of the metal-rubber packs show that they are regular and are not a cause for the accident.

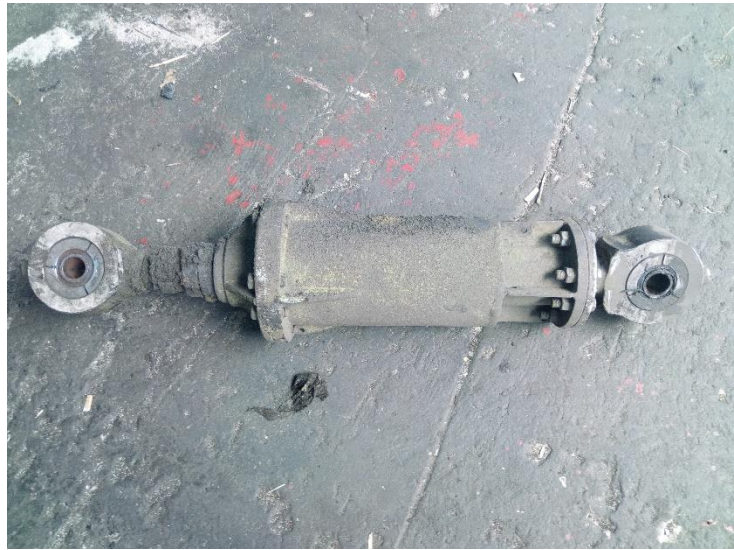
Fig. 4.20.

During the inspection, the Commission found that the technical condition of the coupler is unsatisfactory, mainly because of its irregular maintenance (fig. 4.20). There was found that only the coupler spring was greased (fig. 4.21, pos. 1), which did not need such a treatment, and the friction surfaces of the individual bushings/bosses, ensuring the action of the coupler (stretching and shrinking) by their relative displacement to each other were not greased (fig. 4.22, fig. 4.23, pos. 1), nevertheless the presence of cavities and holes provided for the passage of the grease (fig. 4.23, pos. 2), as well as holes for greases, which were also missing (fig.

- By recommendation 1 is suggested “BDZ-Cargo” Ltd. to improve the technical service of the inter-bogie coupler of locomotive series 46000, respecting the technical documentation requirements for repair and maintenance;
- By recommendation 2 is suggested “BDZ-Cargo” Ltd. to performer the following technical operations during the planned repairs of locomotive series 46.000:
 - Dismantling and measurement of the force-deformation characteristics to all the rubber-metal packs with subsequent setting (defining their optimal placement);

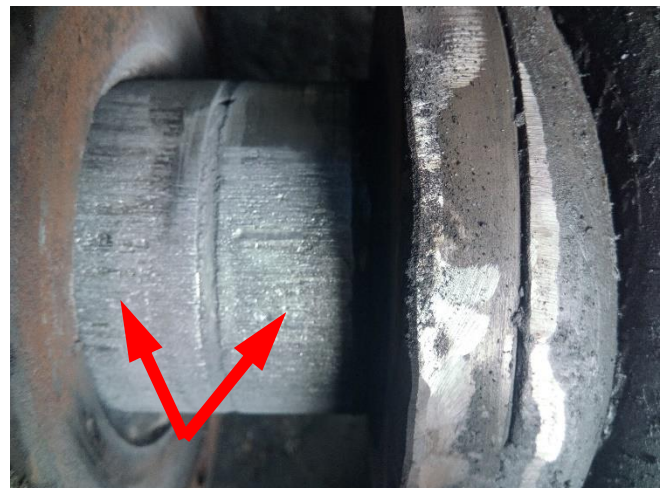
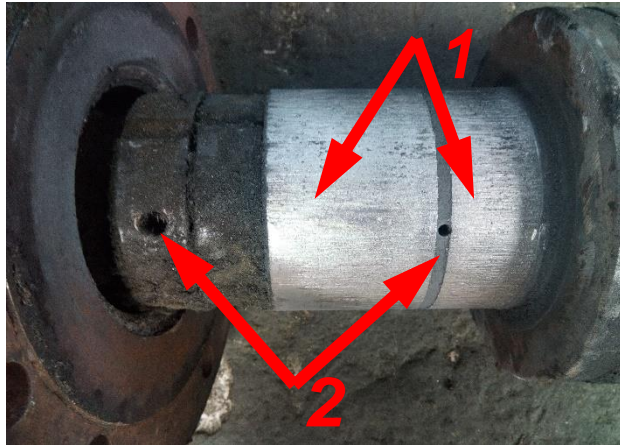
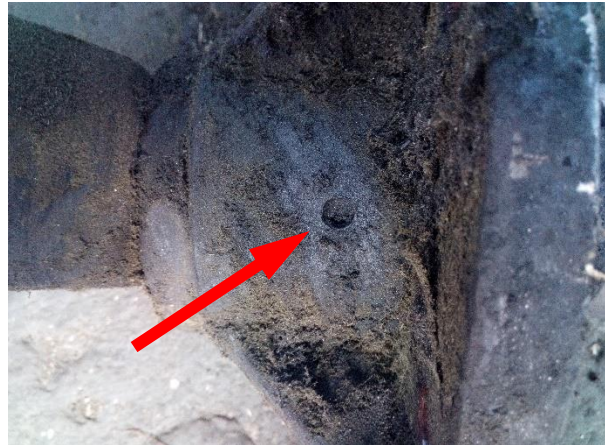
4.24). It confirms that from the condition of the individual bushings and shafts (fig. 4.22

and 4.23), which had torn surfaces, as well as the presence of chips on the individual elements and in the cavities around them.

All the listed findings lead to the conclusion that the neglected condition of the inter-bogie coupler, and the resulting friction between its parts has several times increased the resistance forces when turning the bogies, which has turned the elastic inter-bogie coupler into a rigid coupler,

deteriorating the force interaction between the locomotive and the rail track as it moves in the counter curve.

• By recommendation 3 is suggested „BDZ-Cargo” Ltd. to construct and implement an electronic stand/device for adjustment of the parameters and testing inter-bogie coupler of locomotive series 46000 with objective registration of the measured parameters and issuance of electronic protocol for the condition and adjustments.
