## INVESTIGATING REPORT

Of the railway accident  
Occurred on March 14, 2009 to Comarnic railway station

*Final edition  
October 22, 2009*

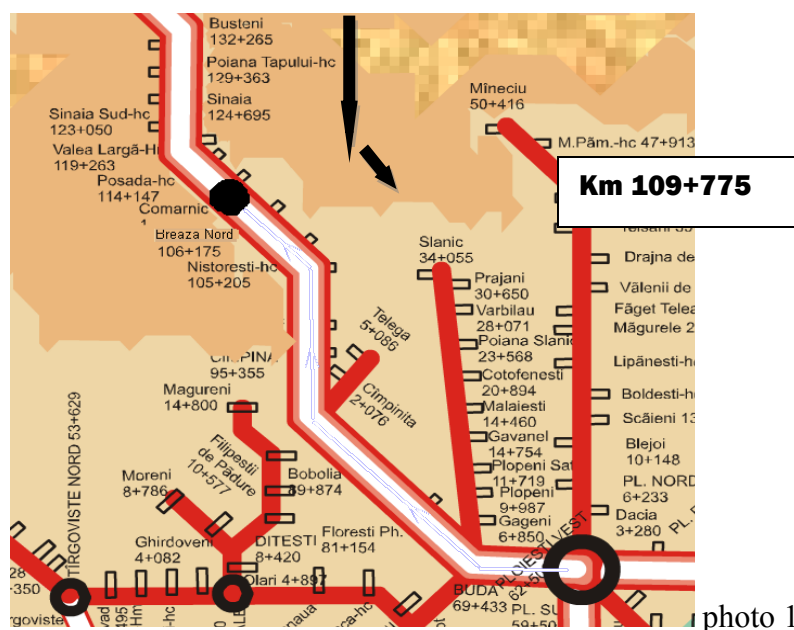
On March 14, 2009, the passenger train no. 3028 that circulated on the route Braşov - Ploieşti Vest moved from Valea Largă halt at 21:33 o'clock, circulated without stopping until Posada halt when it stopped for one minute leaving at 21:42 o'clock and running to Comarnic railway station (photo 1).

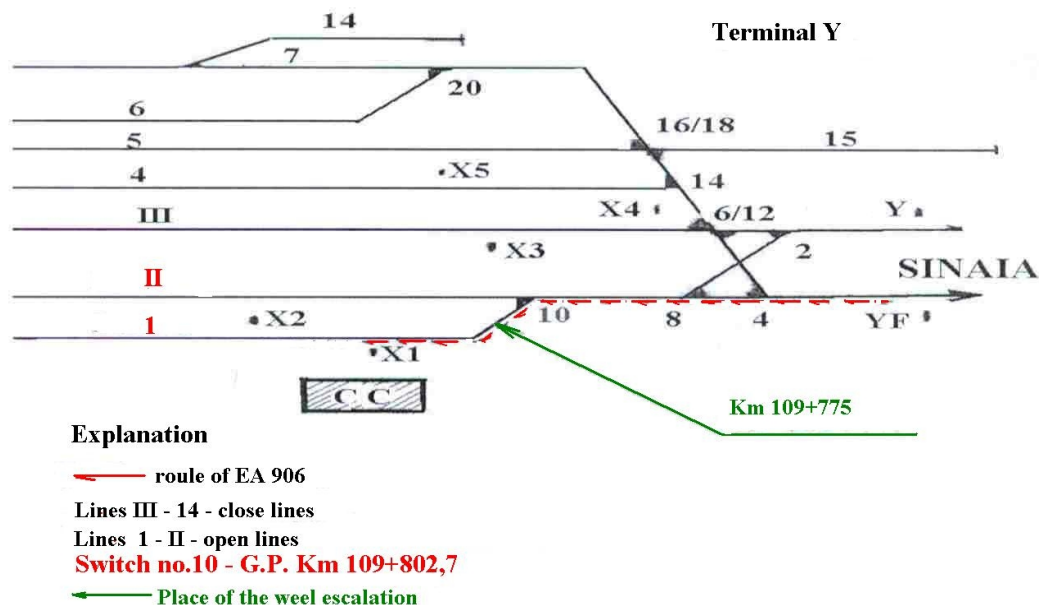
photo 2

According to the scheduled train path, after leaving from Posada halt the next stop was Comarnic railway station (photo 2).

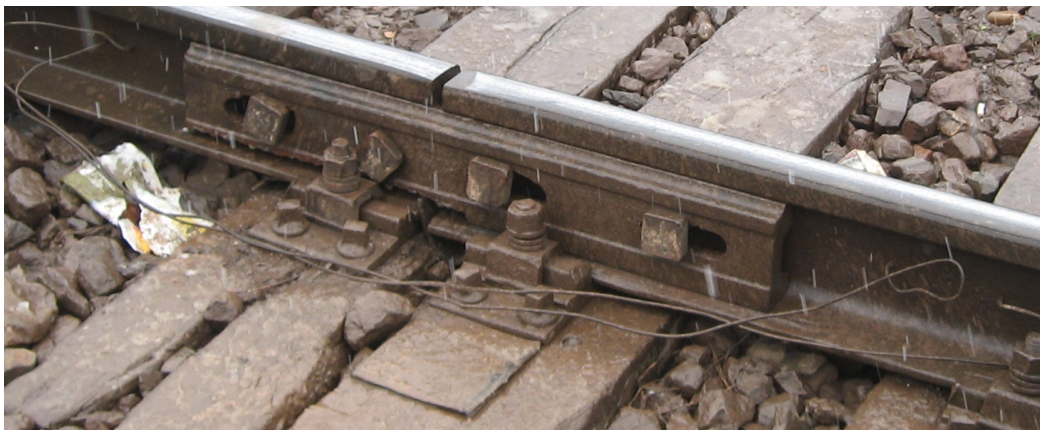
photo 3

On the right rail (exterior to the curve), between the adjustment rail from type 49 to tupe 65 and adjustment rail from type 60 to type 65, the continuity is ensured by fish plates type 65 cutted to the inferior part with oxyacetylene flame (photo 3).

The connection fish plates that connects to the joint the rail section type 65 to the rail section 60 are cutted to the inferior part and have holes widen by cutting with oxyacetylene flame that allowed the creation of a rail joint gap of 20 mm between the extremities of rail type 65 and 60 ( photo 3);

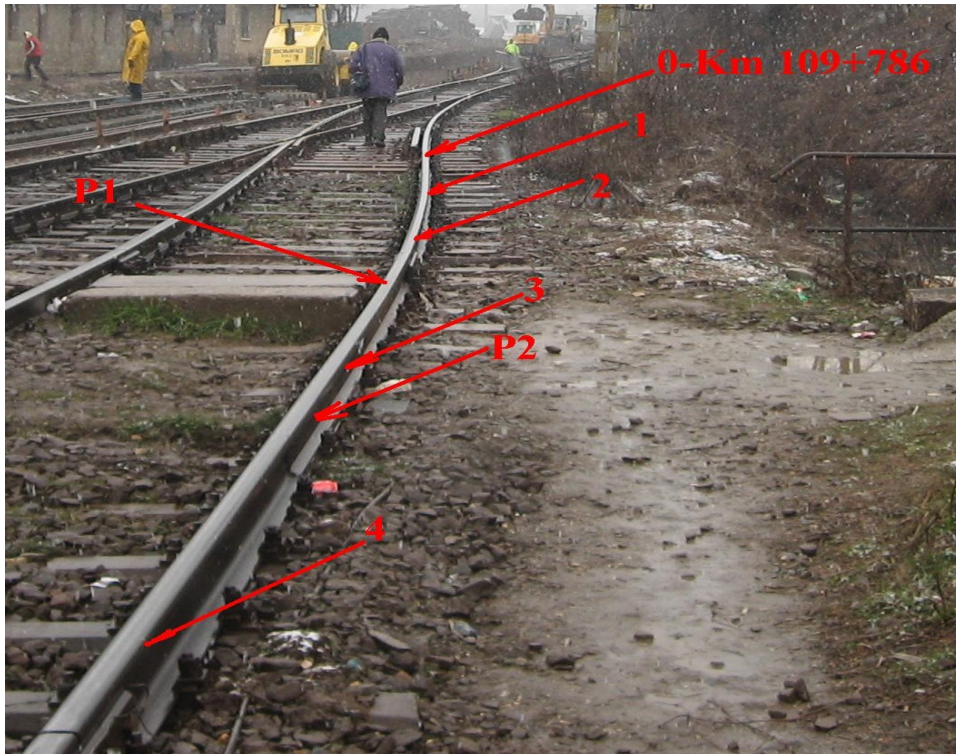
Photo 4

On March 18, 2009 the investigating commission performed on the line 1, measurements of the arrow (f) from 5 to 5 metres with a wire of 10 metres on the curve's length starting with the joint from the heel of the switch no.10 ( photo 4), the values being presented in chart 1.

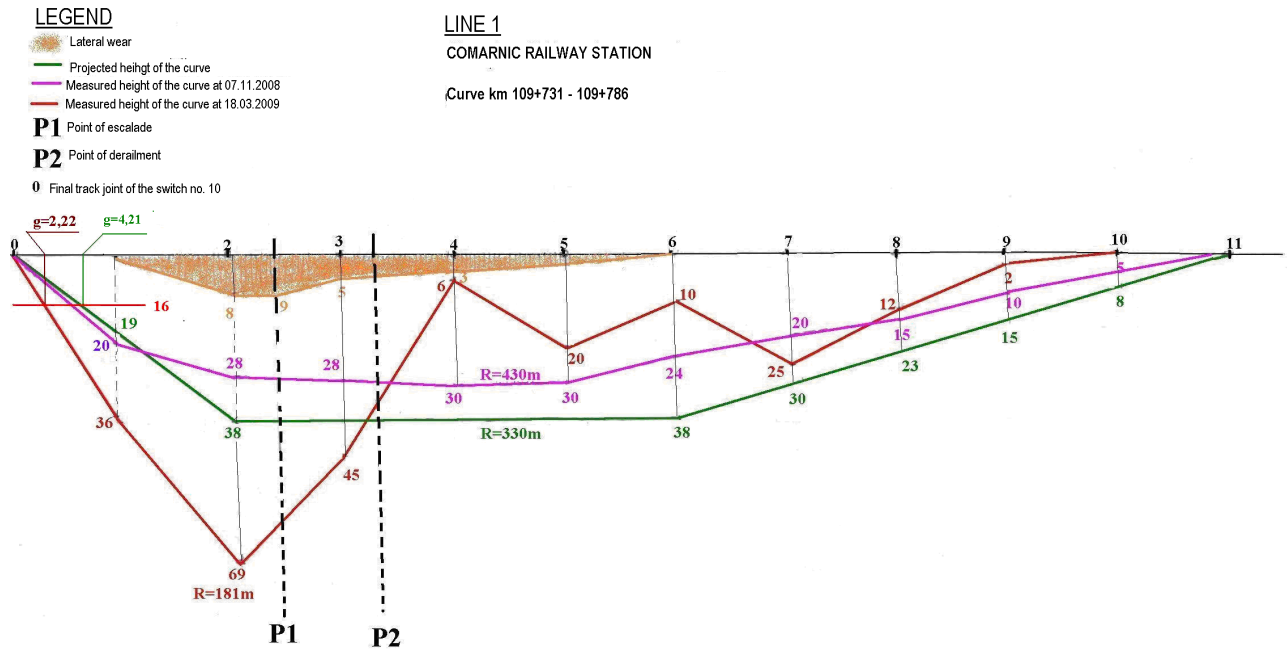
drawing board 1

- For  $g = 4,21$  metres:
  - For the lines where passenger trains are running -  $g \geq V/5$  results that  $V \leq 5g$ , respectively  $V \leq 21,05$  km/h;
  - For the lines where freight trains are running -  $g \geq V/10$  results that  $V \leq 10g$ , respectively  $V \leq 42,1$  km/h;
- pentru  $g = 2,22$  metres:
  - for lines where passenger trains are running -  $g \geq V/5$  rezultă că  $V \leq 5g$ , respectively  $V \leq 11,10$  km/h (drawing board no. 1);
  - For the lines where freight trains are running -  $g \geq V/10$  results  $V \leq 10g$ , respectively  $V \leq 22,20$  km/h (drawing board no. 1);

- the area between the heel of the switch no. 10 and the first 30 m of the connection curve with the deflecting section 1, because of the wrong design and construction, was permanently submitted to some additional running, running that increased following the permanent closing of the lines III, 4-14, from the railway station, for modernization works and change of the traffic on the direct line II and the deflecting section 1;

- the values of the track deflections, after the derailment, on the track section non-concerned indicate that, in conditions of running, in time, the values of the geometrical parts of the curve from the line 1 changed leading to the disappearance ( cancellation ) of the designed connection curve that was replaced by a circular curve with a radius between 330 m and 181 m;

- the proof of the distortion in time of the curve geometrical parts, that led to the decrease of the radius and the increase of the curvature, is the existence of the rail lateral wears of the outer rail with values between 5 and 9 mm ( tabel 1 and picture no. 1), occurred in those 5 months elapsed from the last measurements of those wears until the accident occurrence;

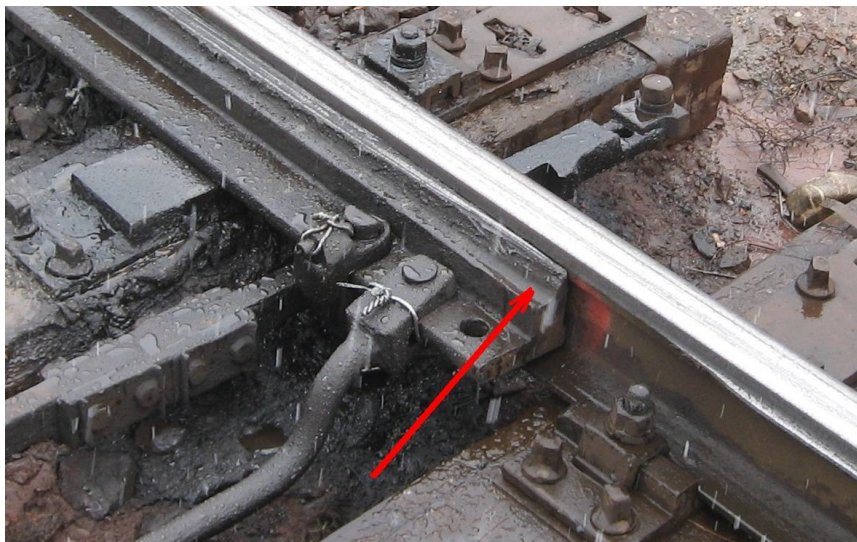
photo 7

- on the 18<sup>th</sup> of March 2009, on the turnout no. 10, the stroke-arresting device of the operation rod was fitted up upside down, together the screw C5 ( picture 6 );
- the curved point of the turnout no. 10 operated on open on the line 1 ( stucked on the right point ) was weared and non grinded in the
