Technical Investigation Report
on the Train Collision that occurred on
11 October 2006
on the French/Luxembourg Border
at Zoufftgen (Moselle)

**Land Transport Accident
Investigation Bureau (BEA-TT)**

Case No.BEATT-2006-013

28 February 2009

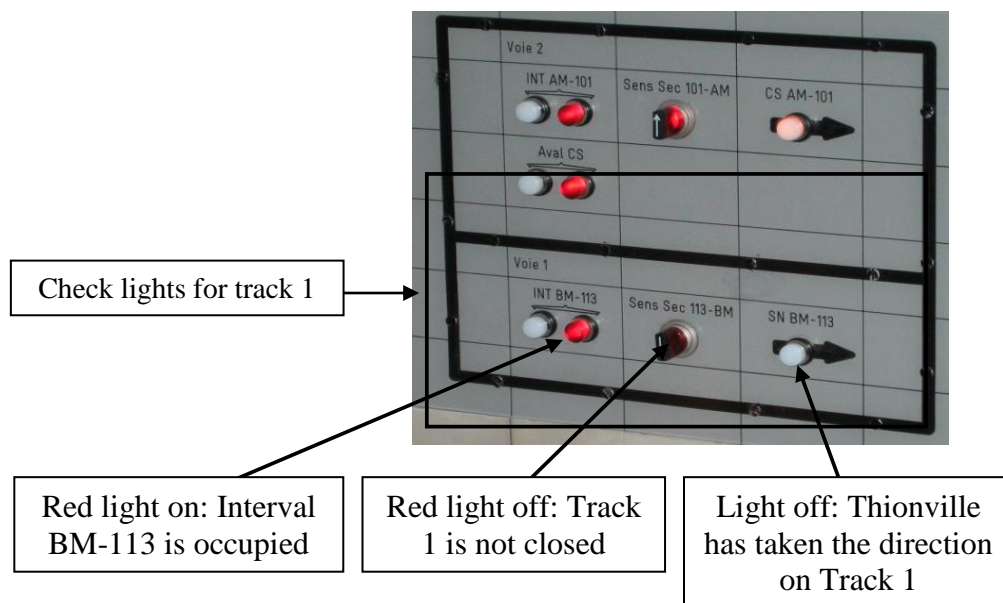
Figure 10: The WWFE Module at 11h40

The Track 1 lights on the WWFE module, for their part, show the following information:

- light INT BM-113 is red, because a train (the freight train) is travelling on this portion of the track;
- light SN BM-113 is off, because Thionville has taken the direction (wrong-track working set);
- emergency-direction switch off, because it had not been activated;
- wrong-track working light is off.

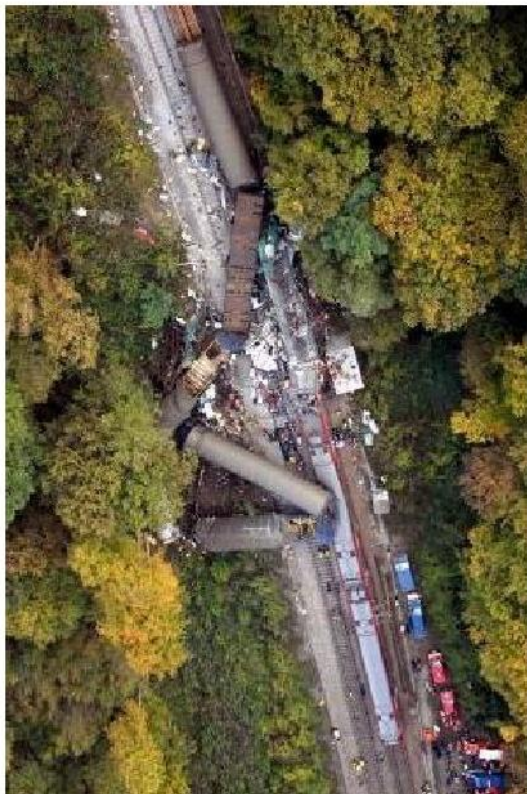
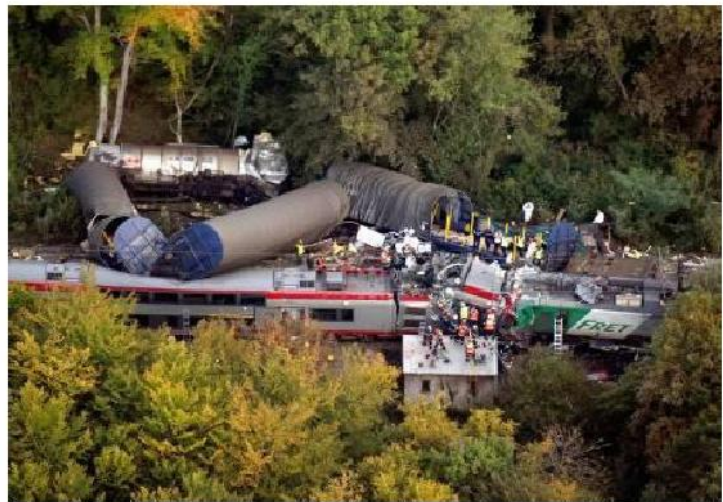
The Freight Train

The locomotive (BB 37007) was totally destroyed and the first 8 wagons were destroyed or seriously damaged. The other 14 remained on the rails. The locomotive mounted the train and the first 8 wagons were either entangled with the locomotive and the train or had surmounted the train, or else overturned into the ditch. Among the first wagons, there was an empty tanker used to transport hazardous substances.

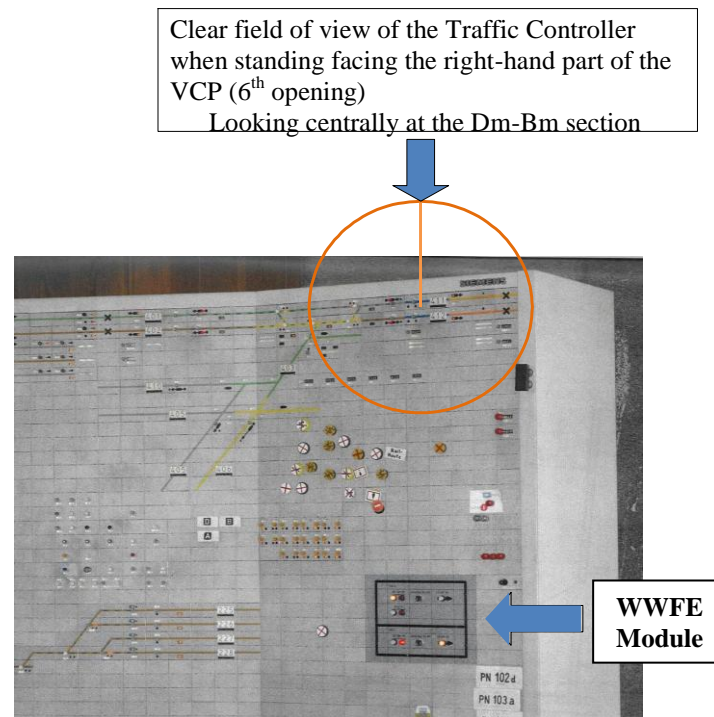
Figure 13: Visibility of the WWFE Module

The WWFE module is positioned on the right-hand side of the VCP (French side) but on a part of it that is located far from the information written on and near the tracks to Thionville (see Figure 13). It cannot be read by the Traffic Controller at a glance at the same time as the information displayed on these tracks. The Controller must consciously move his head to see both parts of the VCP one after the other. In the other directions, all the information concerning the tracks in the same direction (Luxembourg for example) can be read at a glance.

Moreover, the ways of displaying some of the lights on this module are different from those on the rest of the VCP giving equivalent information (occupation of portions of track and direction interlocking status). For example: taking the direction of travel in all directions except towards Thionville is shown on the VCP by a small arrow that lights up white when this direction is taken whereas, on the WWFE module, the direction arrow is painted grey and a light located on this arrow lights when the direction has been taken.

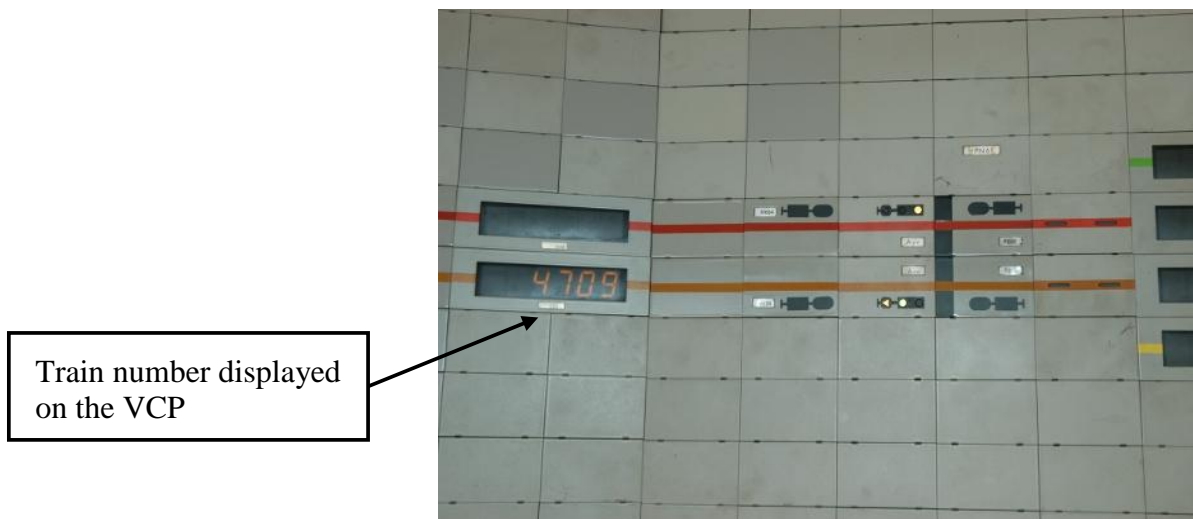
Figure 14: Visual Announcement System

For the vast majority of trains passing through Bettembourg or leaving from Bettembourg, a visual announcement system displays the train number on the VCP; after which there is no verbal announcement or record made in the TAL. This system of visual announcement is not used for trains coming from or going to Thionville.

The setting of an MFS at 'proceed' and the visual train announcement system are not interlocked with each other. If an MFS fails to set at 'proceed' (apart from those heading for Thionville) the Bettembourg Traffic Controller, in order to know whether a train is occupying the portion of track downstream of the signal in question, first looks to see whether a train number is displayed in the window of the visual announcement system of the section of track concerned. This window is positioned in the middle of the track line.
