Investigation Report of Railway Accident

Collision of passenger train No 5307 with a shunting freight train
between
Hlinsko v Čechách and Ždírec nad Doubravou stations

Monday, 10 November 2008

Ref. No: 6-3715/2008/DI

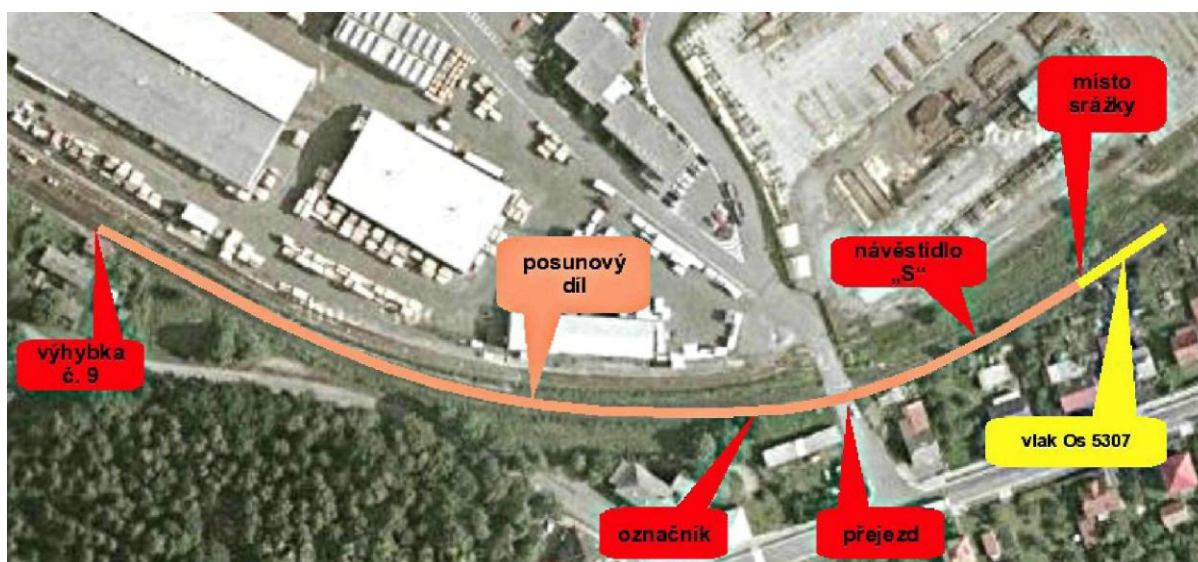
Appendix 2: Situation following the accident

- With the fronts rammed together on impact, the railway vehicles remained standing at km 27.713, i.e. 28 metres before the "S" entry signalling device of Ždírec nad Doubravou station. The signpost is situated 86 metres beyond the entry signalling device and is painted in a prominent colour. There was no damage to the rail track and the points due to this incident. The No 9 set of points, which is manually operated, was unlocked with the switch locks in the down position. The front wheels of the first wagon of the shunting freight train stood 20 cm from the end of the point blades of this set of points. The No 8 set of points was reset for rail track No 2.

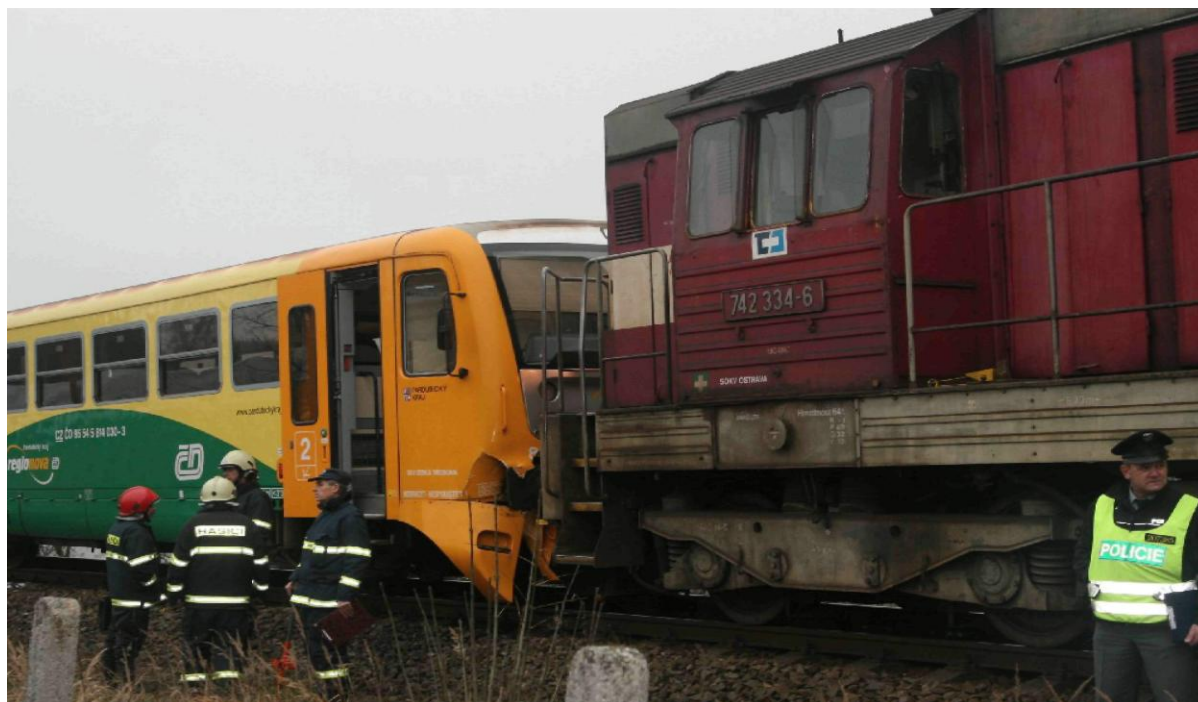
Appendix 4: Vehicles involved in the collision

- damage to engine vehicle No 814.030-3, owner Czech Railways, amounting to CZK 2 000 000.00;
- damage to driving vehicle No 914.030-2, owner Czech Railways, amounting to CZK 750 000.00;
- damage to engine No 742.334-6 of the shunting freight train, owner ČD Cargo, a.s., amounting to CZK 35 101.00.

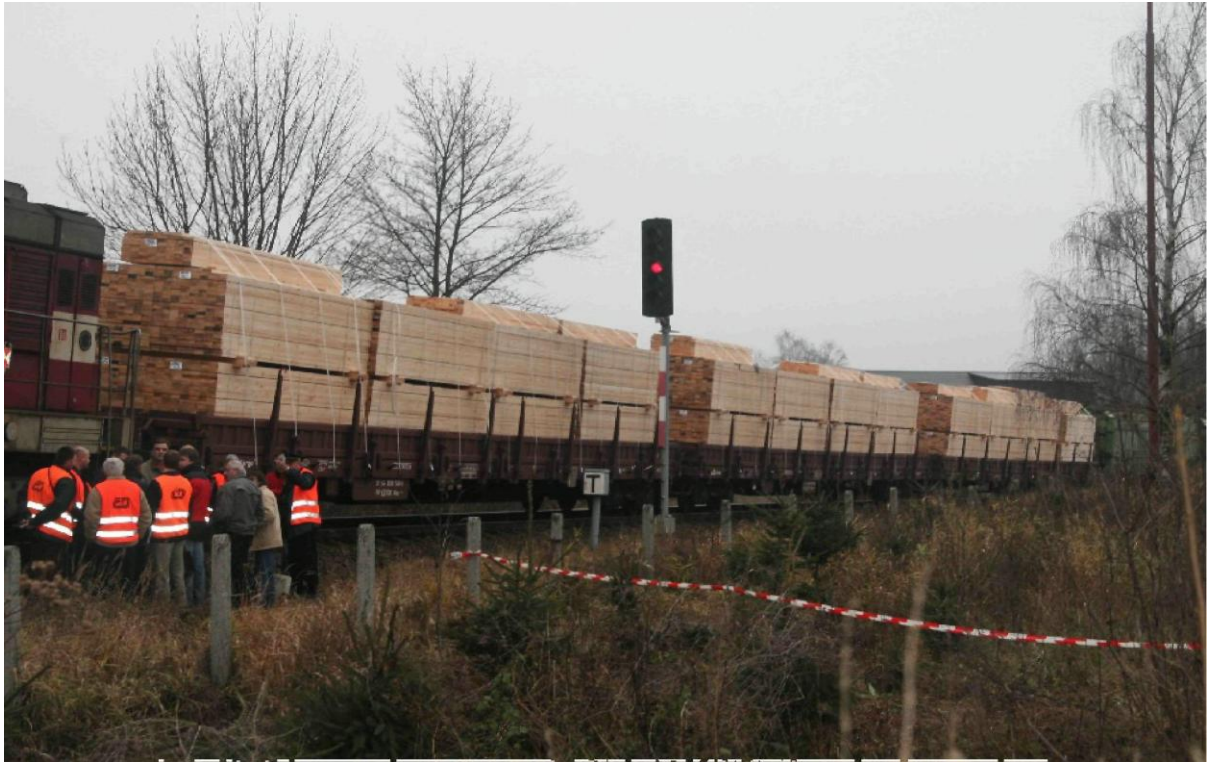
Appendix 5: Position of the shunting freight train in relation to the "S" entry signalling device

- Direct causes:
- the shunting freight train travelling outside the railway station boundary without the shunting operation being organised as shunting between operating points on the railway line, specifically beyond the "S" signalling device marking the railway station boundary on the rail track;

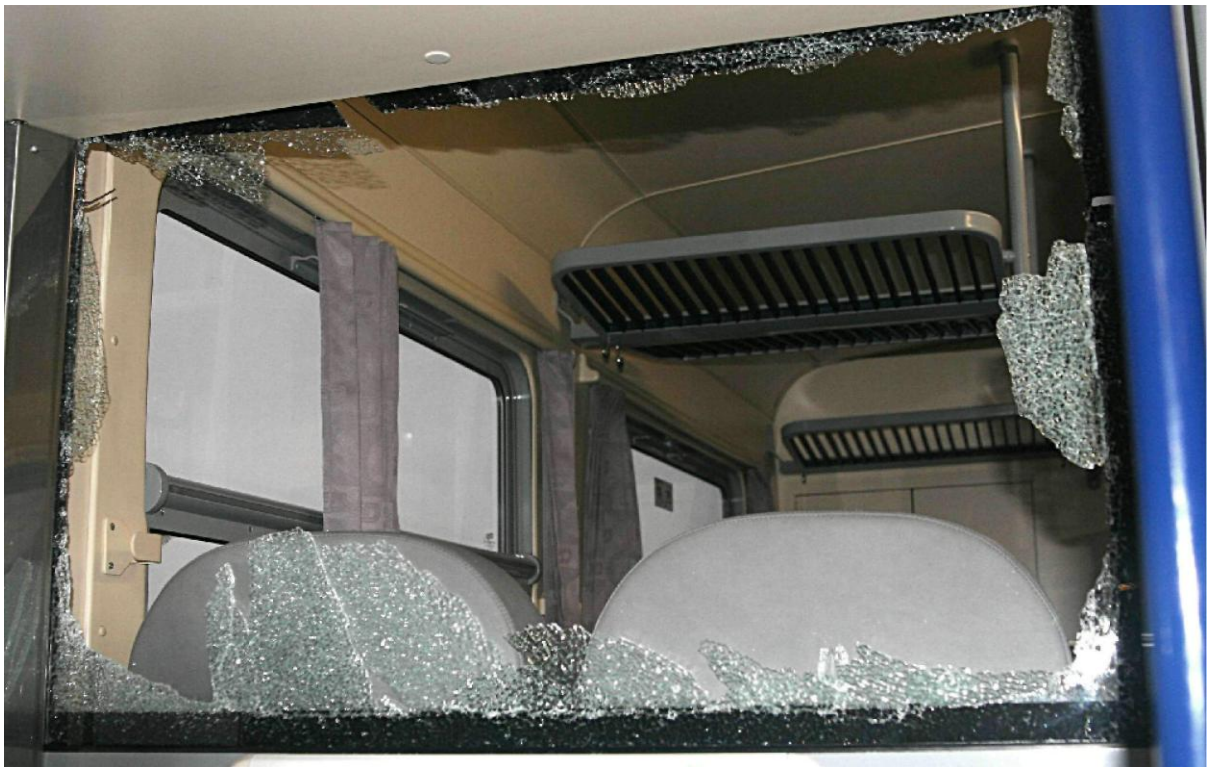
Appendix 6: Broken glazed partition

The impact caused both the glazed partitions between the low-floor section and the passenger compartment in driving vehicle No 914.030-2 to break. Other glazed areas, structures and fittings in the passenger compartments and driver cabins in

- The damage to the two-vehicle motorised unit consisting of the Class 814 engine vehicle and the Class 914 driving vehicle indicates that the resistance

- Recommendations: to the Rail Authority [Drážní úřad], the manufacturer and operators of driving vehicles Class 914 and vehicles of similar construction: It is recommended that the design of the glazed partitions between the low-floor section and the passenger compartment be modified to ensure that the

resistance of these partitions in the event of a collision between vehicles is not lower than the resistance of other glazed partitions, constructions and fittings in passenger compartments and the drivers' cabs.
