RAILWAY ACCIDENT INVESTIGATION UNIT IRELAND

SUMMARY OF INVESTIGATION REPORT

Investigation into SPADs on IÉ Network,
from January 2012 to June 2015

RAIU Report No: RS2016 – R001

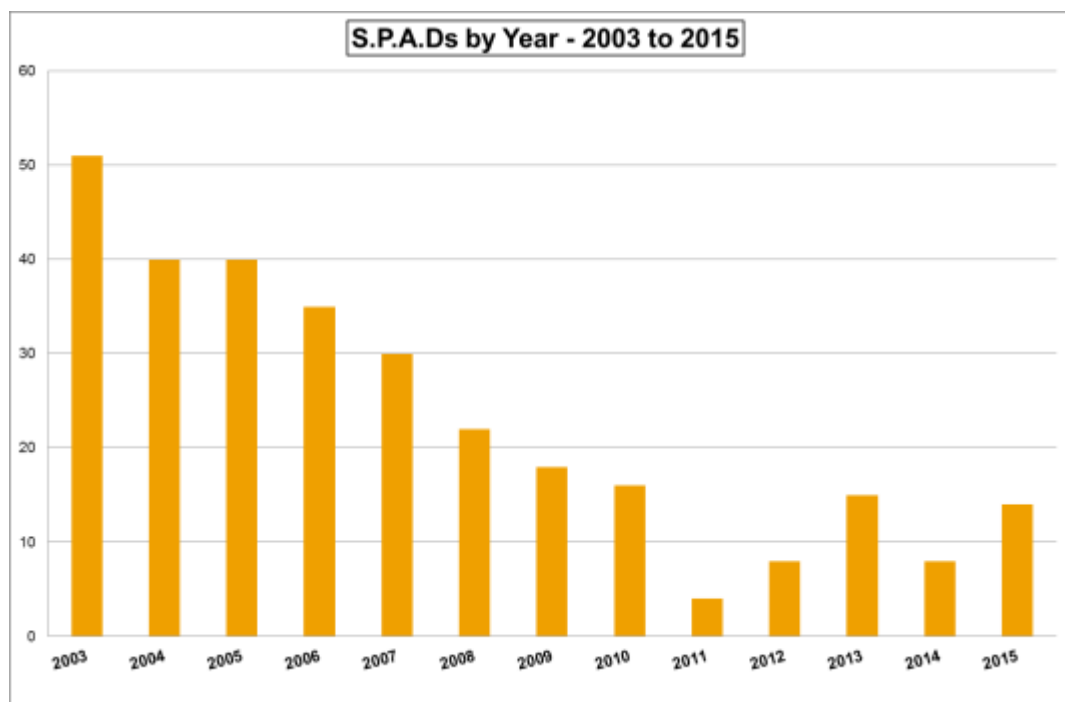
34 IÉ state that they are “seeking to continuously improve its management of SPAD risk”. The following figure shows the significant reduction in the number of SPADs which has been achieved from 2003 to 2015 (however it is noted that there are two peaks in the numbers of SPADs in 2013 and 2015).
