**Railway Accident  
Investigation Unit  
Ireland**

## **INVESTIGATION REPORT**

**Road Rail Vehicle occurrences on Iarnród Éireann Network  
from 2015 to 2018**

RAIU Report No: 2019 – R004

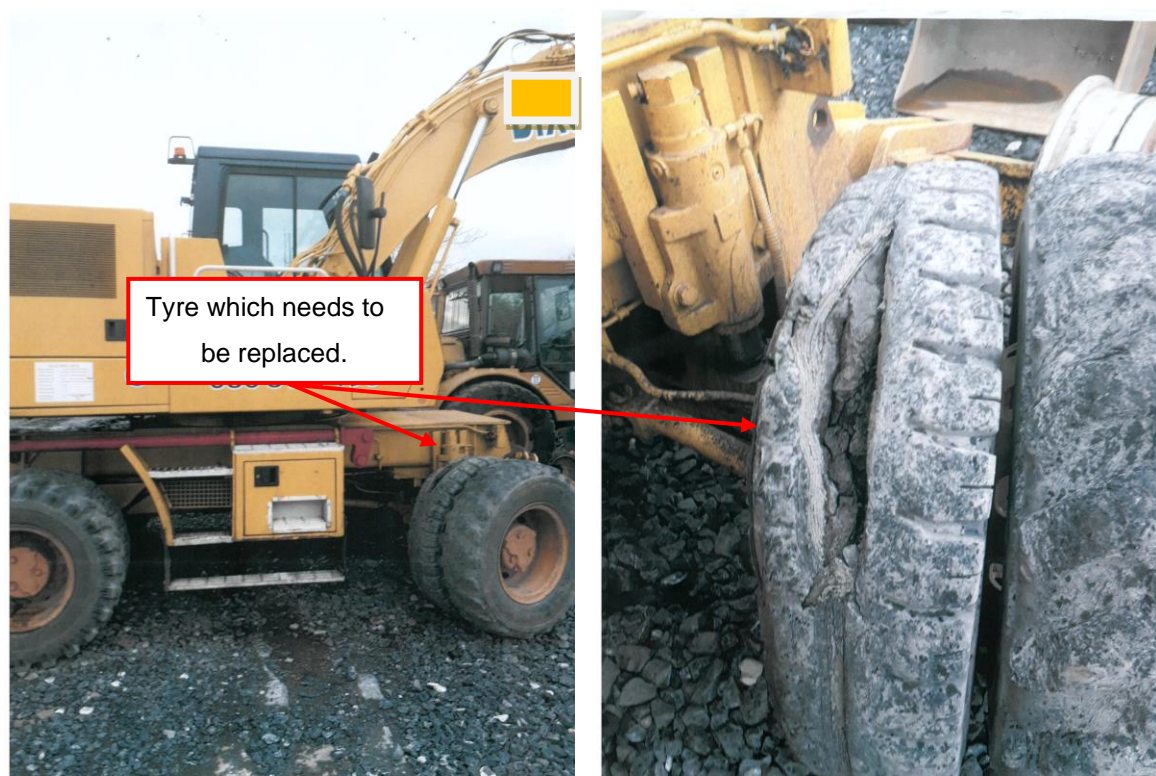
- Another inspection carried out by IÉ-IM on the 24<sup>th</sup> November 2018 found that there was “two bad tyres” on an RRV dumper owned by a contractor which the inspector requested to be changed and the contractor informed IÉ-IM they were changed, however, the inspector followed up on site on the 27<sup>th</sup> November 2018 and only one tyre had been changed.

**Figure 7 – Tyre identified by IÉ-IM which needs replacement**

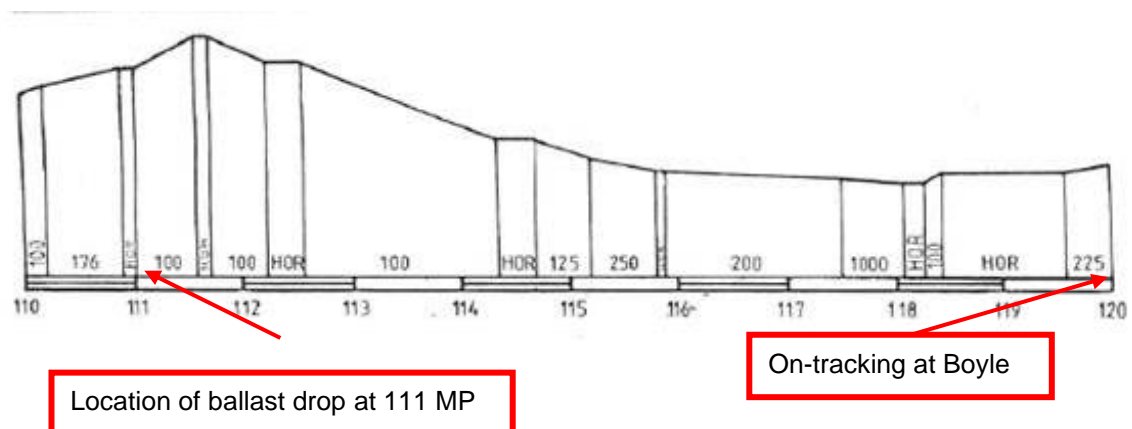
185 The two RRVs Dumpers had ballast placed upon them and then all four RRVs were on-tracked and accompanied by their respective ES/PICs as they travelled in the direction of Boyle with the two RRV Dumpers leading. All four RRVs carried out two controlled stops at a signal and level crossing without incident (RRV3 and its operator were removed here due to a slip and fall accident, the TSC left with the injured party, and PICOP was assigned as the new TSC). The RRVs continued and stopped again at another level crossing where there was an apparent dispute in relation to passing the level crossing signal at danger, and arrangements were made for the level crossing barriers to be closed for the RRVs crossing. The RRVs continued up an incline towards Boyle Station, before travelling around a curve and continuing downhill to the location of the ballast drop (at approximately the 111 Mile Post (MP)), see Figure 13.

**Figure 13 – Illustration of gradients at location of the accident**

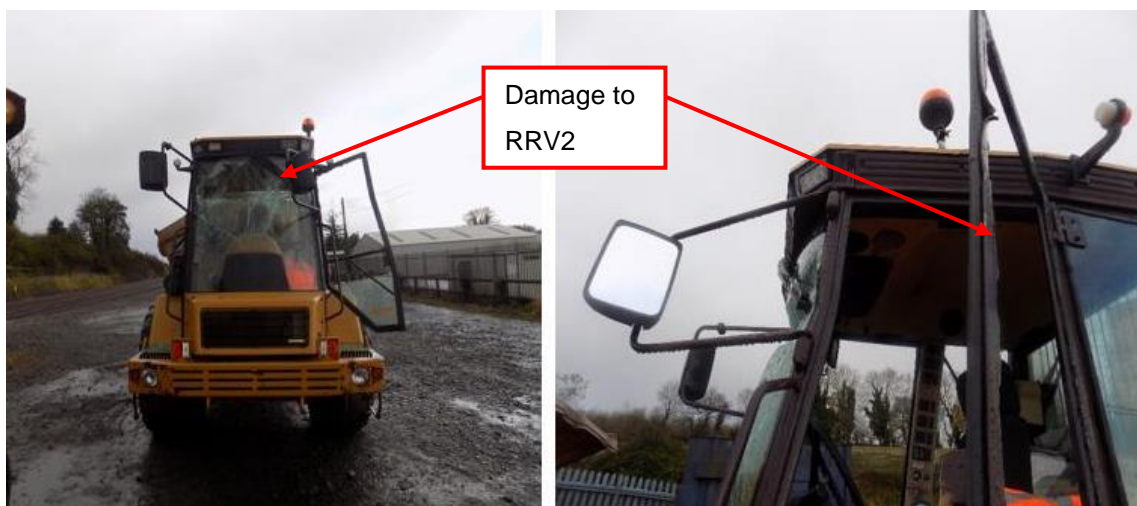
187 The ES/PIC travelling with RRV1 instructed the operator of RRV1 to stop, which he did. The operator of RRV2 saw RRV1 had stopped and notched down through the gears and applied the brakes, however, RRV2 went into a slide, and the bin of RRV2 collided with the cab of RRV1 at a low speed (no more than walking pace), breaking the windscreen of RRV2 (see Figure 14). The ES/PIC accompanying RRV did not see that RRV1 had stopped as his focus was on keeping the door of RRV2 closed, and as such did not issue any instructions to stop.

**Figure 14 – Damage to RRV**

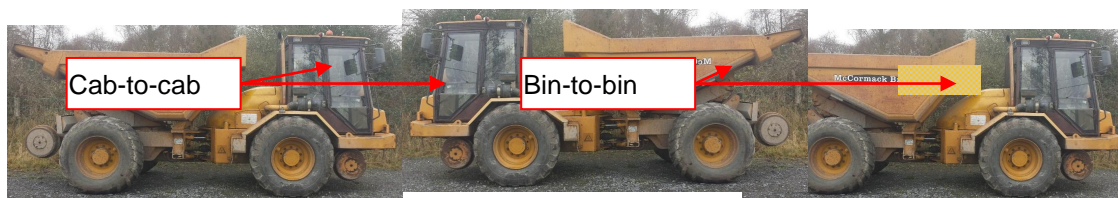
194 The RAIU also noted that had the convoy been travelling in a bin-to-bin / cab-to-cab orientation (see Figure 15), the damage to the RRV would probably be less. It is noted by the RAIU that some RRV suppliers, require that RRVs travel in this orientation, but also understand, that this is not always possible due to the type of work to be carried out.

**Figure 15 – Cab-to-cab / bin-to-bin orientation**

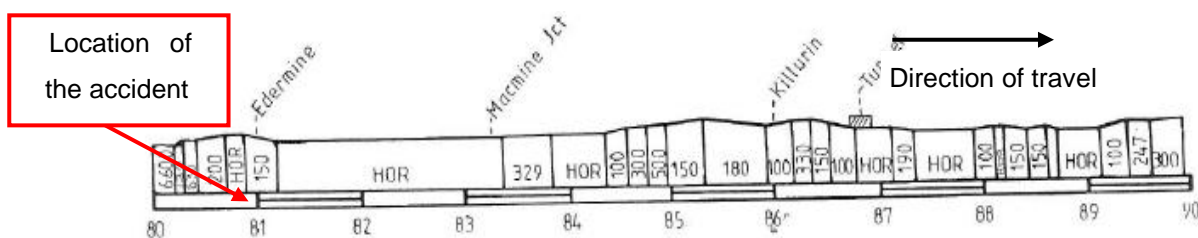
204 The PICOP/ES/PIC travelled on the first RRV Dumper (RRV1) in the convoy (consisting of RRV1, RRV2, RRV3, RRV4) toward Macmine Old Station, adopting the same procedure as before to cross Edermine LC. On arrival at the ballast stockpile, the RRV Dumpers were loaded with ballast. The convoy then began travelling back downhill towards Edermine LC (see Figure 17 illustrating a 1:150 gradient), with the PICOP/ES/PIC travelling on the lead RRV Dumper.

Figure 17 – Illustration of the gradient at the location of the accident

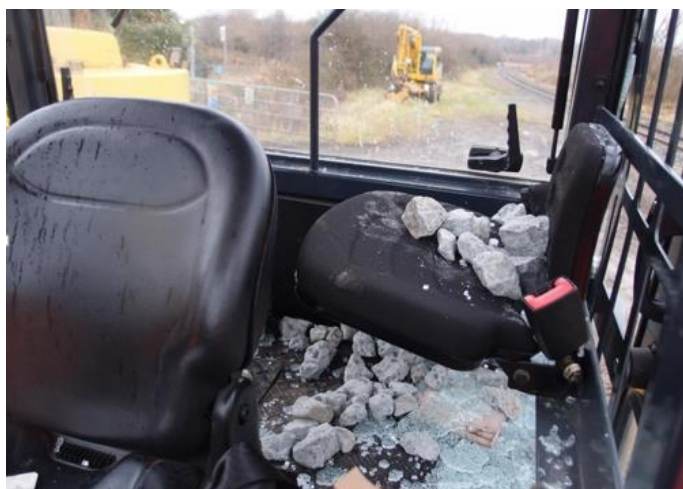
207 The Operator of RRV2 had applied the brakes (similar to the first approach to the Up Stop Signal for Edermine LC). However, the Operator of RRV2 stated that RRV2 seemed to slide and accelerate towards RRV1.

**Figure 18 – Damage to RRV**

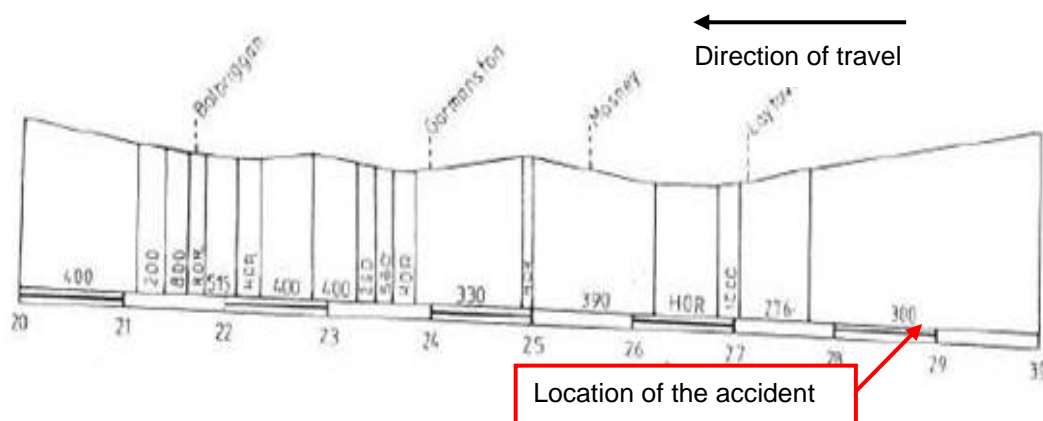
278 At this stage of the night, it was raining very heavily as RRVO1 slewed the excavator around and started to travel back (downhill) to RRV2 at a slow speed, see Figure 24. On approach to RRV2, RRVO1 applied the brakes but the rail wheels “locked-up” resulting in RRV1 going into a slide and colliding with the brushbox attached to RRV2. Both RRVs sustained minor damage and there were no injuries to staff.

**Figure 24 – Illustration of the gradients at the location of the accident**

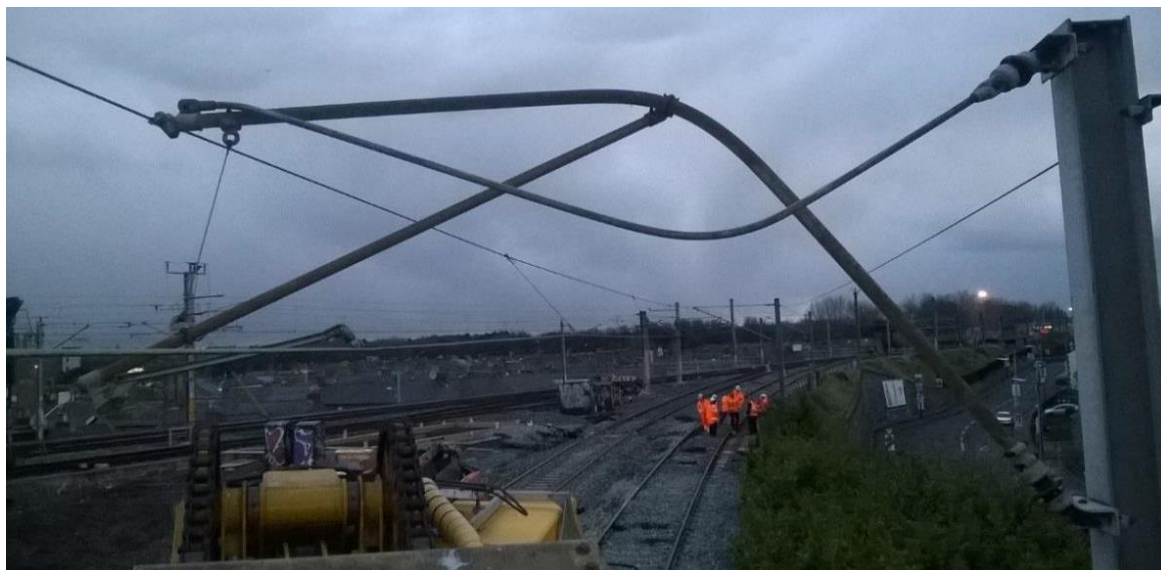
292 On arriving back at the worksite, the operator of RRV1, RRV Operator 1, informed the ES/PIC that RRV2 (operated by RRV Operator 2) had struck the OHLE wires. The ES/PIC then went to the scene and saw that there was damage to the OHLE cantilever and not the wires (see Figure 26). When the ES/PIC returned to talk to the Operators of the RRVs, they informed him that RRV2 had not struck the OHLE cantilever, only the wires.

**Figure 26 – Damage to the cantilever**

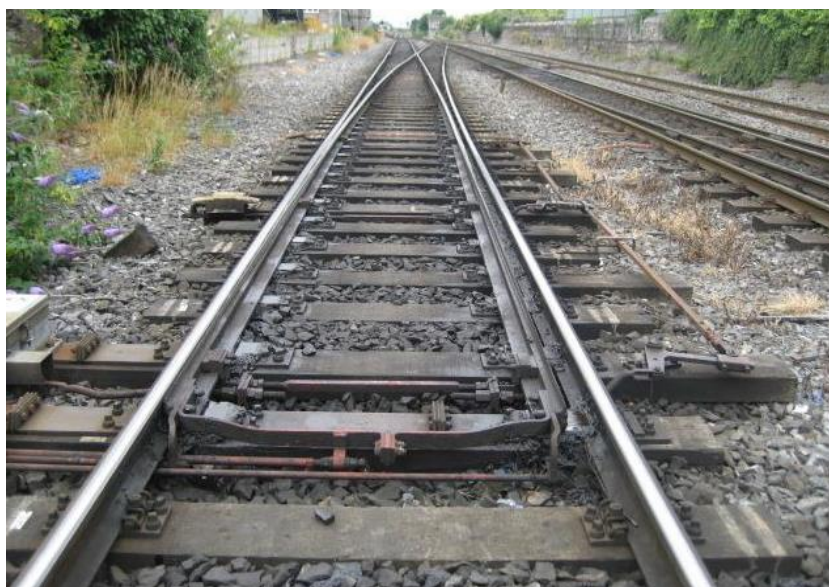
Figure 31 – Points 704

340 At the time of the conversation, the PICOP/ES/PIC and the Signaller did not discuss Points 704a (see Figure 31); with the PICOP/ES/PIC assuming they were in the normal position, when in fact, they were lying in the reverse position. It should be noted that Section T Part 3 Clause 11.3.1 of the IÉ Rule Book states that Signallers must “keep any points in the possession in the proper position except when a movement is to enter, leave or cross the possession there”. In this instance, the Signaller did not place/keep Points 704a in the proper (normal) position.

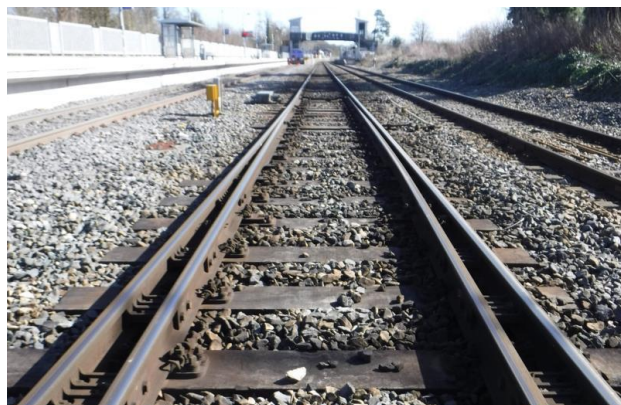
394 As the RRV Dumper approached trailing points CL252 (A end), see Figure 41, the PIC was pre-occupied trying to make contact with the Gatekeeper for Clonsilla Level Crossing to arrange for the passage of the RRVs through the crossing; as a result, he did not check the position of Points CL252. The RRV travelled over the points at no more than walking pace and the points were trailed through by the leading bogie of the RRV, causing the leading bogie to derail.

**Figure 41 – Points CLC252**
