Railway Accident Investigation Unit

INVESTIGATION REPORT

Structural failure of a platform canopy at Kent Station, Cork

18th December 2013
RAIU Report No: R2014 – 005
Published: 7/11/2014

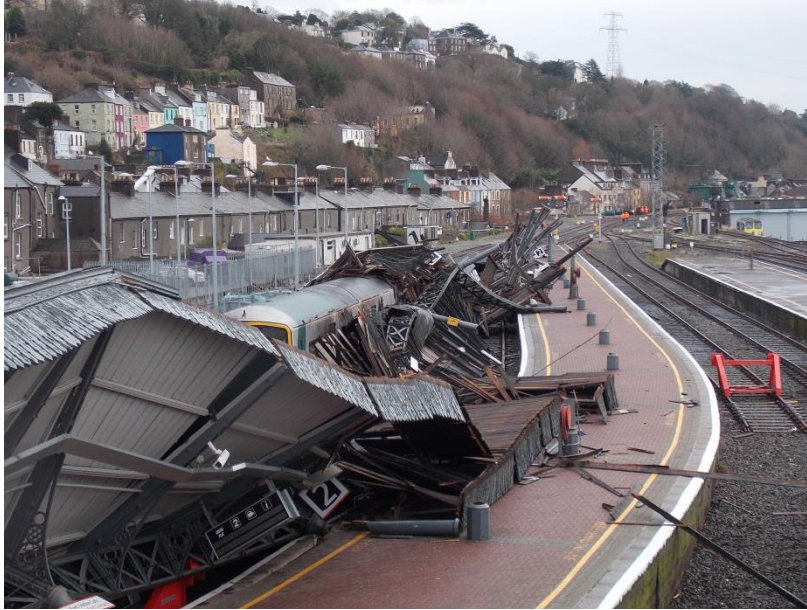
Figure 2 - Collapsed canopy and resultant debris

- 2 Three people were on Platforms 1 and 2 waiting for the 14:45 hrs service from Midleton which was due to arrive into the station at 15:08 hrs.
- 3 The wind and the rain increased in intensity and a section of roof felt was carried by the wind from the canopy over Platform 4 onto the ground beside Platform 2. At 15:02 hrs the canopy above Platforms 1 and 2 started to sway and the supporting columns began to fall at the end of the platform furthest from the concourse. Sequentially the columns fell and this resulted in the canopy collapsing.
- 4 The canopy sections and debris fell onto the platform, the unoccupied track at Platform 1 and onto an empty stationary train stabled on the adjacent 'engine road'. Additionally debris from the roof structure was blown into the car park damaging some vehicles (see Figure 2).

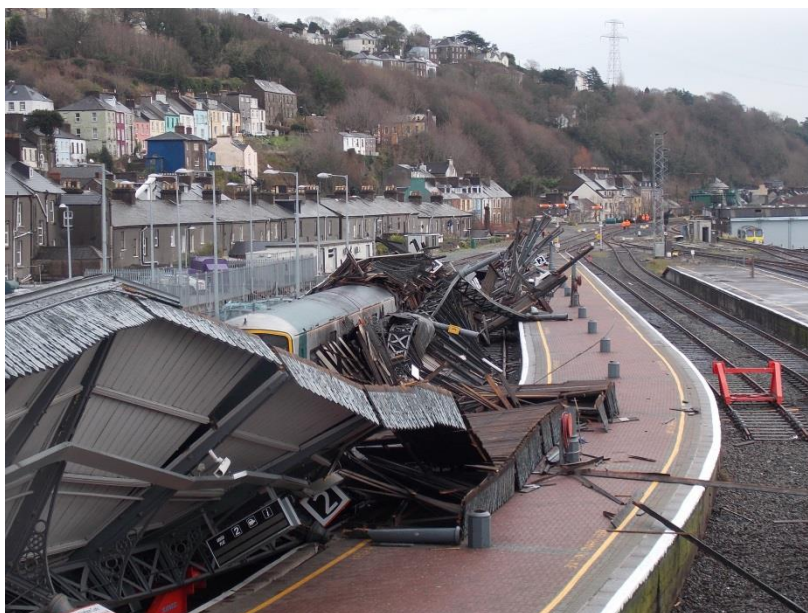
Figure 6 – Collapsed canopy and resultant debris

20 Every supporting column of the canopy over Platforms 1 and 2 fractured leading to the collapse of the structure and subsequently it sustained extensive damage throughout. The following damage was caused by the falling canopy and resultant debris:

- Two sets of railcars were damaged. One of the sets had minor damage when the unit was struck by debris and the engine fire extinguishing system was triggered on the underside;
- There was also damage to the drivers drop light window. This unit was stabled on Platform 3 at the time of the accident;
- The second railcar was the unit stabled in the siding adjacent to Platform 1 and 2 and was struck and mostly covered with debris from the canopy;
- There was damage to a number of road vehicles in the car park adjacent to the accident.

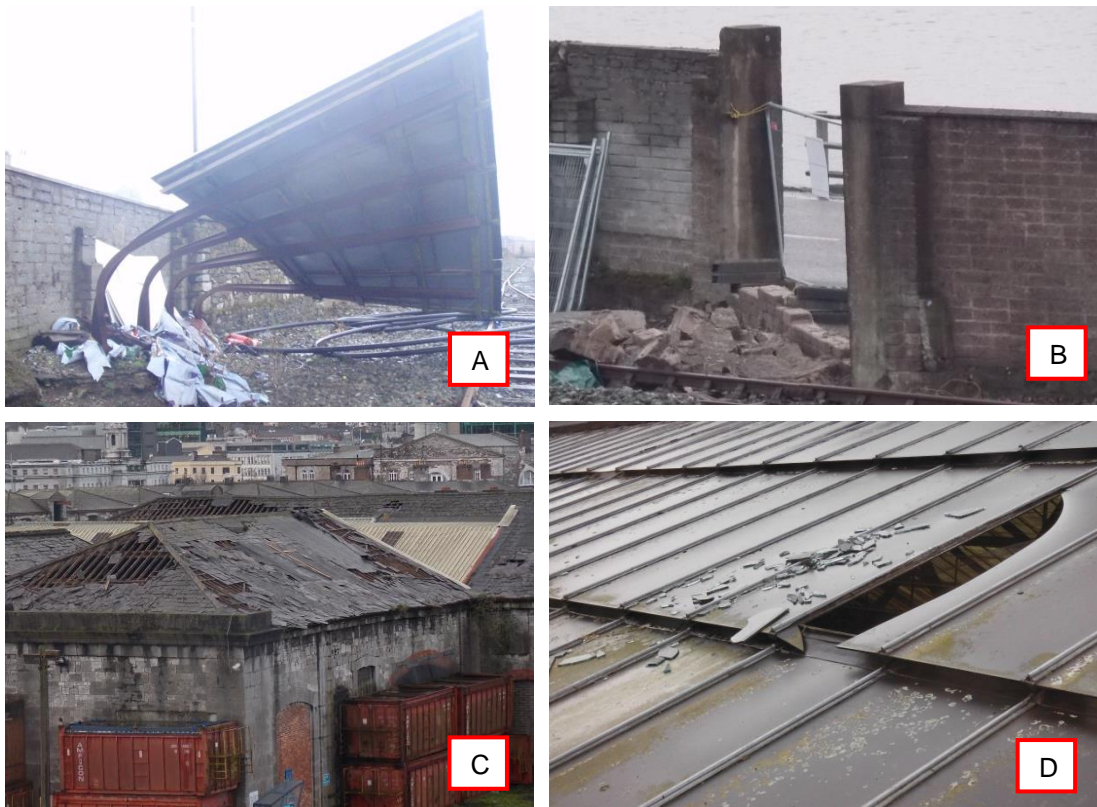
Figure 7 – Additional damage in vicinity of Kent Station

- An advertising hoarding near the perimeter wall on the south side of the station was damaged as shown in Figure 7A. The structure was supported by steel columns which bent over due to the force of the wind;

- Both the goods store and the locomotive shed are large buildings with tiled roofs. A number of tiles were removed from both structures by the wind. It was also observed that a number of houses on Lower Glanmire road adjacent to the station also had tiles removed from their roofs Figure 7C;

- A large section of roof felt was removed from the main canopy and landed on the ground next to Platform 2. In addition to this glass panes failed near the centre of the structure with the glass being blown out through the top of the roof Figure 7D.

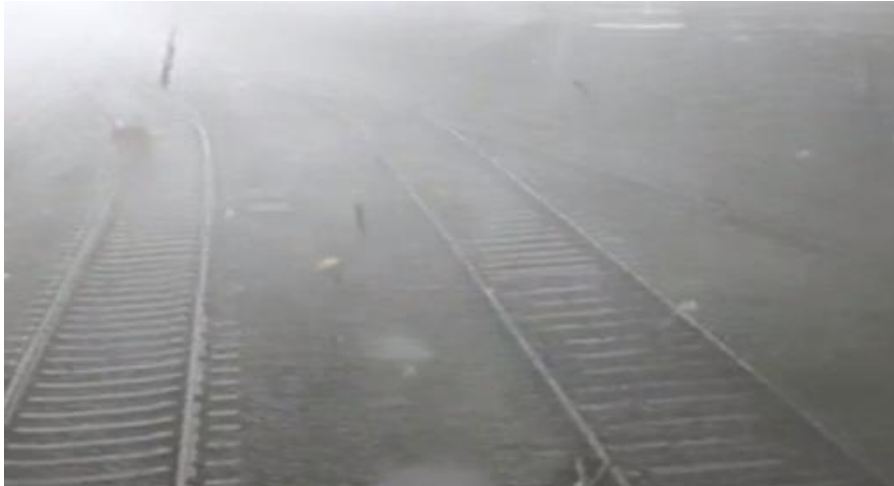
Figure 9 – CCTV from locomotive shed near the location of the accident

28 This is supported by CCTV for the area near the accident which shows consistent rain in the area increased in intensity at approximately 15:01 hrs with persistent heavy rain and gusts of wind of sufficient force to move debris. An illustration of this is shown in Figure 9 which shows the CCTV from the locomotive shed, wood and other debris can be seen being carried by the wind.

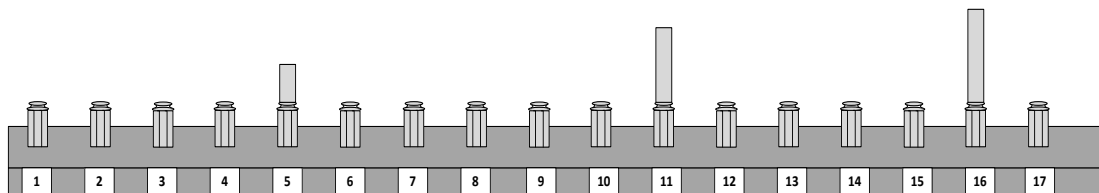
Figure 15 – Schematic of supporting columns post-accident

55 The initial site inspection identified that all of the seventeen supporting columns of the canopy over Platforms 1 and 2 had failed.

57 For the purpose of this report the columns of the canopy are numbered from one to seventeen starting at the station building end of the platform, see Figure 15.

58 Fourteen out of seventeen of the columns failed at a circular feature in the lower part of each column also shown in Figures 15, 16 and 17. This feature acted as a decorative transition between the octagonal base section and the narrow tubular section.

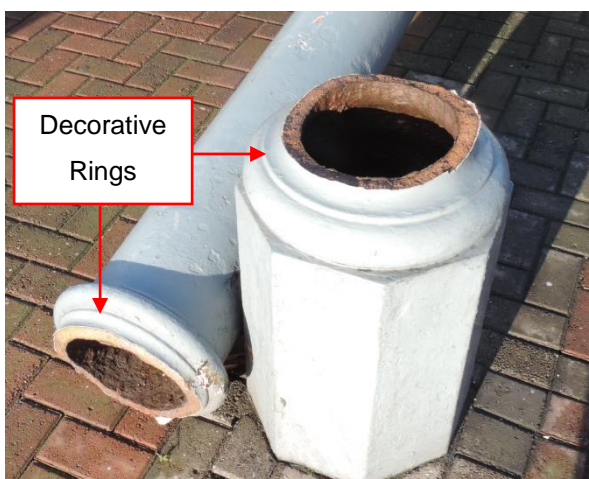
Figure 16 – Point of failure at decorative feature

RAIU Investigation

RAIU decision to investigate

- 59 The decorative feature was comprised of an upper and lower ring structure with an intervening concave groove. A sharp radius marked the transition between the rings and the concave section (Figure 16). Sharp radii such as these are known as stress raisers.

- 60 Examination of the fracture faces showed that they exhibited brittle fracture patterns with no apparent *plastic deformation*. The fracture faces for the columns that failed in this area were essentially flat, which is indicative of *brittle overload* consistent with the application of the maximum tensile stress. With a brittle fracture, crack propagation is very fast with the crack propagating almost perpendicular to the direction of applied stress. In addition to this no evidence of pre-existing cracks was observed in any of the columns.

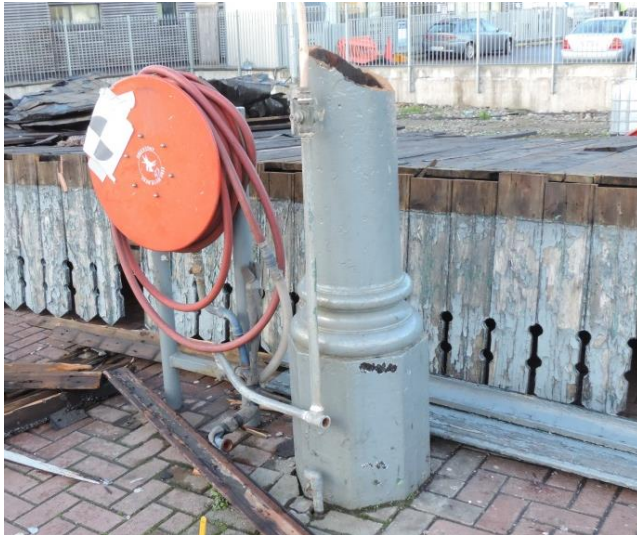
Figure 18 – Column five

- 64 Measured values for the column thickness were also affected by the width of the internal layer of corrosion within each column.
- 65 Columns five, eleven and sixteen did not fail at the decorative feature at the base of the column. All three failed at different heights. Column eleven failed a similar decorative feature near the top of the column. Whereas columns five (Figure 18) and sixteen failed nearer the middle of the columns. Both of these columns demonstrated *porosity* in the fracture surface which may have weakened the columns at these points (Figure 19). Porosity in the column would again be due to inconsistencies within the original manufacturing techniques.

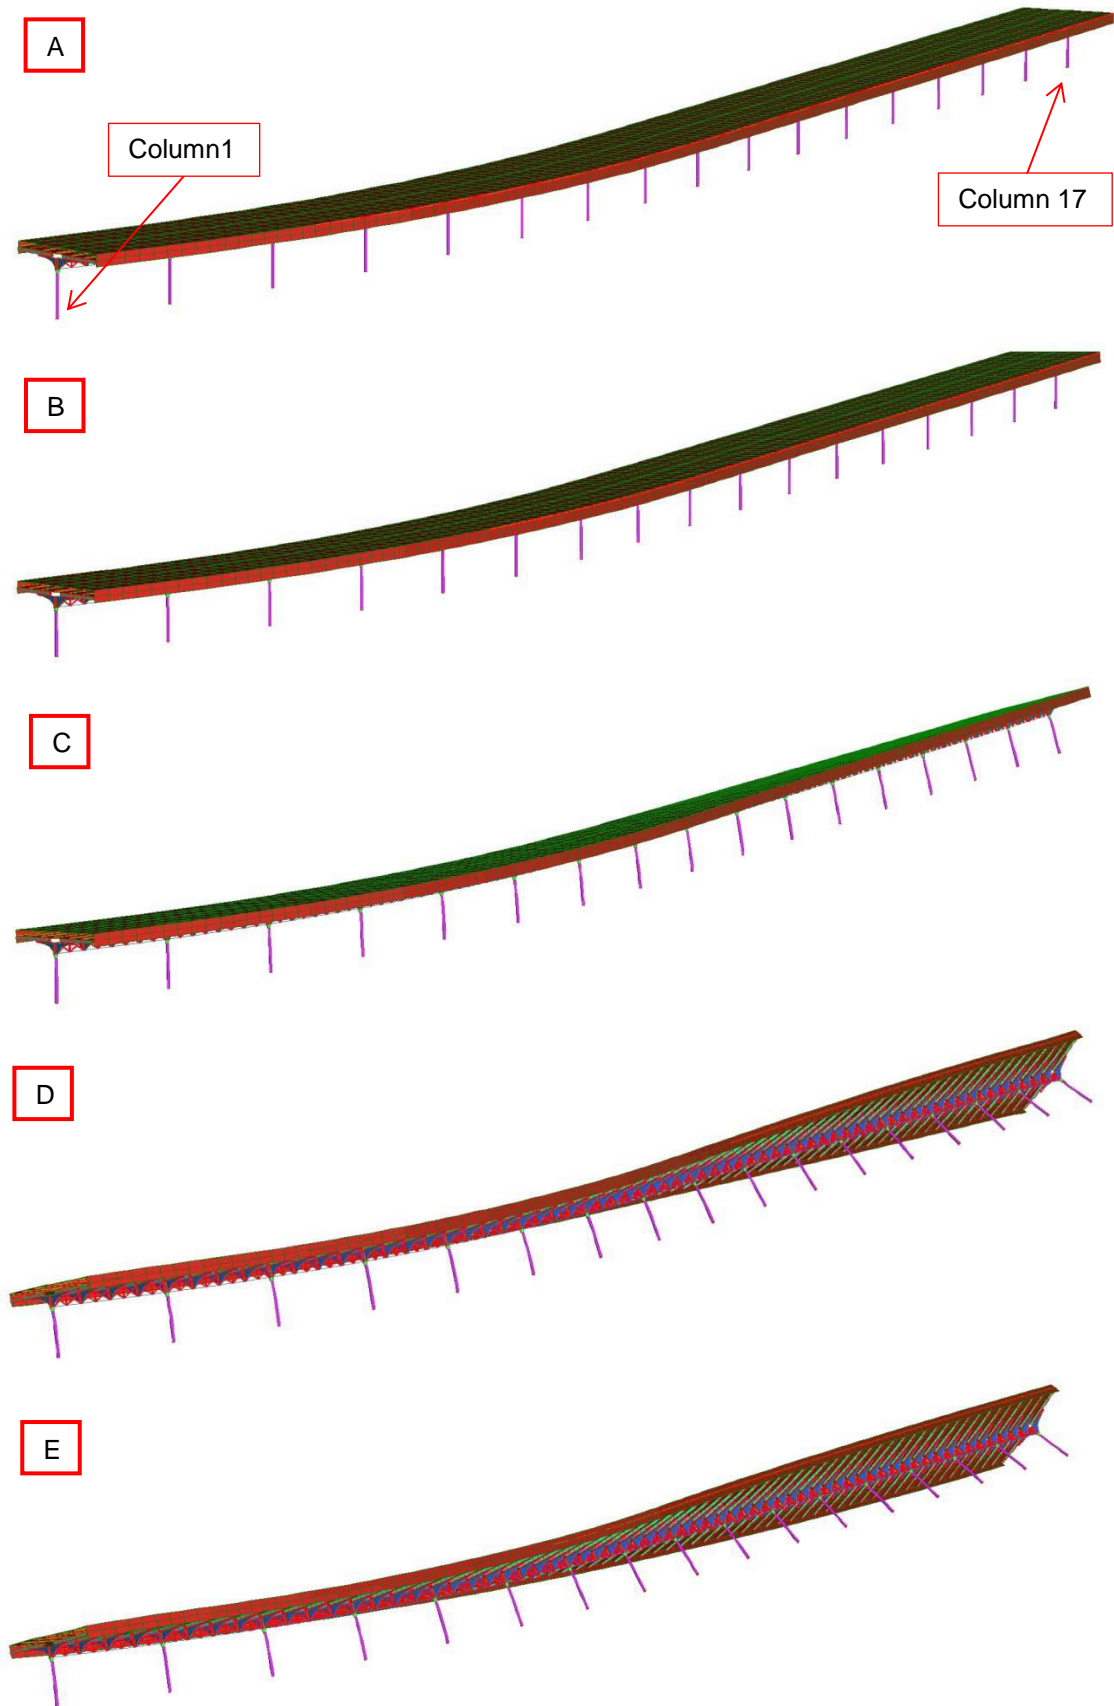
Figure 24 – Selected moments from simulation of canopy collapse, Fluvio (2014)

73 Figure 24 shows five images which best represent the displacement response of the canopy (Figure 24 has the columns numbered 1 – 17, from left to right, as illustrated in Figure 24A).

- At 0.02 s the canopy is in its equilibrium state (Figure 24 A);
- At 1.84 s the first column fails (Figure 24 B);
- At 2.64 s the last column fails (Figure 24 C);
- At 3.48 s the north-eastern corner of the canopy impacts the ground (Figure 24 D);
- At 3.80s more of the structure impacts the ground as the time progresses (Figure 24 E).

- 76 At the time of the last column failing, the most eastern column, i.e. the first column to fail, had displaced over 1m. At this stage progressive collapse had been initiated. This result ties in with the eye-witness accounts that indicated that the canopy collapsed progressively from the far end of the platform.
