INVESTIGATING REPORT

on the railway incident
occured on the 8th of September 2009 in the railway station Ilva Mică

*Final Edition
May 25, 2010*

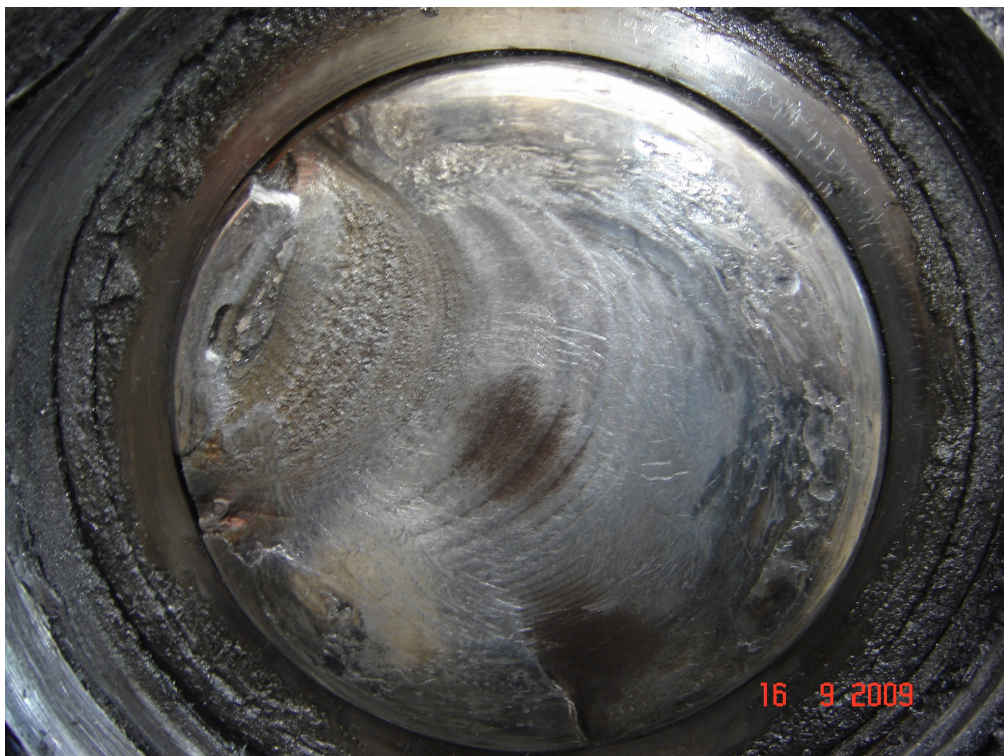
Photo nr. 1

- the weld size shows two distinct areas (photo no. 1) :
 - a specific area with fatigue fracture representing about 80 % of the breaking section;
 - an area with sharp breaking aspect, with material pluck representing about 20 % of the breaking section;

- the axle breakage is a fatigue fracture;
- one could not identify the tendency to this fatigue fracture because the exterior areas of the two fracture surfaces were distorsioned due to the repeated blows of the open cracks surfaces until complete breakage;
- because the results of these tests, examinations and determinations were within the limits imposed by reference documents, one could not identify any favoured factors of these breakage;
- the breakage occurred as a result of exceeding the fatigue limit of the material from which the axle was made, which favoured a large number of stretching – compression cycles that were applied on this axle along its length of operation, from the date the pair of wheels were mounted at the locomotive EA 040-139-2 - 12.01.2006 the axle covered a distance of 352.501 km.

The direct cause of the incident occurrence exceeding the material fatigue limit from which the axle no.41751 was manufactured.

The favoured fact was a large number of stretching – compression cycles that were applied on this axle along its length of operation. Thus, from the date the pair of wheels were mounted at the locomotive EA 040-139-2 - 12.01.2006 the axle covered a distance of 352.501 km.

The Romanian Railway Safety Authority together with the railway transport operators will analyse the opportunity that, at the pair of wheels of the type involved in this incident, after a certain operation period, to be increased the frequency of the ultrasonic inspections.

If, following this analyse, it will be determined that is appropriate to increase the frequency of ultrasonic checks at this type of pair of wheels, the Romanian Railway Authority shall draw up a railway technical norm that will be the base for the implementation of this safety recommendation.
