INVESTIGATING REPORT

of the railway accident
occurred on the 17th of November 2010, on the running wire I,
between the subway stations Piata Unirii – Timpuri Noi

FINAL EDITION

The 3rd of February 2011

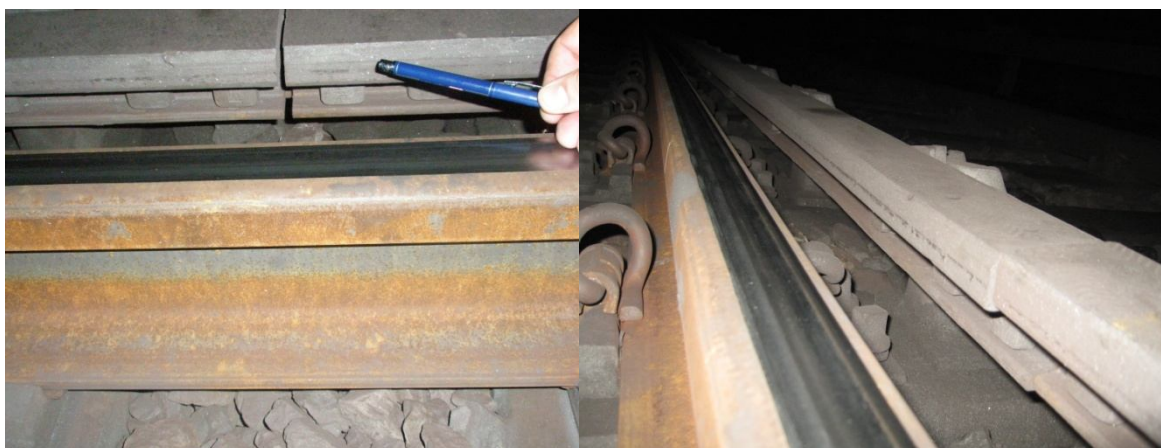
a) *the checkrail of the curve “V8”*

on the entire length of the checkrail of the curve “8”, on its active side in several areas were found specific signs of the touch left on the inner side of the wheel on the right;

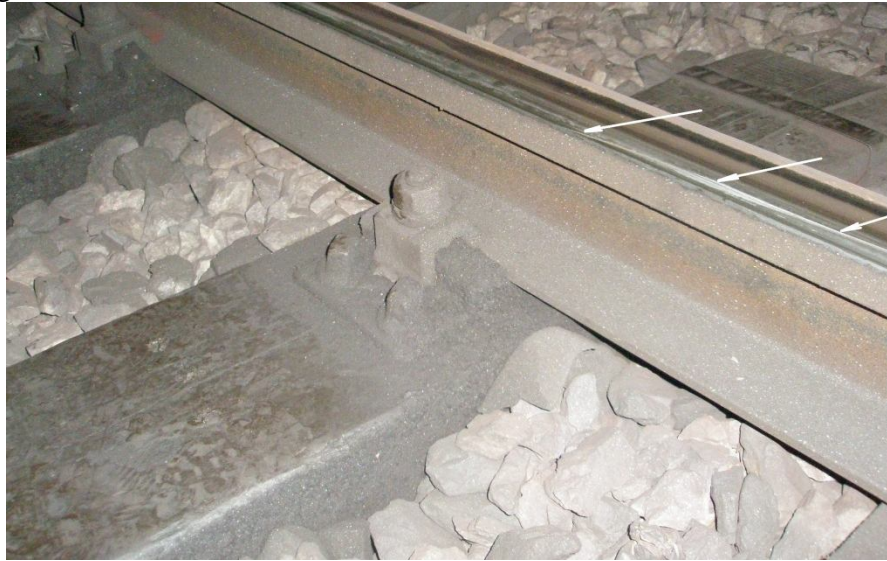
- b) the rail on the left of the running wire I Piata Unirii I-Timpuri Noi
at the km 5+858, on area in line, was found the sign left by the wheel bandage rim on the left on the rolling surface of the railhead

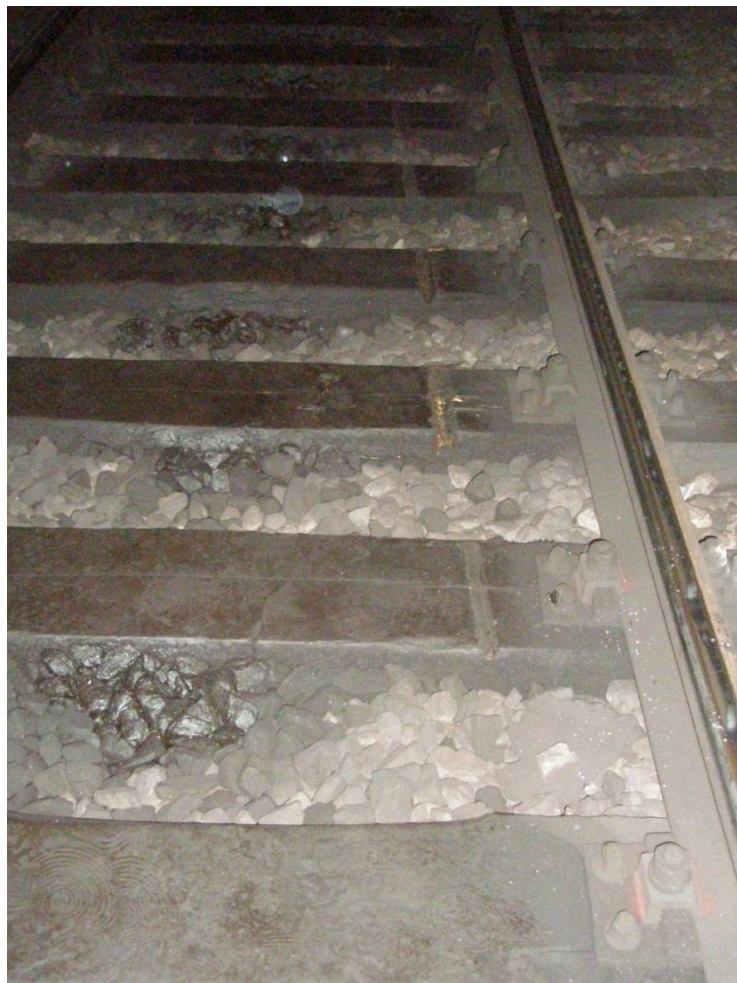
- c) the wooden sleepers
- starting from the km 5+858 and to the point where the train stopped, on the upper side of the wooden sleepers was identified the sign of rolling of the wheel rim on the right in the running direction.

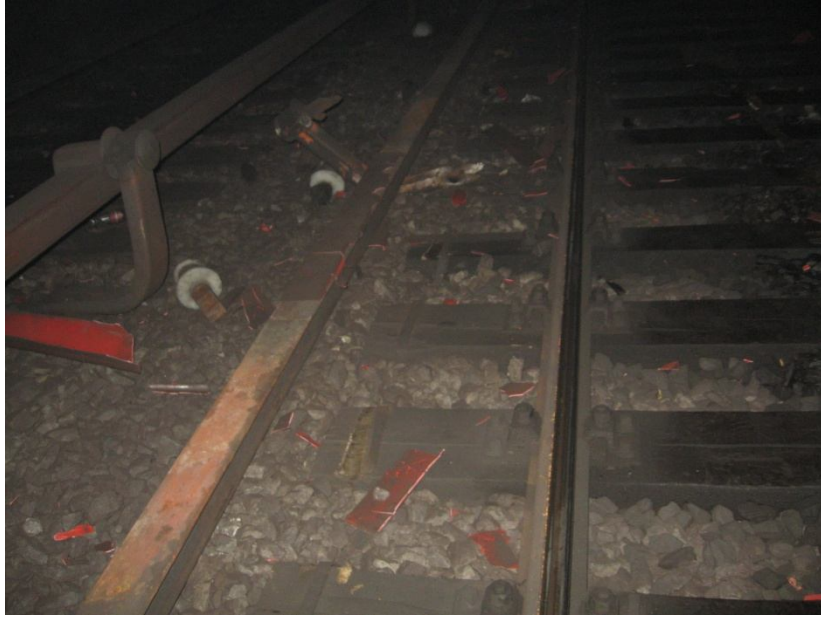
- starting from the km 5+858 and to the km 6+269 on the left was found the sign of wheel bandage rim rolling on the sleepers end on the upper surface, the supports of the 3rd rail destroyed and the rail fallen (corresponding to the running wire)

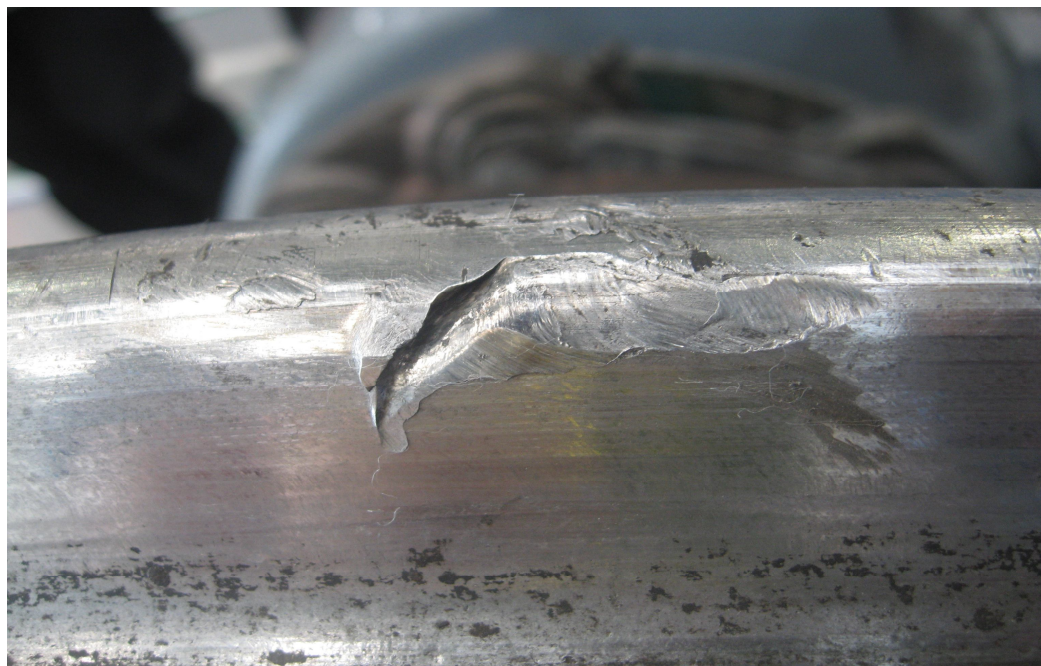
- at the axle 8 from the bogie 4, on the X head wheel (the left in the running direction), in the area of the point A2 to the top tor of the rim is found a mark with release of material with a length of 35

mm, depth of 3 mm as consequence of an mechanic interaction and on the Y head wheel (the right in the running direction) in the area of the bevel of 45° from the outer side of the wheel (at a distance of about 150 mm in transverse plan to the position of the sign on the X head wheel) is found a marking by material repression on a length of 35 mm,

then, after about 500 mm another transverse hit with the length of about 30 mm and width of 4 mm in the area of the running plane with conic 1:10.

From the mark shape found on the active flank of the wheel rim it could be concluded that the impact took place while the running of the train in the direction Anghel Saligny – Preciziei. After changing the running direction of the train at the station Preciziei, on the distance Preciziei – Piata Unirii 1, the profile in line of the running path did not contain curves with low radii (under 300 m), that could have generate running conditions similar to these in the area of the curve “V8” (with radius of 190 m), so that on this distance was not affected the guidance capacity of the wheel on the left of the axle no. 8 (appeal wheel).

- Displacement of material from the running surface of the wheel on the left of the axle no.8, in the area of the point A2 on the active flank of the wheel rim, followed by pulling out of the material on this surface and forming of some accumulations of material;
- Running, given the defects mentioned above, on a curve with radius of 190 m and over-elevation of 130 mm.
