INVESTIGATING REPORT

on the fire occurred on the 21st of July 2011, on the range of
CF Bucharest Regional Branch, between the railway stations CFR Peris – Buftea,
at the locomotive EB 91 53 0 425-210-8 (belonging to SC Grup Feroviar Roman SA
Bucharest) in the composition of the freight train no. 70852

Final edition
The 25th of October 2011

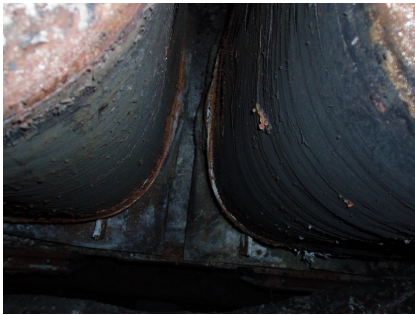
- the winding of the flattening self of the traction engine no. 1 at the end placed to the ventilation channel of the engine, on a portion of about 180 mm of the column length had burned insulation, reddish on the entire turns circumference, which indicates the turns insulation piercing and the occurrence of a short-circuit between the turns, the rest of the column has the insulation charred, black;

The short circuit occurred between the windings of the flattening self was due to an accidental technical cause, under normal operating conditions of the locomotive.

The piercing of the windings insulation of the flattening self did not have immediate effect, detectable by the protection circuits of the locomotive, because the self construction, with adjacent windings in a single layer, do not favors the occurrence of overloads in the power circuit. Under these conditions, the tension between two windings being reduced, the short circuit determined by the piercing of the insulation had a local effect, unnoticed by the main circuit, but sufficient for the ignition of the insulating material of the windings cover in the composition of the flattening self coil.

The thick insulating layer between the self coil and the iron core delayed the entry into action of the protection against making mass, the necessary time for burning the insulating material being higher, which given that the tension between two windings is reduced led to a local effect unnoticed by the main circuit, but sufficient for the ignition of the insulating material.

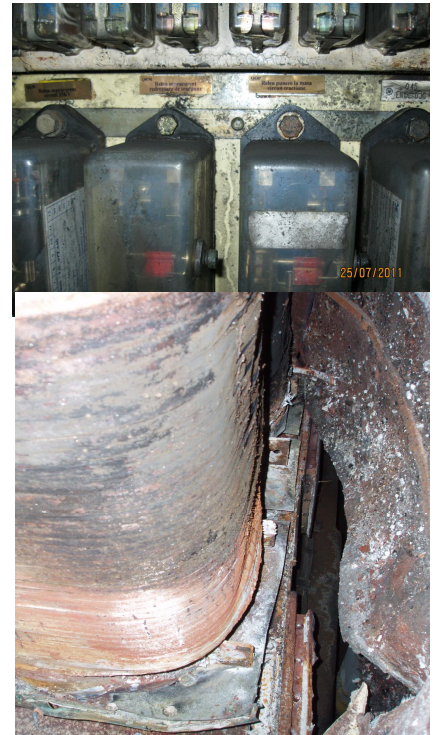
- the winding of the flattening self of the traction engine no. 2 had charred insulation, black; on a portion of about 100 mm of the column length (next to the burnt section of the self of the traction engine no. 1) had reddish insulation;

By thermal influence occurred also the thermal damage of the flattening self associated to the traction engine no. 2, the phenomenon being followed by the propagation to the combustible parts in the area of the traction engines MT1 and MT2, the fire propagation occurring by the burning of the wiring insulation of the command and power circuits.

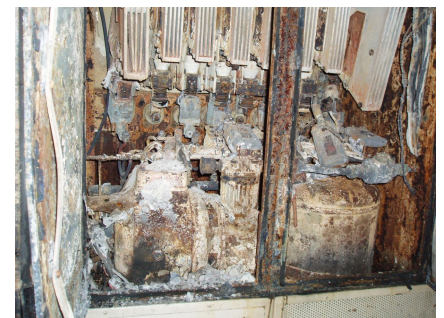
- the antilock resistances (RAP 1-2) had the wiring and the supply connection thermally affected by the fire;
- the field weakening resistances (RS1-2) had the wiring and the supply connection thermally affected by the fire;
- the main compressor resistances (R101) and auxiliary services (R192) had the wiring and the supply connection thermally affected by the fire;
- the field weakening contactors placed in the block from the driving cabin I (S1.1- S1.4 and S 2.1-S 2.4) had the insulators, the supply wiring, the fire chambers, the main and auxiliary contacts thermally affected by the fire;
- the electric motor of the auxiliary compressor is affected by the thermal influence during the fire;

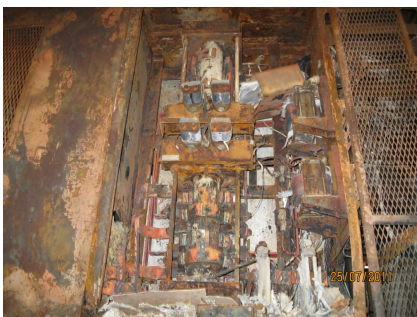
- the drive inverter (J21) and the switch selector (TR30-traction-braking) had the supply wiring, the connecting rods, the main and auxiliary contacts fix and mobile and also the actuator cylinder thermally affected by the influence during the fire;

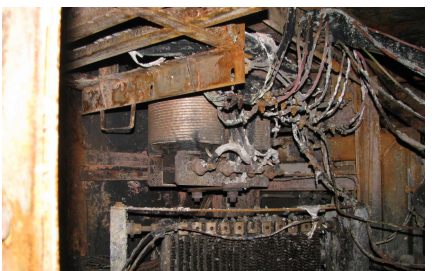
- the additional resistance of the voltage voltmeter MT1 (RUM 1) was removed from the holder and thermally affected;

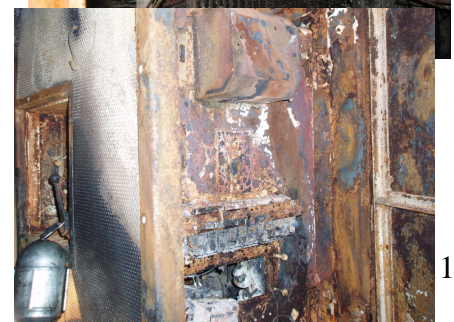
- the block of command devices station 1 (automatic fuses, battery switch, battery diodes, switches, compressor pressure relay, sockets) affected by the thermal influence during the fire;

- the block of command devices auxiliary services (contactors, fuses, switch, relays, wiring), thermally affected by the fire;

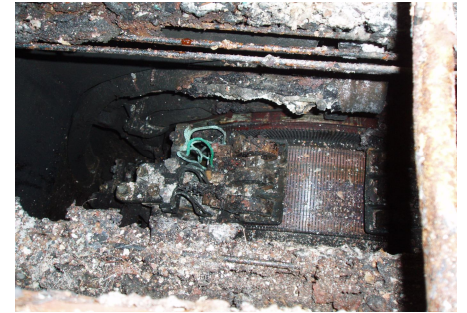
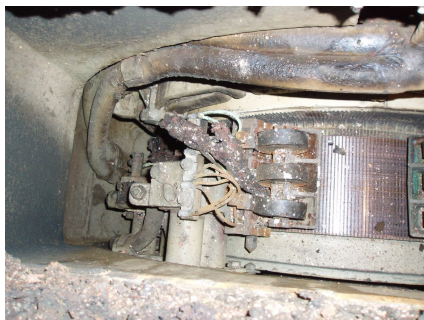
- the solenoid station 1 (VEPTM), command chamber, wiring, valve and air supply pipes of the pantograph, completely thermally affected by the fire;
- at the traction engine no. 1 (MT1), the insulation of the stator poles, of the rotor winding and the interlocks of the serial registration of the electromotor, at the upper side were burned by falling inside the collector chamber of the burnt materials above the engine, and the brush holders were thermally affected by the fire at the upper side;

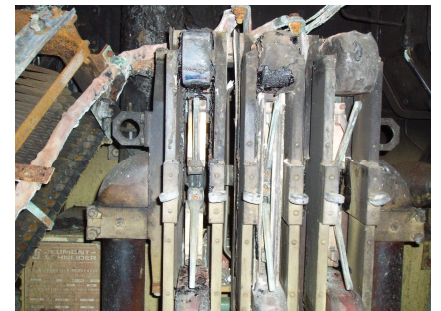
- the load contactors of the graduator had the extinguishing chambers cracked and blocked by the thermal effect during the fire, effect that led also to the melt and flow of molten materials on the mounting brackets; the insulating support of the contactors, at the upper side was thermally affected by the fire; the main contacts (contact surfaces) were not welded, had no sign of melting or ridges, having only specific signs of the thermal effect during the fire;

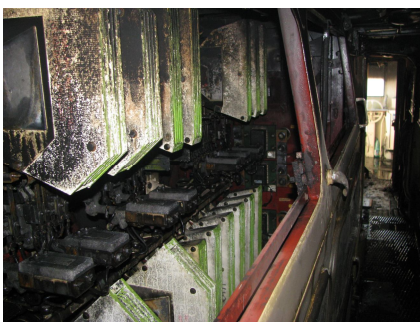
- devices in the central block:
 - the line contactors L1-L4, the braking contactors F, C23, C31-33 (the extinguishing chambers, the support of the extinguishing chamber and the insulator support of the main mobile contact) were thermally affected by the fire; the main and auxiliary contacts (the contact surfaces) were not welded, had no sign of melting or ridges, having only specific signs of the thermal effect during the fire;

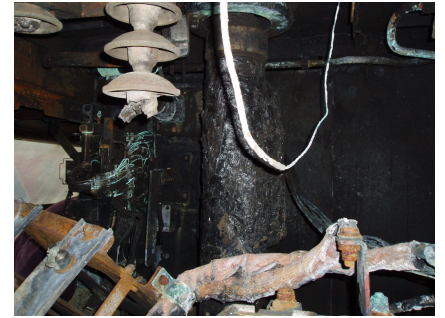
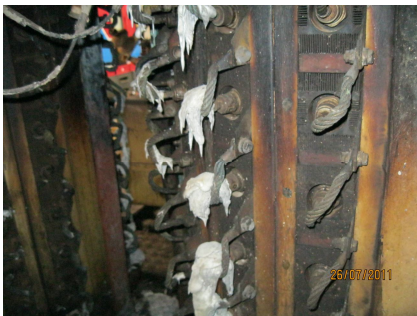
- the chargers blocks of the MT (RM1-2) were thermally affected by the fire, showing pierced diodes on different columns and branches of the deck, by the appearance of a top of current intensity, which led to their successive damage and on two columns of the same arm of the charging deck were pierced all the diodes;

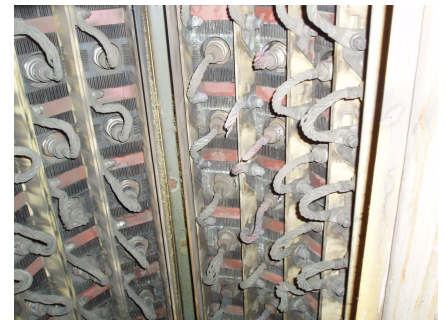
- some terminals (connected) of the diodes had deposits of melt material that was coming from the aluminum fins of the auxiliary charger coolers placed above the charging blocks of the traction engines;
- some terminals (connected) of the diodes were interrupted by the appearance of a current

top from successive breakthrough on the two columns of the charging deck branch;

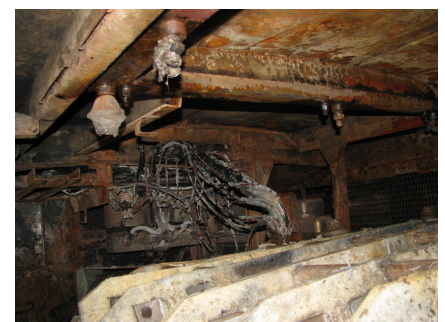
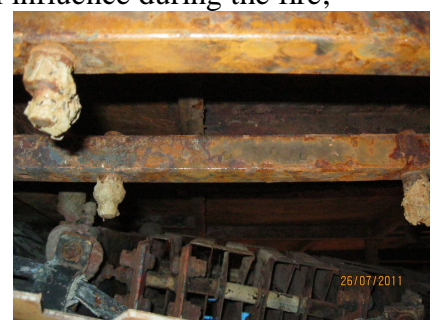
- the auxiliary charger for auxiliary services of 1500V and 215 V had the support insulators melt, being fallen on the chargers RM1-2 and the diodes and the terminals (connected) were affected by the thermal influence during the fire;
- the fans flattening self MT had the insulation affected by the thermal influence during the fire;
- the field weakening resistance from the traction electromotor 1 was affected by the thermal influence during the fire;
- the main compressor electromotor had the wires and the collector thermally affected by the fire;
- the terminal board and the wires associated to the charger were affected by the thermal influence during the fire;
- the panel of the braking system PBL2 had the wires and the solenoids thermally affected by the fire;
- the protection cover of the pneumatic servomotor was affected by

the thermal influence during the fire;

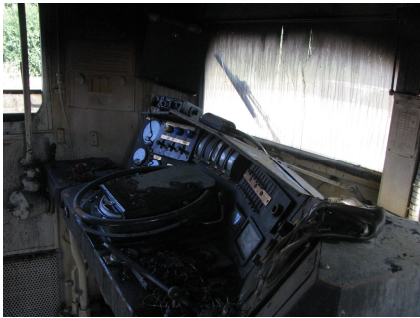
- the trim and the insulation were burnt;
- the RTF station (Motorola), the marks for current MT, the speedometer, the INDUSI and DSV ringer, the service books, the plugs were thermally affected by the fire;
- the side access doors in the engines box were deformed and with insulation burnt by the fire;
- the front windows were cracked by the thermal effect during the fire;

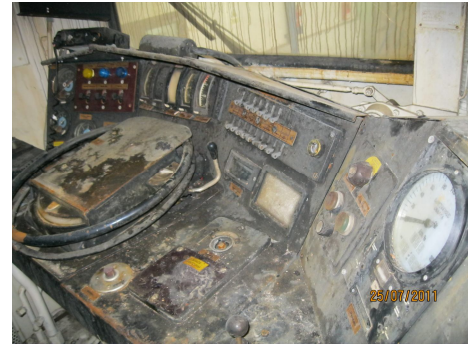
- deposits of soot on the walls, ceiling, windows and also on all the parts and the devices associated to the equipments and installations inside the cabin;
- the circuit breaker DBTF had the pneumatic command block, the command wiring and the connector thermally affected during the fire and the protection cover deformed;
- the sheet covers from the devices block, the protection panels from the high voltage chamber and the devices block were

deformed and those of aluminum were melted by the thermal effect during the fire;
