ROMANIAN RAILWAY INVESTIGATING BODY

INVESTIGATING REPORT

on the railway accident
occurred on the 27th of January 2011 in the flag station Vulcan
in CF Timisoara Regional Branch

Final edition
The 28th of February 2011

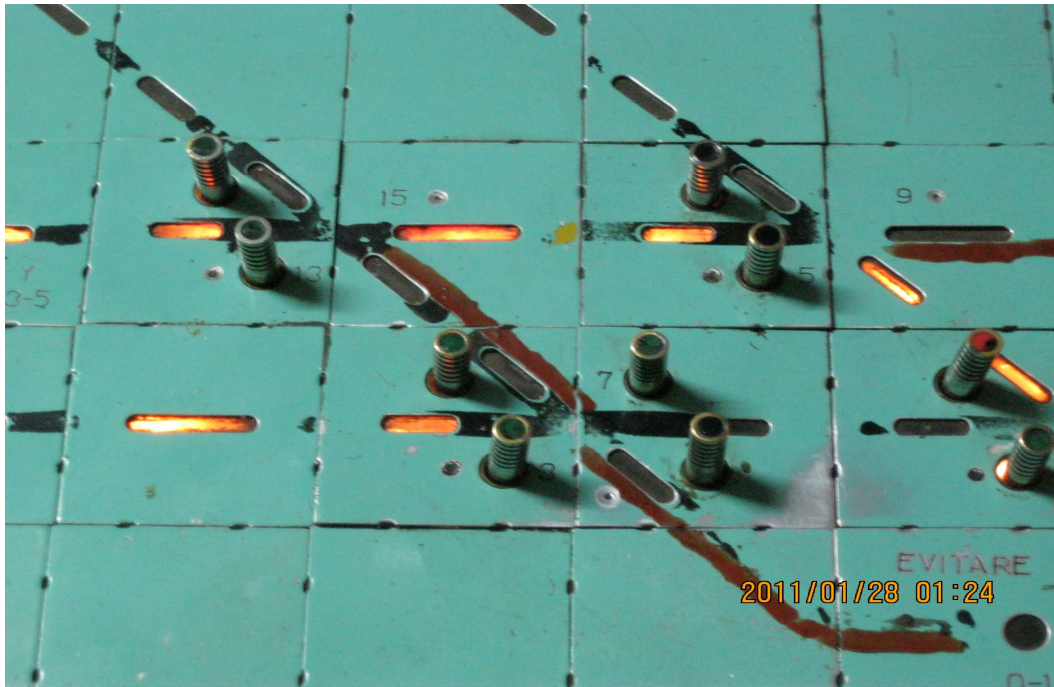
- The inappropriate handling of the switch no. 7 part of the output path;
- The failing to verify the position of the switches in the output path by acting the button “switches control position” on the control panel in the movement office;
- Failure of the bright cells of the switch no. 7 on the control panel;

Fig.1 Position of the switch no. 7 on the control panel

Failure of the bright cells of the switch no. 7 on the control panel;

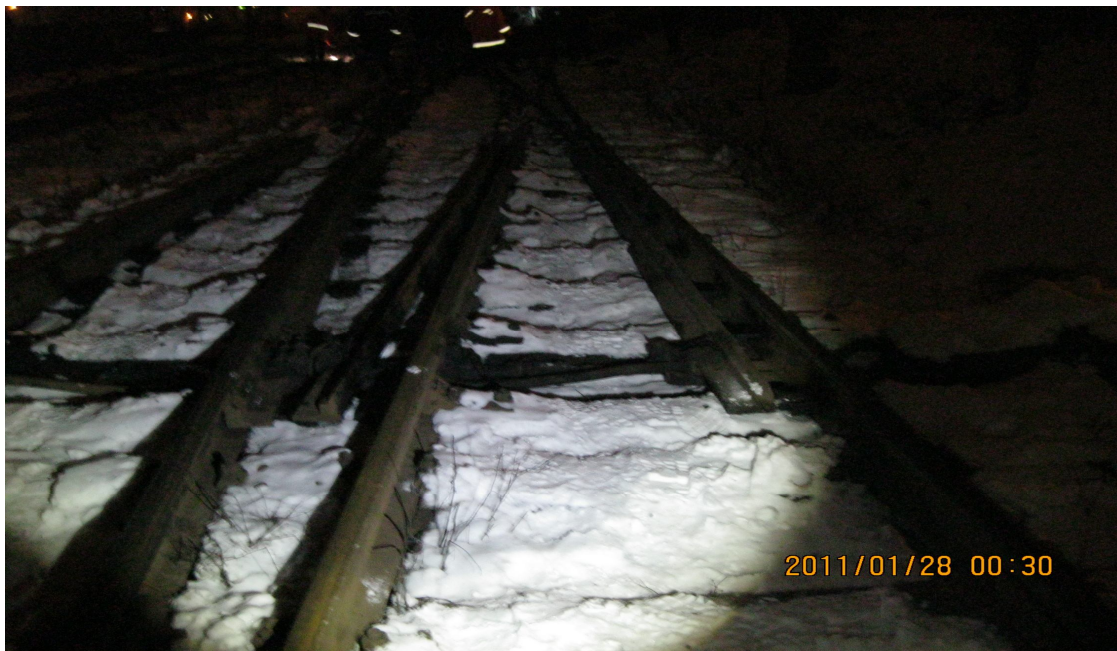
At 6.38 p.m. the train 23815 leaves with a speed from 0-16 Km/h and getting to TJD 3/7 finds the switch 7 on the position on deviation (-) entering the avoidance line X end closed.

Fig.2 Switch no. 7 in TDJ 3/7

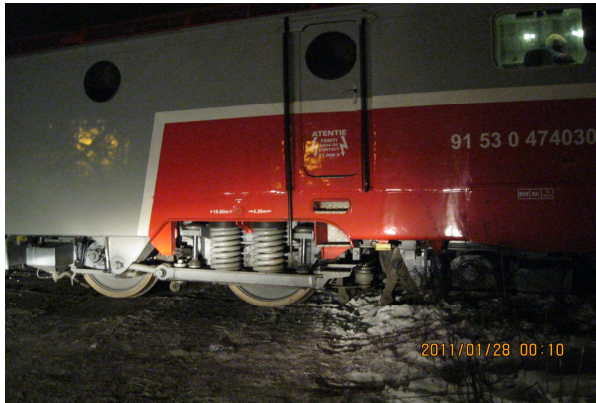
Going down from the locomotive they notice its derailment by all the axles due to the missing of the last two rail coupons from the two wires of the path and with the front driving station in the prism of ballast of the fix stopper. They report the derailment to the IDM through the RER station at 6.43 p.m.

Fig.3 Position of the locom.ED 474030-0 after the derailment

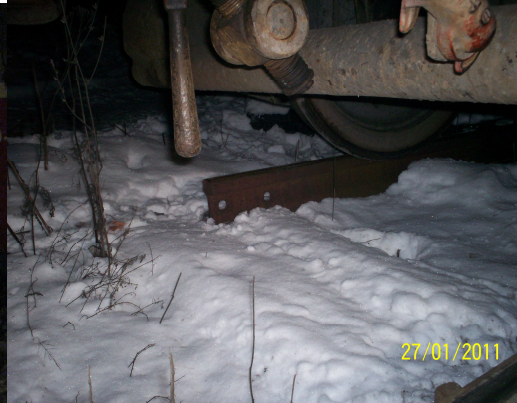
Fig.4 the 2 missing rail coupons on the avoidance line

The avoidance line X end **closed** on the 1st of February 2007 due to missing of the clamping materials, to the thefts of the previous years (2 rail coupons on the two wires of about 23 m) and to the inappropriate sleepers.

The derailment of the locomotive occurred by the missing of two rail coupons of about 23 m on the two wires of the avoidance line, stolen in previous years.
