INVESTIGATING REPORT

of the railway accident

occured on the 14th of February 2013, in the activity of the Branch of Regional Center for Railway Operation, Maintenance and Repairs Galați Galati, between the railway stations Galati Brateș and Cătușa, in the running of the freight train no. 76052

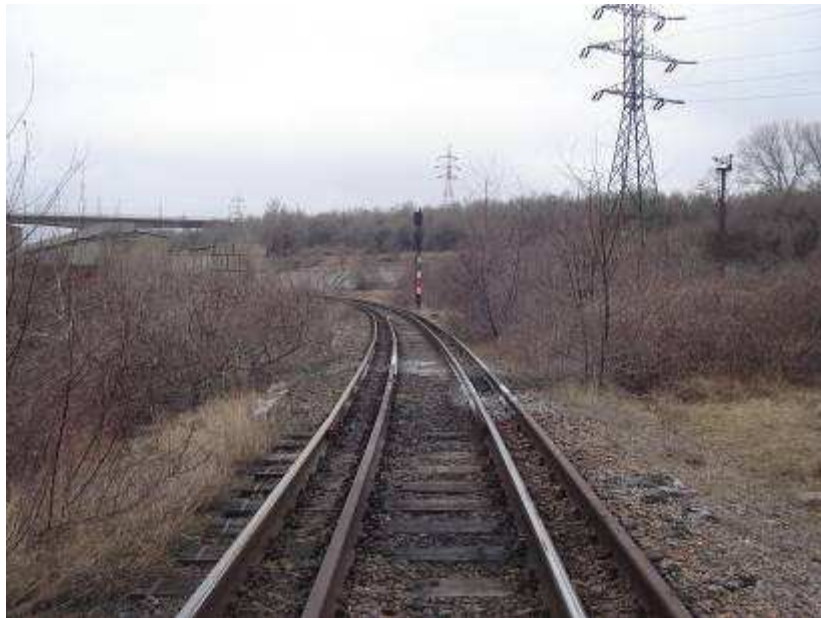
On the distance between railway station Galați Brateș and Cătușa, the investigation commission did not find failures at the lines and interlocking installations, caused by the fire triggering at the locomotive DA 67-1069-3 (photo no. 1).

Photo no. 1 The place where the accident occurred

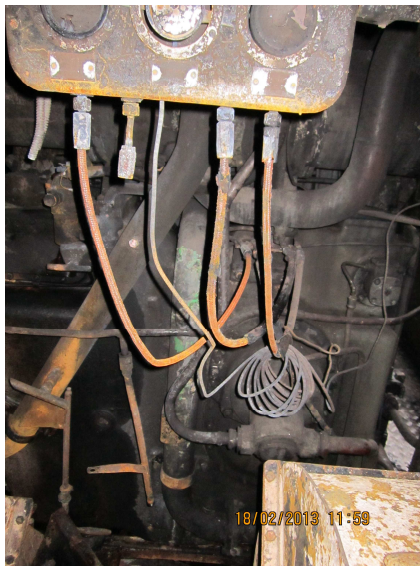
Photo no. 2 The devices area from the damaged engine room

- the running gear and buffering were in good condition;
- the oil and water manometer and thermometer for the Diesel engine degraded (subjected to a heating treatment with high temperatures) (photo no. 2);

- the flexible tubes from the cooling installation, the lubricating with oil and the fuel supply installation of the Diesel engine were degraded (burnt) (photo no. 2);

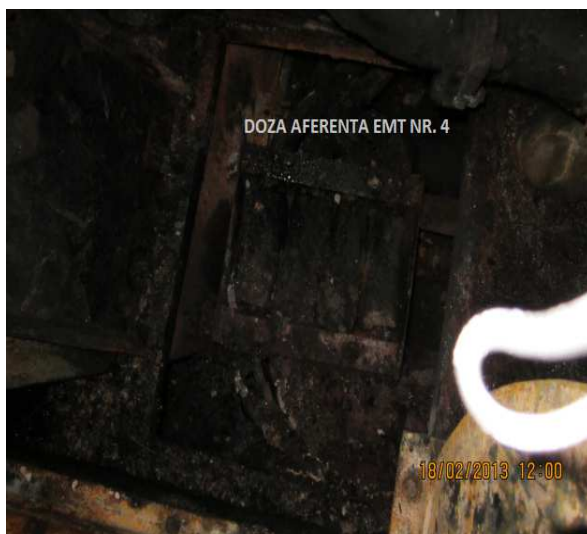
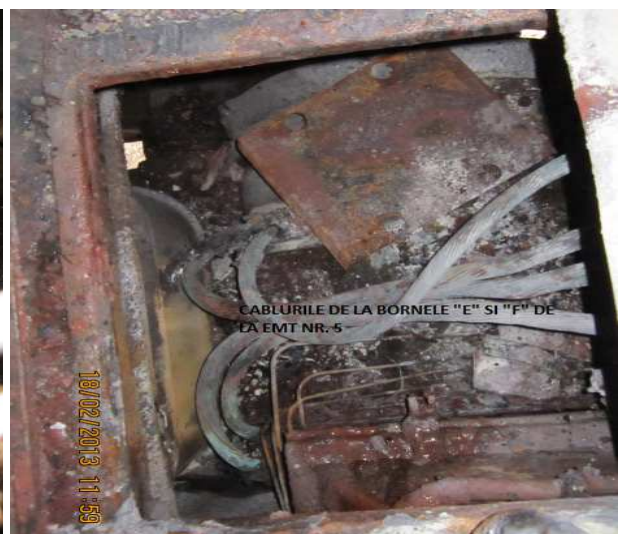
Photo no. 3 The force cables from the EMT no.4 and 5

- the electric fun for the traction engines (EMT) at the bogie no. 2 was degraded because of the excessive heating;
- the force cables from EMT no. 4 and 5 with degraded isolation (burnt) (photo no. 3);

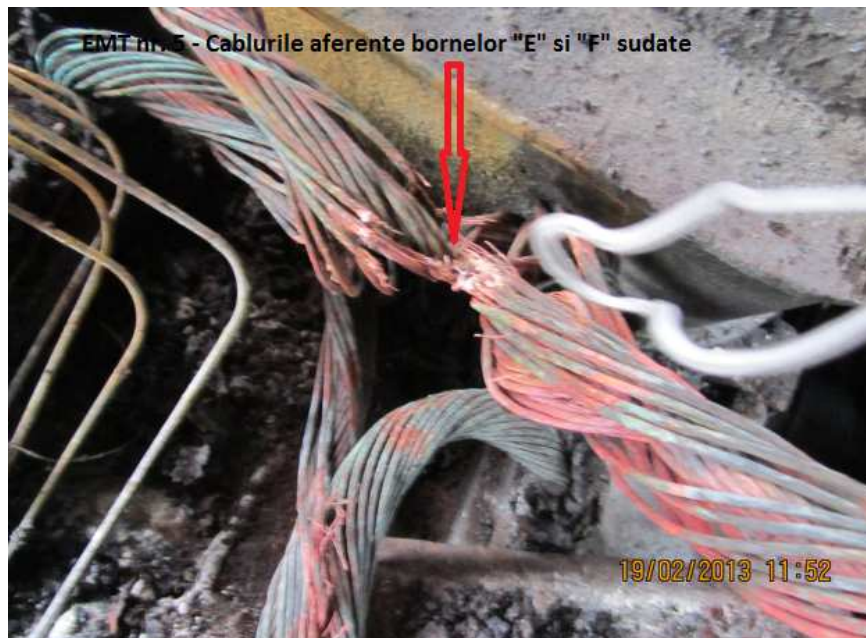
Photo no. 4 EMT no. 5 – Cables E and F melted together

- the force cables from the terminals E and F melted at a distance of 300 mm at the exit from the casing, at EMT no. 5 (photo no. 4).
- diesel and oil loses (photo no. 5);

The fire occurred due the short-circuit at the force wiring from the traction engine no. 5, due the decreasing of the isolation resistance of the cables insulation and its breakthrough, which led finally at the welding of the cables at a distance of 300 mm from traction engine terminals and the ignition of the cable insulation.

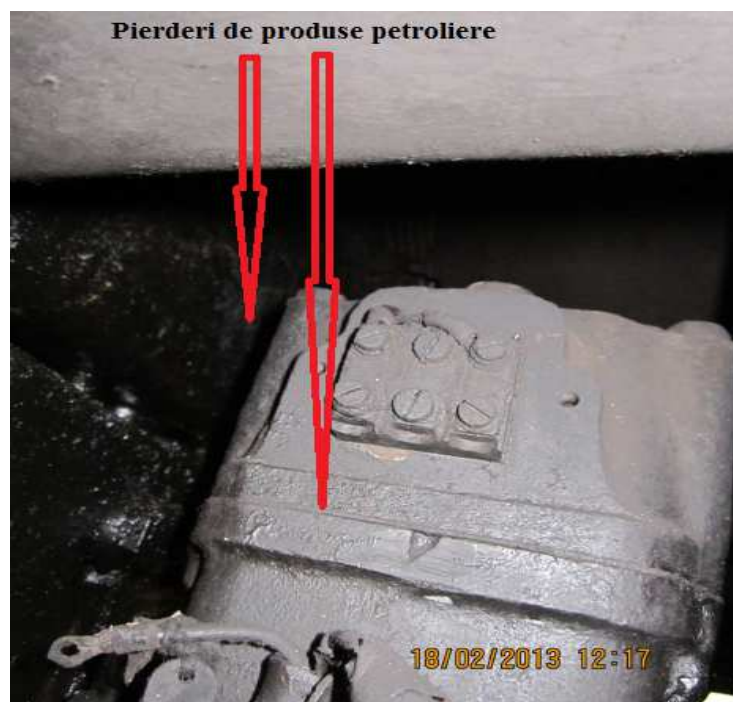
Photo no. 5 Diesel engine with diesel and oil loses

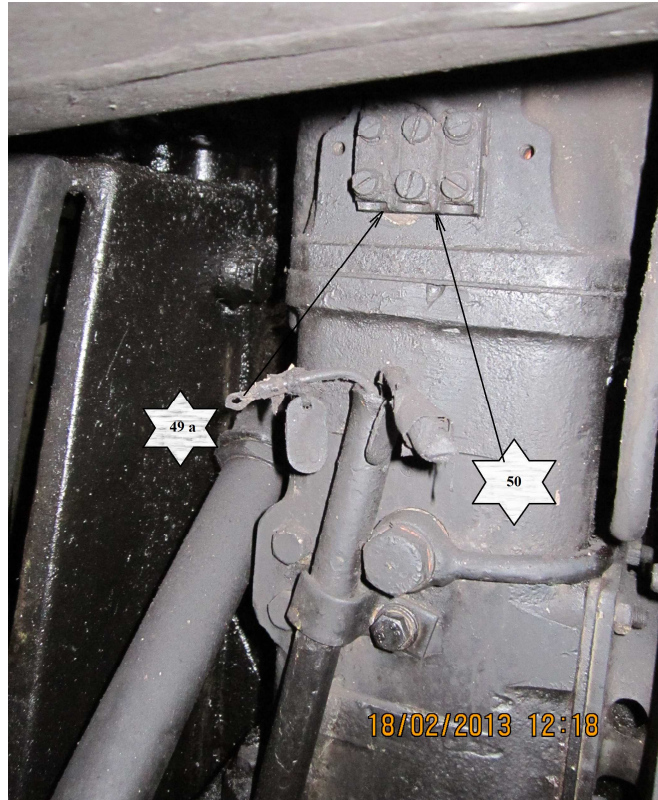
Photo no. 6 Anti-sliding from the mechanic regulator

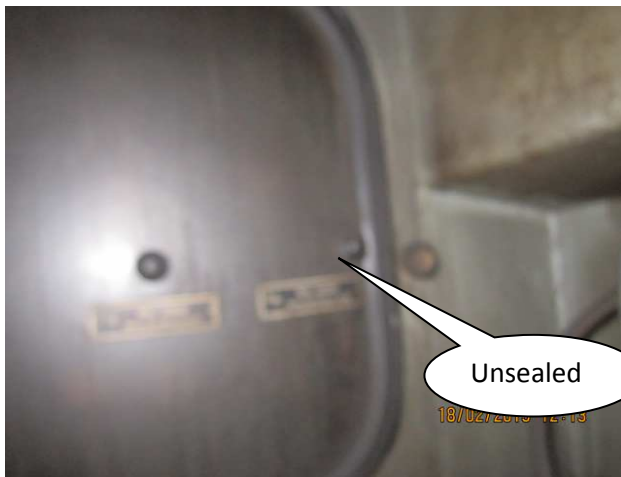
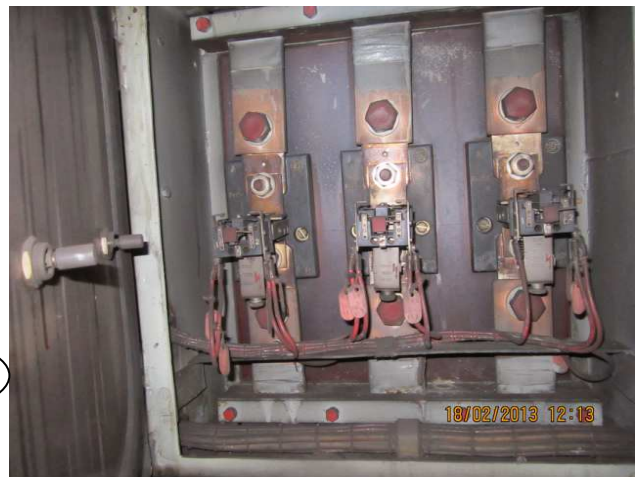
Photos no. 7 and 8 Maximum current relay

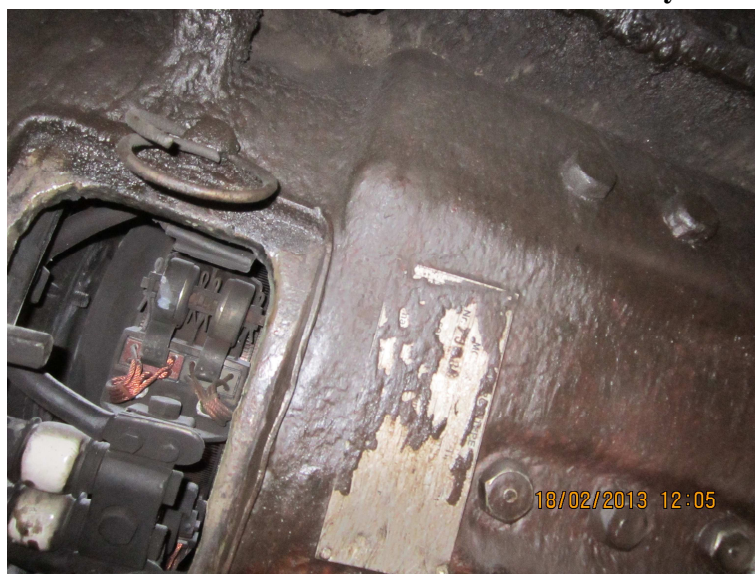
Photo no. 9 Cleanliness of the traction engines

- the aging phenomenon of power cables coatings traction engine no. 5;
- the poor state of cleanliness of the traction engines due the losses of fuel and oil from the installations.
