INVESTIGATING REPORT

of the railway accident occurred on the 02nd of February 2013,
in the activity of the Branch of the Regional Center for Railway Operation, Maintenance and
Repairs Timișoara, in the running of the freight train no. 23817 (belonging to the railway
undertaking SNTFM „CFR Marfă” SA), in the railway station Pui, through the derailment of the
last two wagons, due the circular breakage of the wheel's no. 2 web (monobloc wheel) of the wagon
no. 81536655875-8.

Final edition
Bucharest, the 21th of January 2014

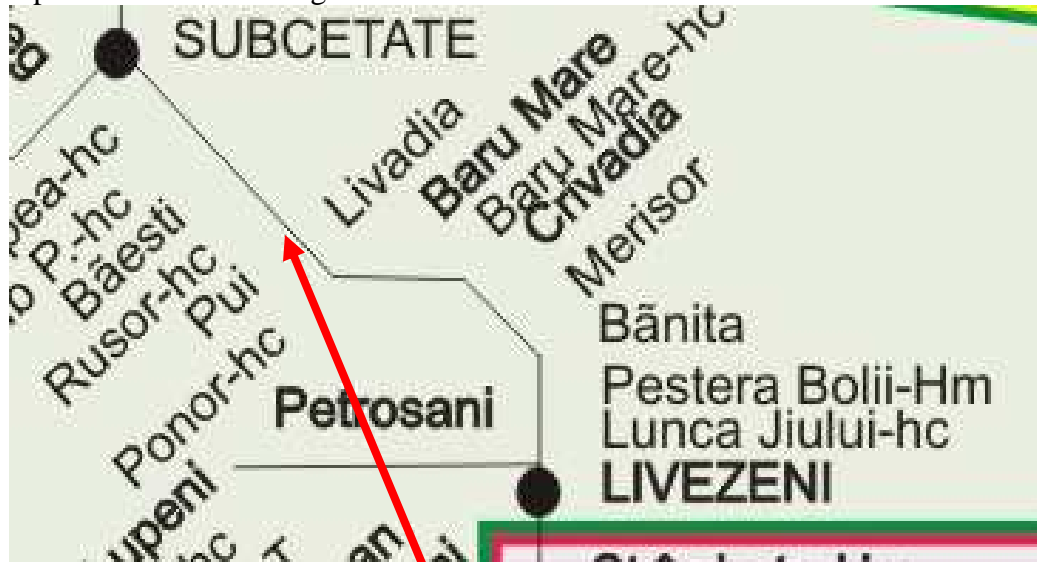
Image no. 1

The accident place is shown in image no. 1

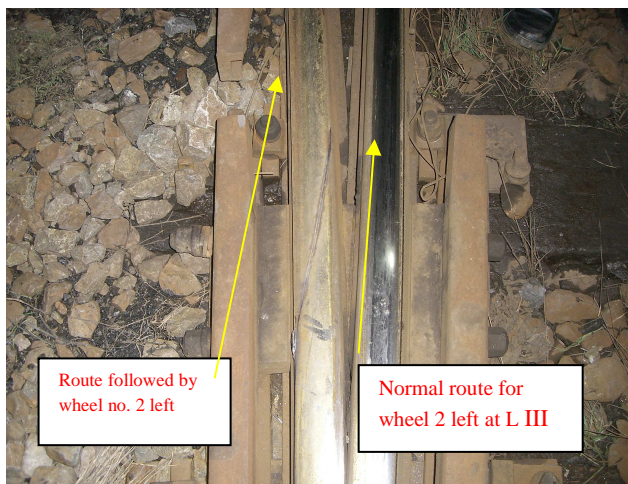
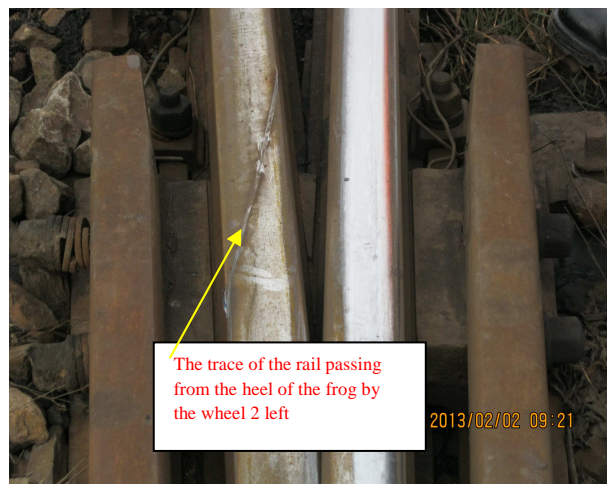
1. at the date of the accident occurrence, the traffic speed on the combined double cross-over S7 – TJD 13/15 – S9 – S11 from line III from the railway station Pui was of 60 km/h for freight trains and 80 km/h for passenger trains;
2. the first trace of derailment was found on the crossing frog from the simple switch no. 7 (type 49 Aa, tg. 1/9, R = 300 m, left deviation) after the running of the flange of the wheel no. 2 from the left side in the running direction afferent to the pair of wheels 1-2 of the bogie no. 1, from wagon no. 81536655875-8, penultimate from the front of the train, on the trench afferent to the deflecting traffic and climbing of the rail from deflection which forms the frog in the right of the last shims at km 44 + 280 (Photo no. 1 and 2);

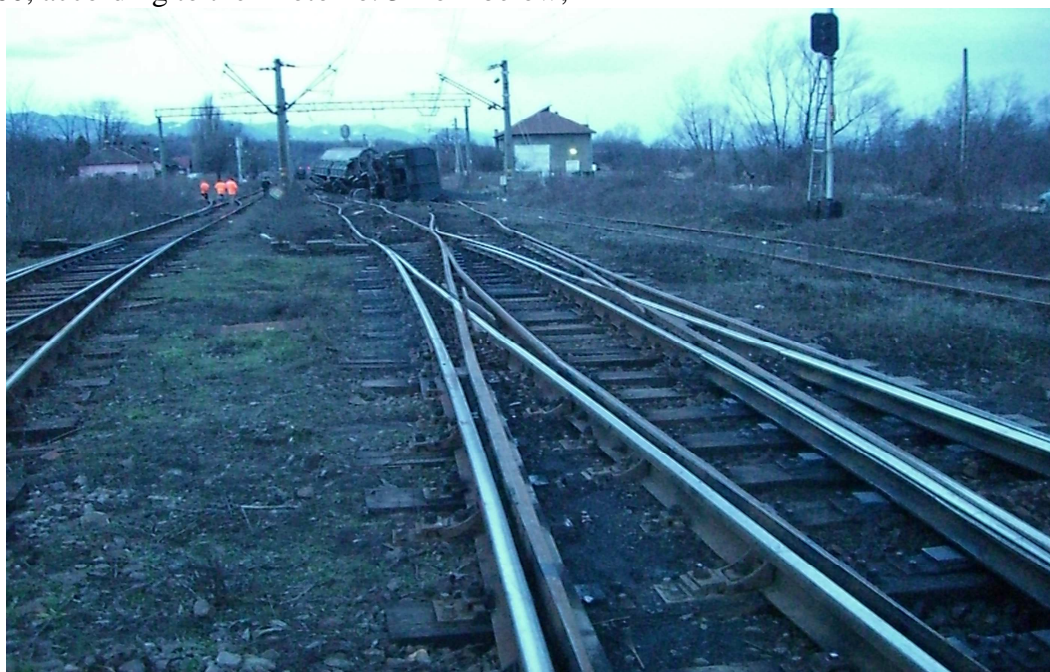
3. after the derailment is running a distance of 120 meters over TJD 13/15 and line III until km 44+160, according to the Photo no. 3 from below;

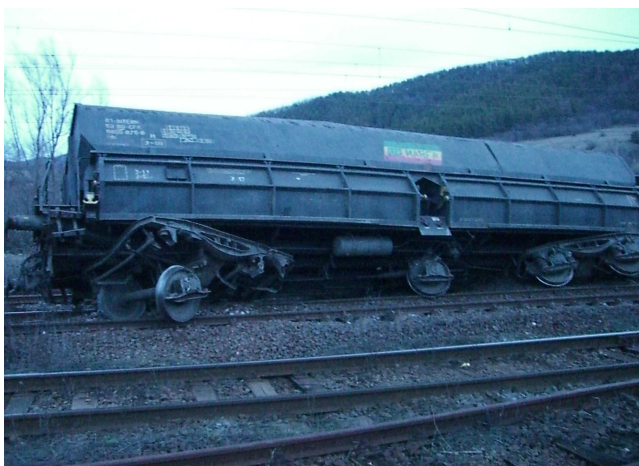
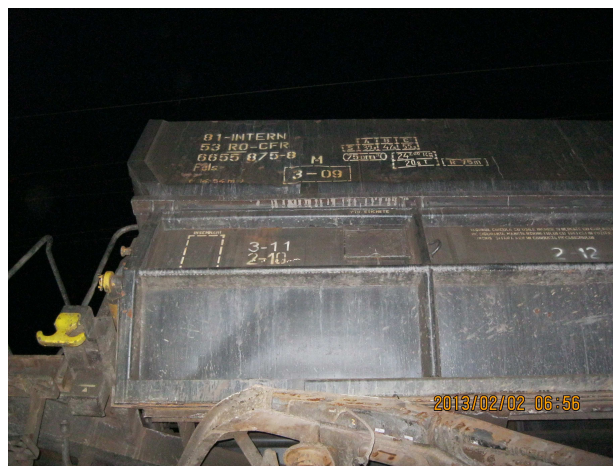
The penultimate wagons from the train, derailed by both bogies, was bended at 45° to the right in the running direction (photos no. 4 – 5)

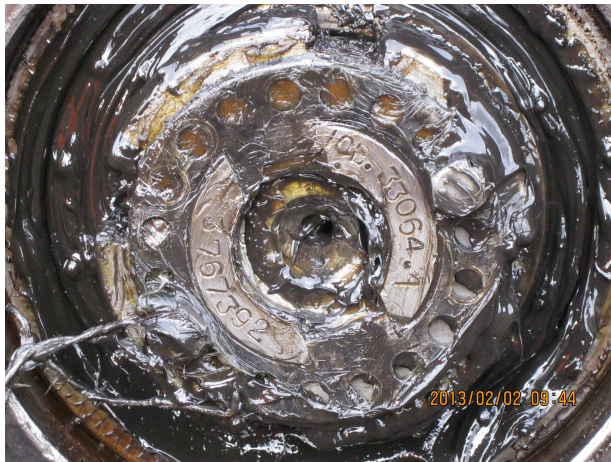
Photo no. 6

- the wheelset with the wheels no. 1-2 had axle with serial no. **3767392**, manufactured by IOB from the cast batch no. 33064.1, the data read from the axle journal, after it was dismantled the cover from the axle box (photo no. 6)

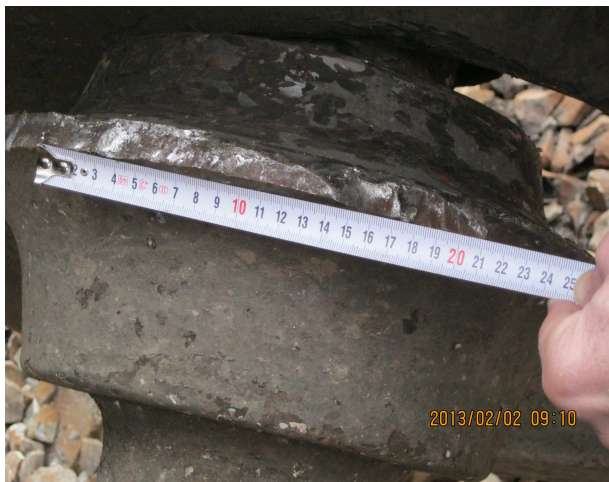
Photo no. 8

- the wheel set with wheels no. 1-2 with wheel no. 2 derailed in the exterior left rail of the track, in the running direction, having the web circular broken on the entire circumference (the length of the circle being of ca. 1200 mm), being deformed to the exterior with an arrow of 20 mm on a length of 220 mm due the impact between this and the wheels boss, occurred after the complete break of the web (photo no. 8 and 9);

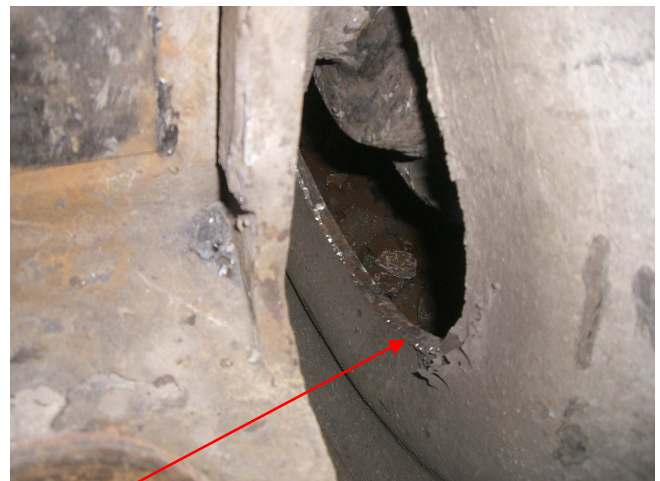
Photo no. 9

old crack

- at the visual inspection in the breaking section was found an **old crack** (Photo no. 9) on the entire circumference with a width of ca. **60% from the web thickness**, the crack was propagating from the interior to the exterior of the wheel. This crack was at a distance of 30 mm in relation with the wheel boss;
- the circular crack was in the connection area of the membrane with the wheel boss (Photo no. 10);
- the wheels no. 1 and 2 don't have transversal movement traces on the axle's body;
- it was found the axle collar, mounted on the axle, this had illegible writings about the axle series and the date of the overhaul;
- the body support from wheel no. 2 broken and at wheel no. 4 being deformed and detached from welding;
- three brake beam deformed;
- the safety steps pieces from the axle with the wheels no. 3-4 are deformed.

1. The monobloc wheel web no. 2, afferent to the axle with wheel no. 1-2 from the first bogie in the running direction of the wagon no. 81536655875-8 had an old circular crack in the transition area with the wheel boss which, due the dynamic loadings at which the wheels was subject in operation, it propagated in section at ca. 60% from the web thickness on the entire circumference.

- the circular breaking of the monobloc wheel's no. 2 web from the first axle of the first bogie from wagon no. 81536655875-8, left part in the running direction, due a circumferential crack occurred in the connection area between the web and the wheel boss, at a distance of ca. 300 mm from the edge of the wheel boss.

The immediate identification of all wagons from the active wagon's stock of SNTFM "CFR Marfă" SA equipped with monobloc wheel made from the cast batch no. 55743 IOB 1991 and those withdrawal from traffic to perform the inspections imposed by the regulations in force at the monobloc wheels to found possibly cracks at the web, rim and wheel boss of those and the applying of the necessary provisions.

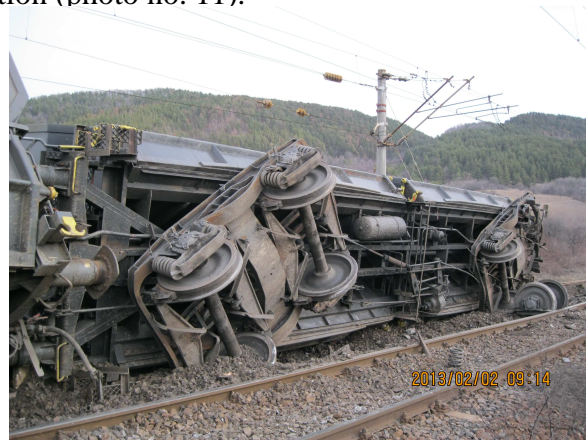
Photo no. 11

- wagon series Fals;
- date of the last overhaul type RP: 25th of June 2012, 6 REV Simeria;
- date of the last repair type DA: 24th of September 2012 – SPC;
- the wagon was he last in the train composition, derailed by both bogies, was overturned on the right side beside the track, in the running direction (photo no. 11).

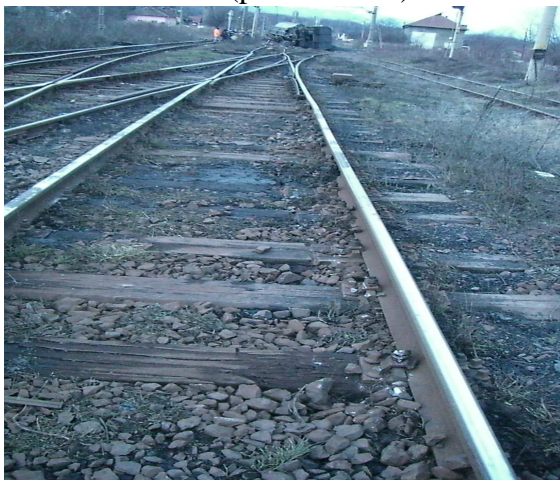
Photo no. 12

4. After the follow of wheel no. 2 on the trench for the deflecting line, wheel no. 1 was guided by the check rail, determined wheel no. 2 to cross over the rail corresponding to the short point of the frog and the fall of wheel no. 2 in the exterior of the rail on the left part in the running direction of the train, time when it is engaged in the derailment and wheel no. 1 in the interior of the rails of the track (photo no. 12).
