SEKTOR ZA PREISKOVANJE ŽELEZNIŠKIH NESREČ IN INCIDENTOV

Ref. No: 375-14/2009/6

Date: 5 October 2009

**FINAL REPORT ON INVESTIGATION OF A RAILWAY ACCIDENT –
COLLISION OF PASSENGER TRAIN NO. 2803 WITH ROAD
FREIGHT VEHICLE AT THE CONSTRUCTED LEVEL CROSSING
MARKED WITH ROAD SIGNS BETWEEN BLANCA AND SEVNICA
STATIONS AT KM 481+840**

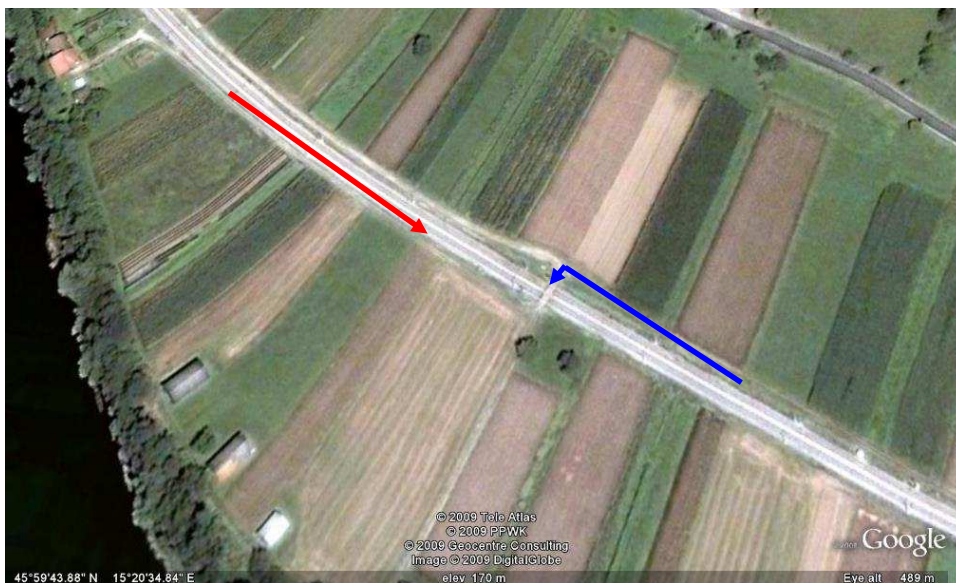
The road freight vehicle drove onto the level crossing at the precise moment when train no. 2803 approached the crossing from the direction of Sevnica. The road freight vehicle first drove onto the right-hand track, which was at the time free of trains, and then proceeded onto the left-hand track where it collided with passenger train no. 2803 at km 481+838.5 at 12:18.

When the train hit the vehicle, the latter became attached to the automatic coupler and ended up wedged under the front of electric motor unit 312-119. The train pushed the vehicle forward for 289 m up to km 481+549.5, where it stopped.

Figure 1: The blue arrow shows the direction of the road freight vehicle while the red arrow shows the direction of the local passenger train

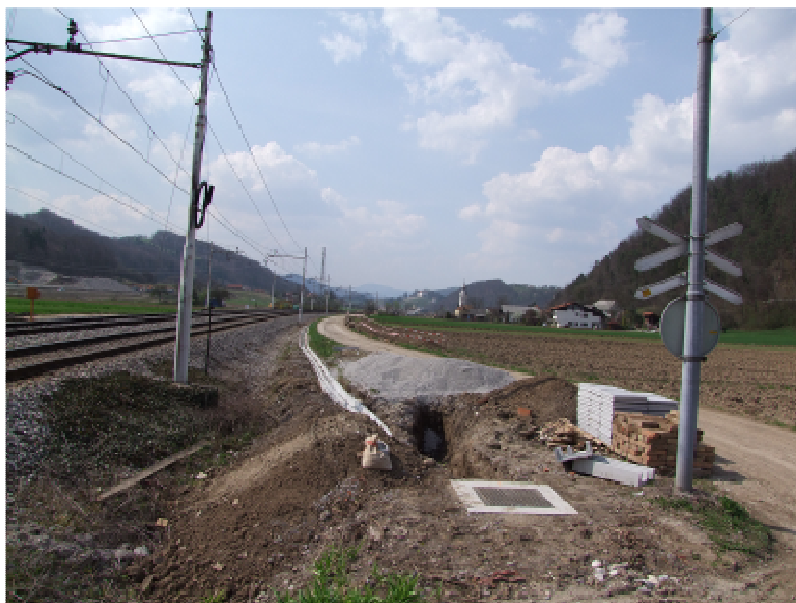
Weather conditions at the time of the accident: sunny, +21° C, good visibility. The sun did not reduce the visibility of the driver of the freight vehicle in the direction of Sevnica. From the level crossing at km 481+840 in the direction of Sevnica, the sighting distance is 370 m.

Ahead of the level crossing, there is a slight bend in the road running parallel to the railway line. The sighting distance of road users at the level crossing is 370 m for trains approaching from Sevnica and 399 m for trains from Blanca.

Figure 2: Visibility or view of the railway line from the level crossing in the direction of Sevnica

For the purposes of safety at the level crossing between Blanca and Sevnica stations at km 481+840, the maximum permitted speed of trains must be limited to 60km/h on the left-hand track from the direction of Sevnica for 370 m ahead of the crossing, and to 65 km/h on the right-hand track from the direction of Blanca for 400 m ahead of the crossing.

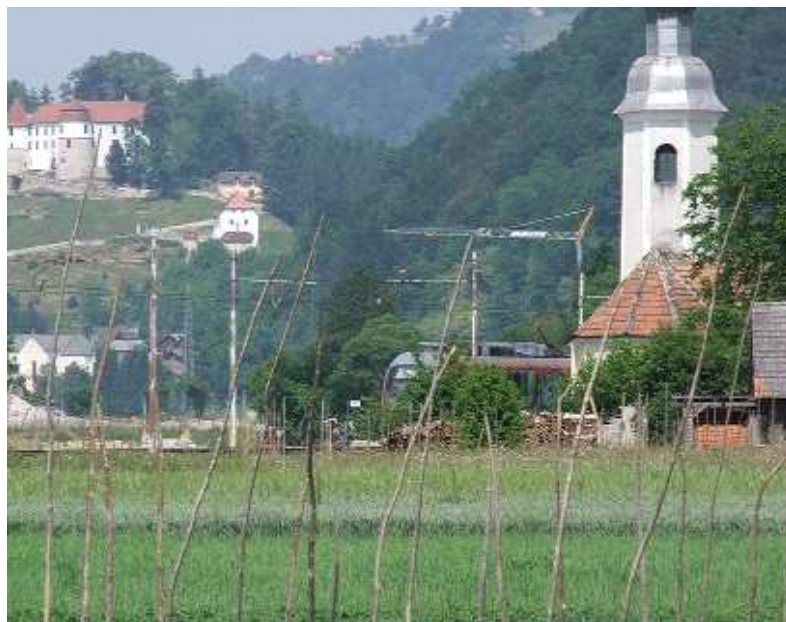
Figure 3: Train coming into a road user's view

It is possible that the driver while driving towards the level crossing observed the railway line in the direction of Sevnica and, since he did not see a train because the latter was at that moment hidden behind the bend, believed that no train is coming from this direction. For this very reason, immediately ahead of the level crossing he probably focused on checking for trains in the direction of Blanca. At the moment he entered the danger zone of the level crossing, he suddenly saw the train approaching on his left along the left-hand track.

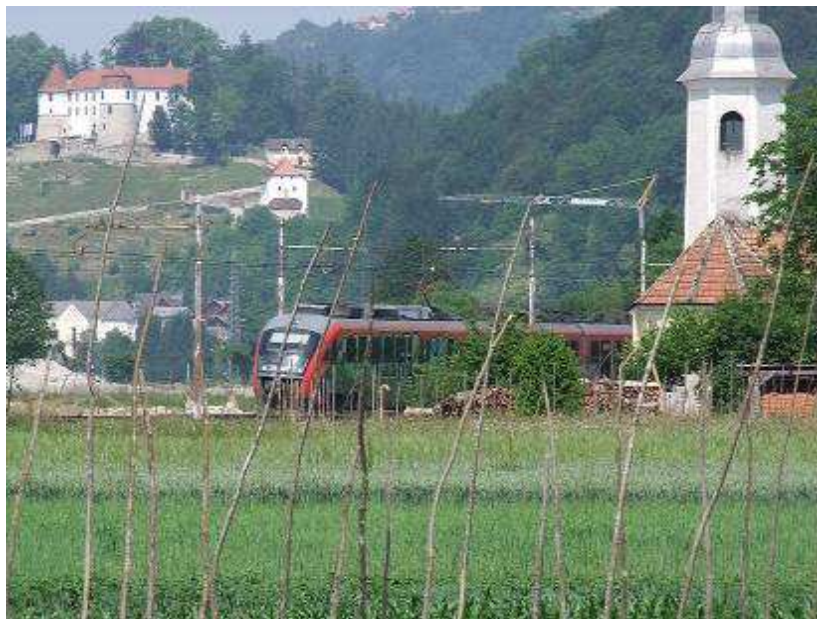
It is of utmost importance to provide road users at constructed level crossings marked by road signs with sufficient time to cross the railway line safely. All the individual units of time needed for safe crossing of a railway line must be included into this time frame. Sufficient time must be available to make sure that the left- and right-hand tracks are free. The speed of vehicles on rails must be adjusted to the sighting distance or visibility.

Figure 4: Illustrates that at the start of the field of view road users cannot assess along which track the train is travelling
