ROMANIAN RAILWAY INVESTIGATING BODY

INVESTIGATING REPORT

on the railway accident
between the railway stations Lehliu - Sărulești,
km. 66+100, on 17.10.2009

Final edition
23.02.2010

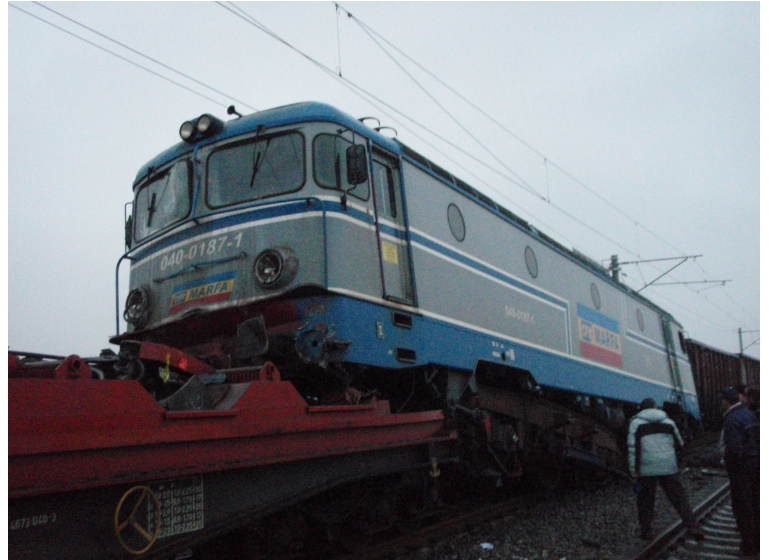
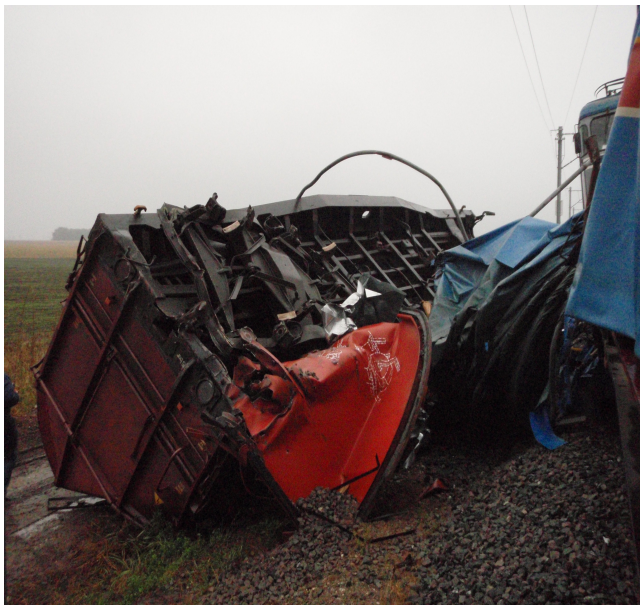
- the locomotive EA 040-187-1 (being hauled by the train no. 93400) with all axle derailed, with the driver cab II climbed on the under-frame of the wagon no. 31534673040-3 (the last but one from the composition of the train no. 93402) with active pantograph completely broken, the bogies, the buffing and coupling gears, brake rigging as well as the suspension affected;

- the wagon no. 31534673034-6, the last in the composition of the train no. 93402, derailed and overturned on the right side in the traffic direction, and its axles and bogies caught under the locomotive EA 040-0187-1;

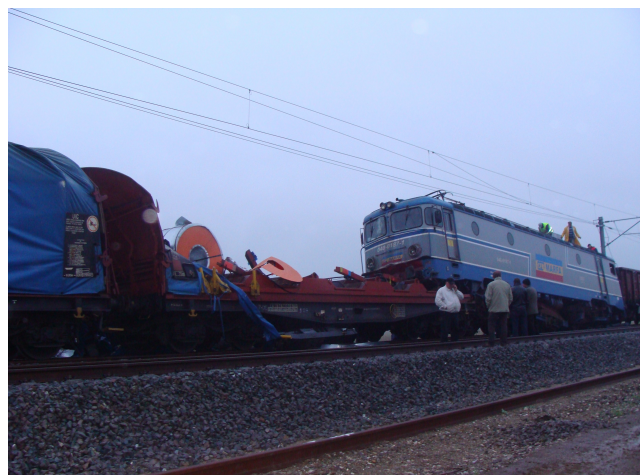
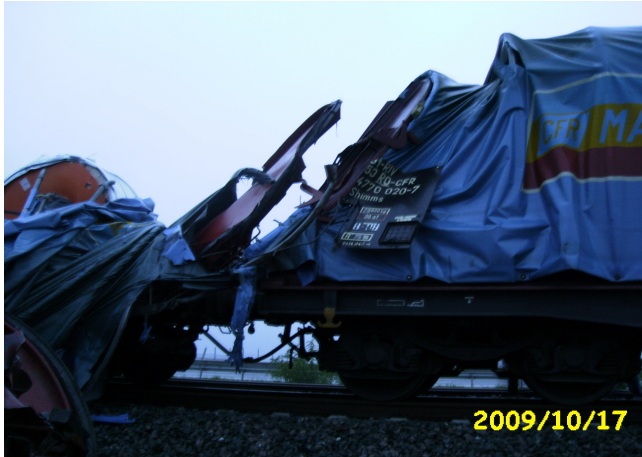
- the wagon no. 31534673040-3, last but one from the composition of the train no. 93402, with the tarpaulin, the tarpaulin fastening system and end walls seriously damaged;

- the wagon no. 31534770020-7, the third from the end of the train no. 93402 with the buffers and the end wall from the rear of the train damaged;

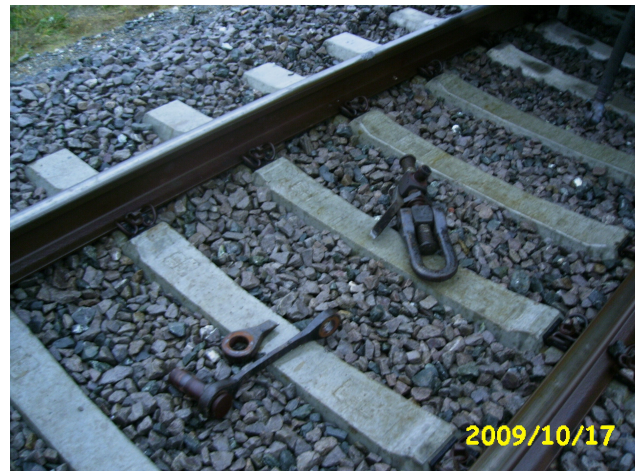
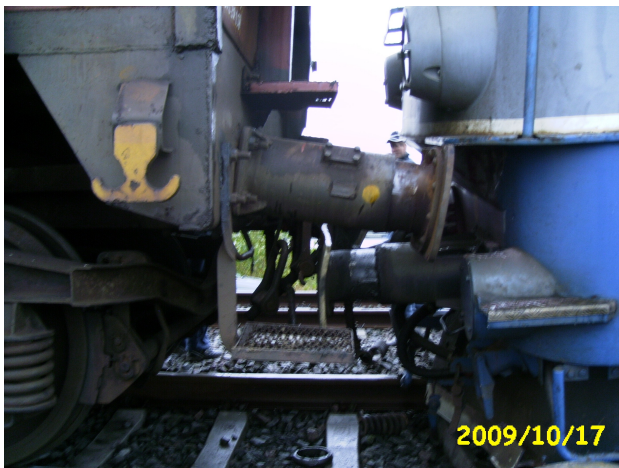
- the coupling of the wagon no. 31534673063-5, being the 9th from the rear of the train no. 93402, that ensured the coupling between this wagon and the wagon no. 31534673019-7 (the 8th from the rear of the train) was broken, end the general air pipe of the train was interrupted between these two wagons;

- the wagon no. 31535483285-1 the first from the locomotive in the composition of the train no. 93400 had the buffers from the locomotive damaged and the head bar bent.
