MINISTRY OF TRANSPORTS AND INFRASTRUCTURE
ROMANIAN RAILWAY AUTHORITY - AFER

ROMANIAN RAILWAY INVESTIGATING BODY

INVESTIGATING REPORT

on the derailments of the electric multiple units type Z 6100
occurred between the 25th and 26th of January 2010

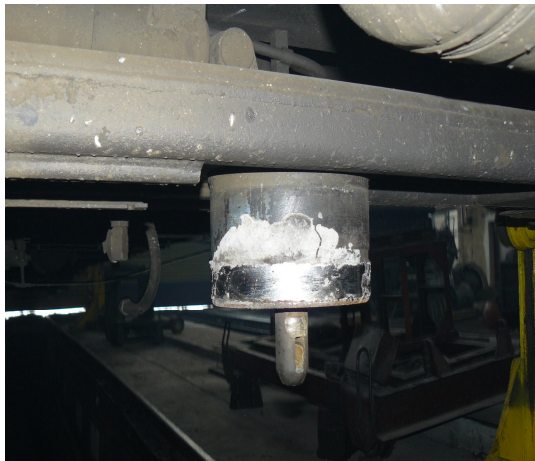
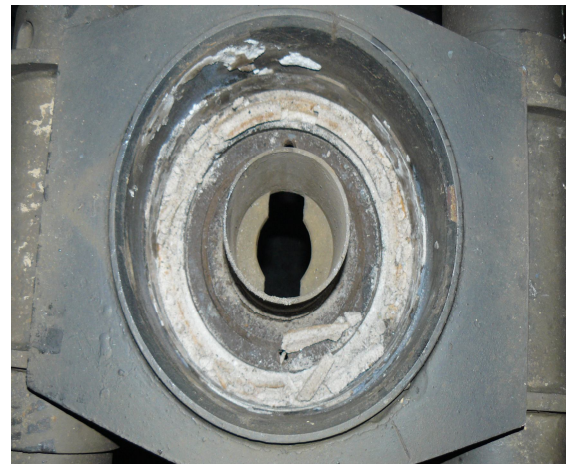
Central pivot and the bogie bearing of the pivot

in the operation area it is found out metallic luster, following the friction with the pivot bearing;

- one found out ice on the existing friction areas, between the outside surface of the pivot centre jacket and the inside surface of the bogie bearing;
- one found out pressed snow and ice between the outside surface of the pivot centre jacket and the inside surface of the bogie bearing, in the area with constructive clearance, above the friction area between the outside surface of the pivot jacket and the inside surface of the bogie bearing;
- one found out pressed snow and ice inside the bogie bearing;

- no lubrication traces were found out.

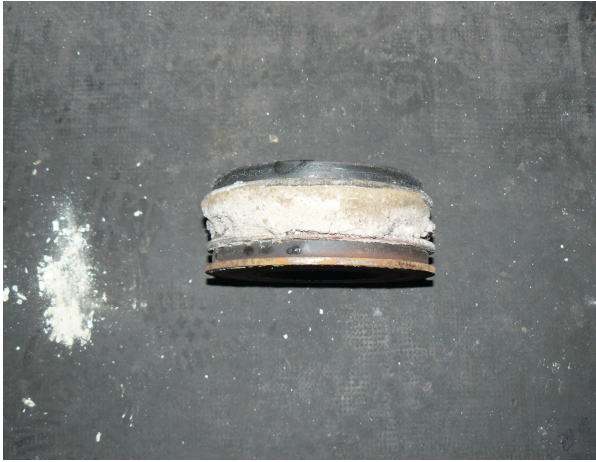
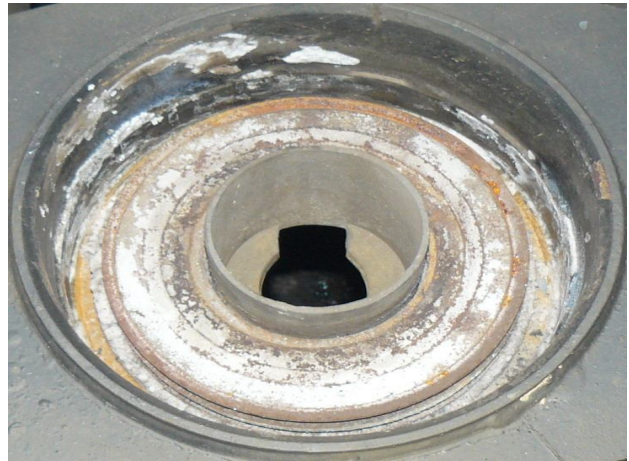
Metalastic parts existing between the pivot jacket and the bogie bearing of the pivot (placed inside the bogie bearing)

- there were pressed snow and ice on the outside lateral surface of the inferior metalastic part (existing inside the bogie bearing);
- one found out rust traces in the pressed snow and ice, resulted from the contact between the pressed snow and ice with the inside lateral metallic surface of the pivot centre jacket;
- there were snow and ice on the superior surface of the outside metallic part of the inferior metalastic;
- metallic plates of the lower metallic part have rust traces.

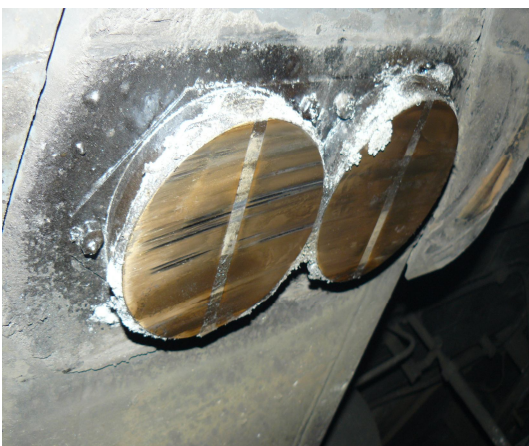
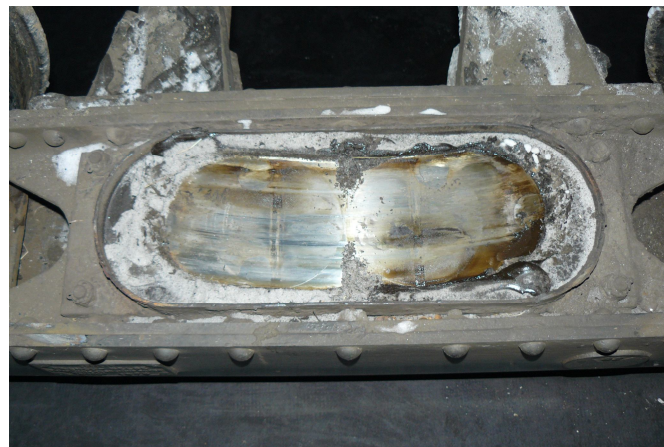
Upper shoes for support of the body on the bogie and the lateral guides

- On the operation parts of the upper shoes there were snow and ice
- On the contact surfaces of the upper shoes there were lubrication irregular traces,

- In the cross oil grooves stipulated in the median area of the shoes there was a mixture of lubricant, pressed snow and ice;
- In the lower sliding trays, in the areas limited by the lateral edges and the working longitudinal – axial limits of upper shoes, there were snow and ice mixed with lubricant;
- On the friction metallic layer of the contact surfaces both at the upper shoes and at the lower trays are presented in the thermic influence area.

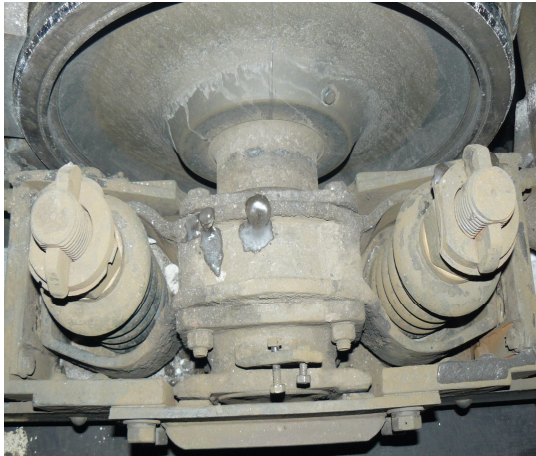
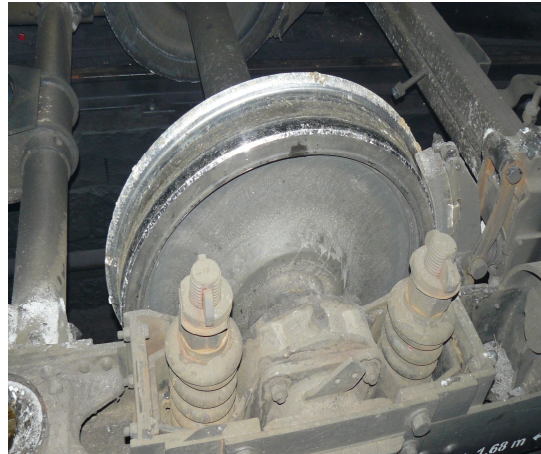
Primary suspension

- The primary suspensions had no parts missing, out of shape or broken and inside it had snow;
- There were no traces of lubrication of the friction areas between the axle boxes and the vertical guides of the bogie sidebars;

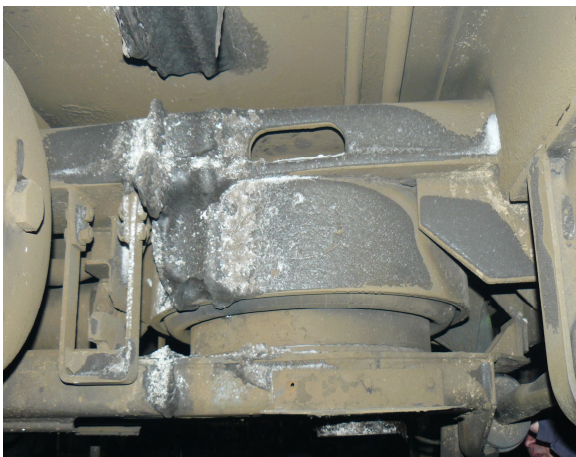
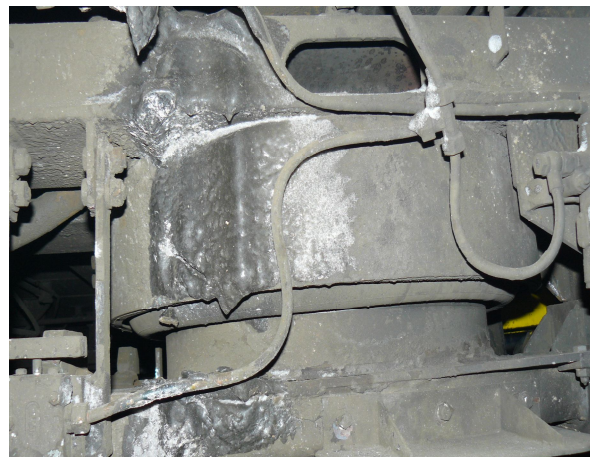
Secondary air suspension

- The air suspension parts of the derailed bogie had no distortion, degradation or breakage of the rubber parts;
- On the outside metallic reinforcements of the pneumatic air suspension parts there were very dense and adherent ice at the lateral side (situated to the wagon centre);
- The ice on the lateral surfaces of the outside metallic reinforcement extended also above the active rubber parts of the bellows;

- On the active rubber parts of the bellows there were ice traces, but one could not evidence possible friction traces between the ice from the rubber parts and the inside metallic reinforcements;
- On the active rubber parts of the bellows one did not find out traces of wears resulted by their distortion following the vertically – axially or horizontally – transversally friction with the inside metallic reinforcements.

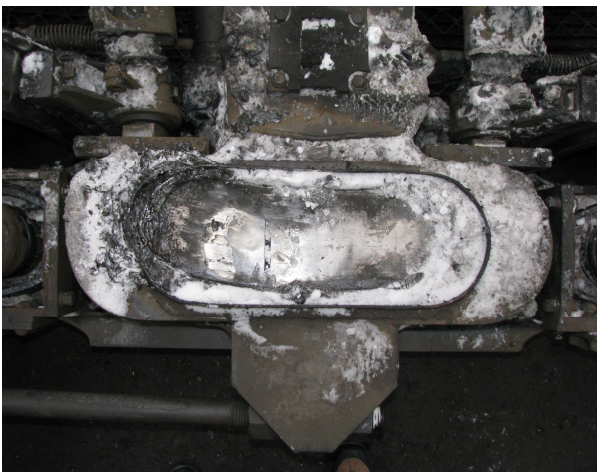
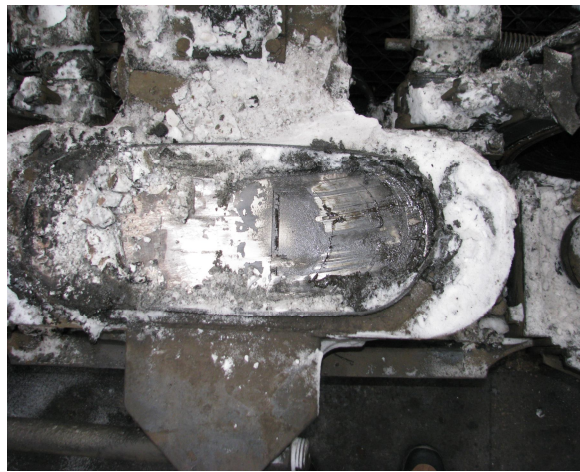
Lateral guides from the bogie no. 6

- In the sliding tray one found out a mixture from ice and solidified lubricant, accumulated in the front of the box, related to the running direction;
- One found out ice mixed with solidified lubricant between the edge of the sliding tray and the operation parts of the upper shoes (breadth of about 90 mm, representing about 20% from the length of the sliding tray);
- On some areas of the operation part of the sliding tray one can notice metallic luster following the dry friction.

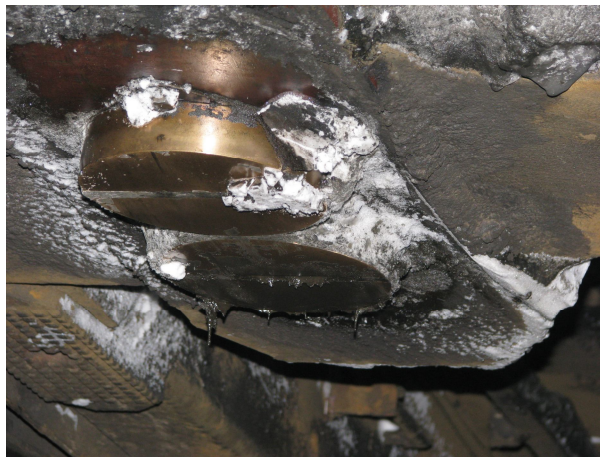
Upper shoes of the wagon body on the bogie no. 6

- One found out pressed snow and ice mixed with solidified grease, both between the both shoes and on the lateral side of the shoes (to the centre of the wagon body)
- One found out pressed snow on the operation parts of the shoes;
- On the contact surfaces of the upper shoes there were irregular lubricant traces;
- In the cross lubrication grooves in the median area of the shoes there was a mixture of lubricant, pressed snow and ice;

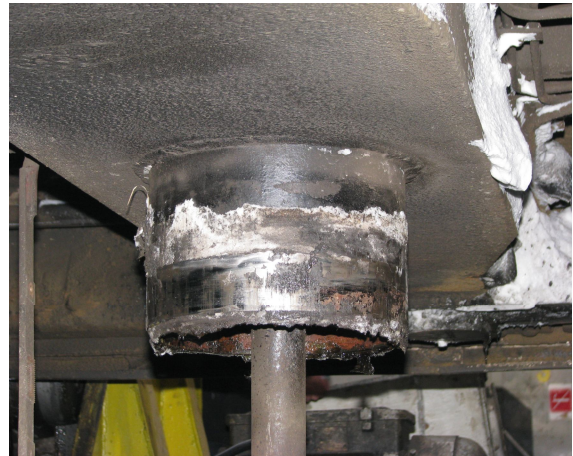
Central pin of the bogie no. 6

- On the operation part of the outside surface of the pivot centre is observed metallic luster following the friction with the pivot bearing;
- One found out ice mixed with lubricant on the friction areas on the outside surface of the pivot centre jacket;
- One found out pressed snow and ice on the outside surface of the pivot centre bearing, in the area with constructive clearance between the outside surface of the pivot jacket and the inside surface of the bogie bearing (above the friction area between the outside surface of the pivot jacket and the inside of the bogie bearing);
- One found out pressed snow and ice under the area between the outside surface of the pivot centre jacket and the inside surface of the bogie bearing.

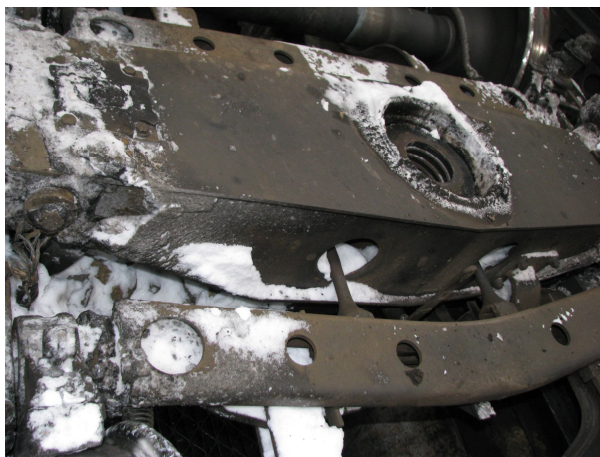
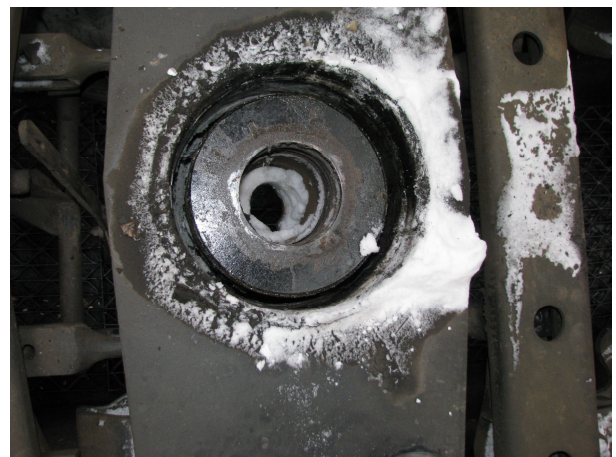
Pivot bearing of the bogie no. 6

- One found out pressed snow and ice both on the inside surface of the bogie bearing and on the metalastic elements.

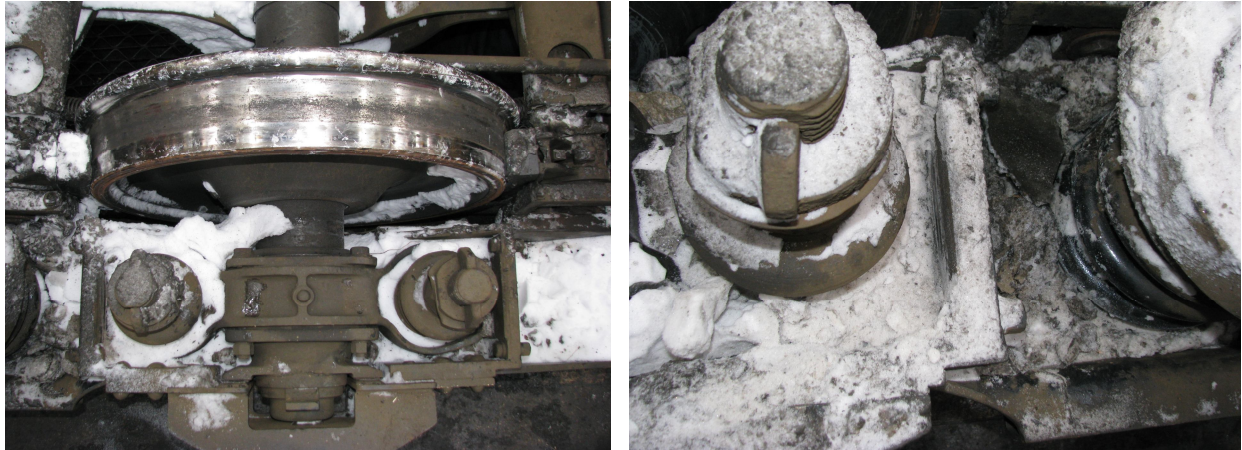
The primary suspension of the bogie no. 6

- One found out ice on the bogie sidebar (leading to the disappearance of the longitudinal clearance of the axle boxes);

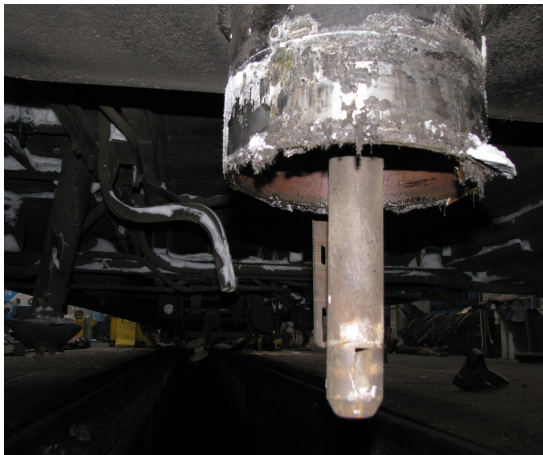
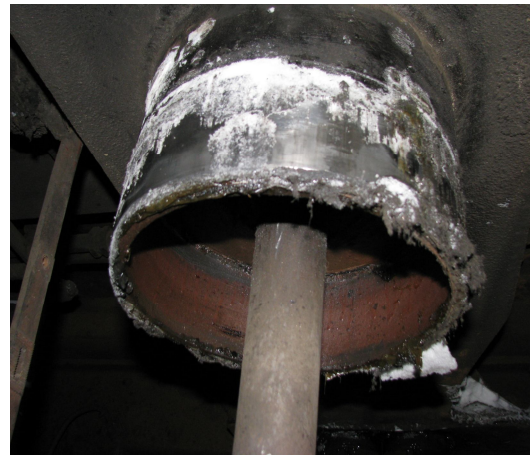
Central pivot of the bogie no. 5

operation part of the outside surface of the pivot axis jacket are found out metallic luster areas following the friction with the pivot bearing;

- One found out ice mixed with lubricant on the friction areas on the outside surface of the pivot centre jacket;
- One found out pressed snow and ice on the outside surface of the pivot centre jacket, in the area with constructive clearance between the outside surface of the pivot jacket and the inside surface of the bogie bearing (above the friction area between the outside surface of the pivot jacket and the inside of the bogie bearing);
- One found out pressed snow and ice under the area between the outside surface of the pivot centre jacket and the inside surface of the bogie bearing.

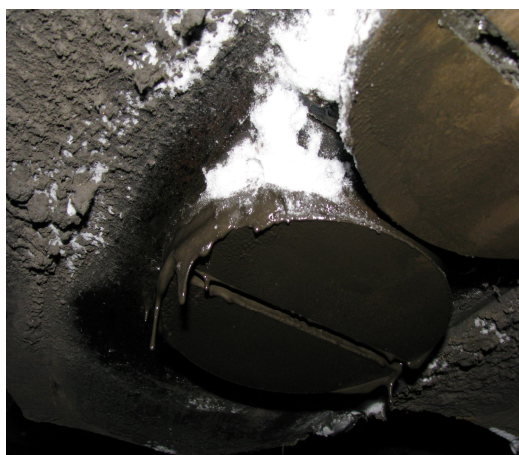
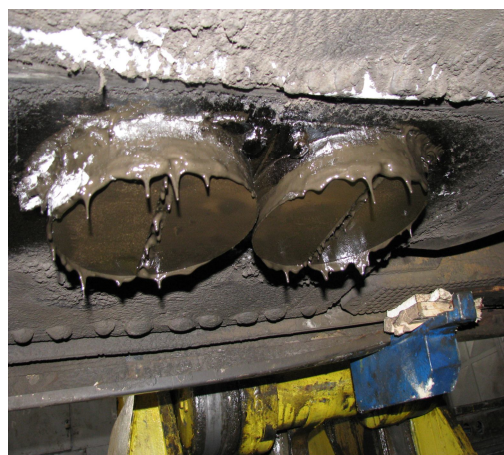
Upper shoes of the wagon body on the bogie no. 5

contact surfaces of the upper shoes there is lubricant;

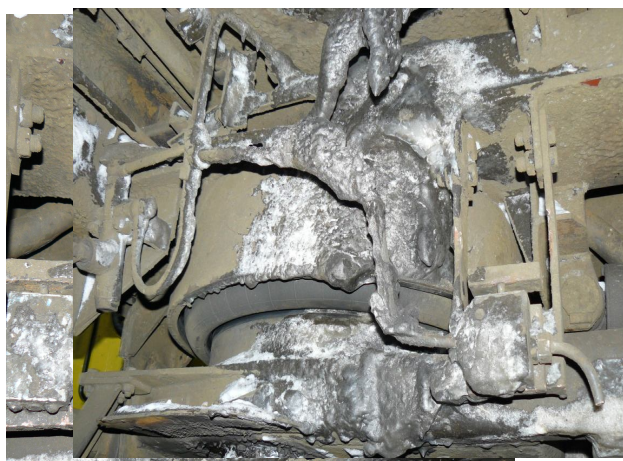
Secondary pneumatic suspension

The air suspension parts of the derailed bogie had no distortion, degradation or breakage of the rubber parts;

On the outside metallic reinforcements of the pneumatic air suspension parts there were very dense and adherent ice at the lateral sides (situated to the axle of the wagon);

- On the active rubber parts of the bellows there were ice traces, but one could not evidence possible friction traces between the ice from the rubber parts and the inside metallic reinforcements;
- On the active rubber parts of the bellows one did not find out traces of wears resulted by their distortion following the vertically – axially or horizontally – transversally friction with the inside metallic reinforcements.

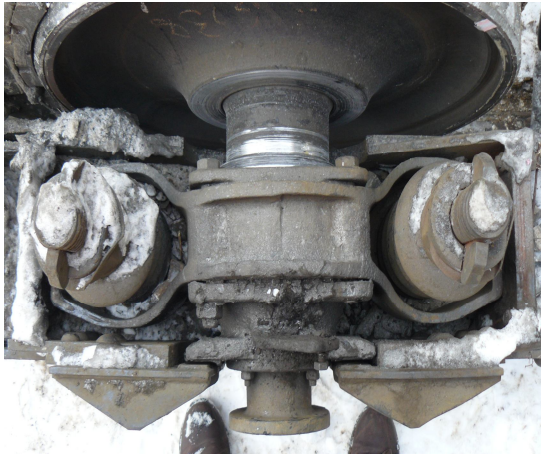
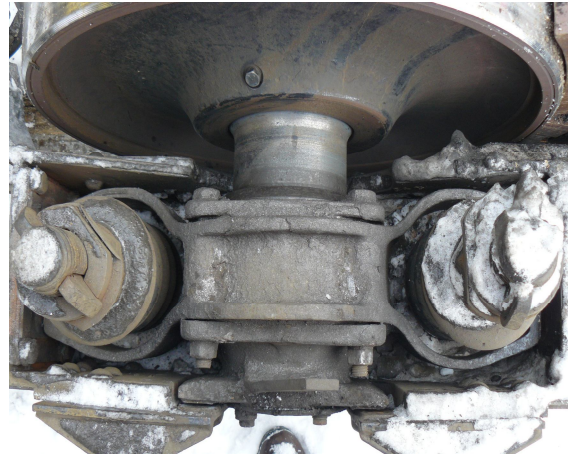
Primary pneumatic suspension

primary suspensions had no parts missing, out of shape or broken and inside it had pressed snow and ice;

- There were no traces of lubrication of the friction areas between the axle boxes and the vertical guides of the bogie sidebars;
- The friction traces existing on the axle journal of the first wheel are due to a stone entered at the derailment between it and the bogie frame.

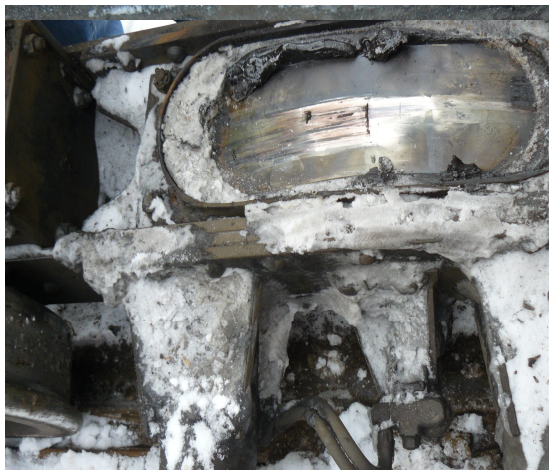
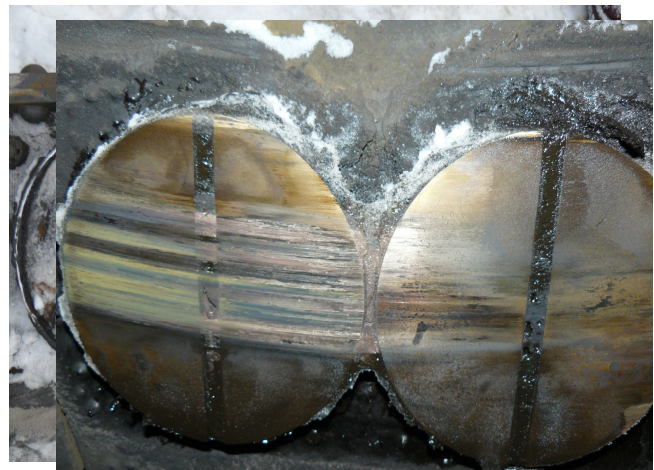
Upper shoes of the body on the bogie and the lateral guides from the bogie

- On the operation parts of the upper shoes there were snow and ice;
- On the contact surfaces of the upper surfaces there were irregular lubricant traces;
- In the cross oil grooves stipulated in the median area of the shoes there was a mixture of lubricant, pressed snow and ice;
- In the lower sliding trays, in the areas limited by the lateral edges and the working longitudinal – axial limits of upper shoes, there were snow and ice mixed with lubricant;
- On the friction metallic layer of the contact surfaces both at the upper shoes and at the lower trays are presented in the thermal influence area.

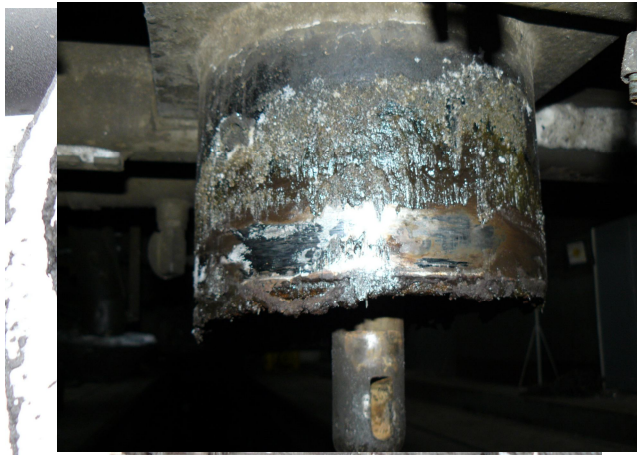
Central pivot and the bogie bearing of the pivot

On the operation part of the outside surface of the pivot centre jacket are found out metallic luster areas following the friction with the pivot bearing;

One found out ice mixed with lubricant on the friction areas on the outside surface of the pivot centre jacket;

- One found out pressed snow and ice on the outside surface of the pivot centre jacket, in the area with constructive clearance between the outside surface of the pivot jacket and the inside surface of the bogie bearing (above the friction area between the outside surface of the pivot jacket and the inside of the bogie bearing);
- One found out pressed snow and ice under the area between the outside surface of the pivot centre jacket and the inside surface of the bogie bearing.
