NOTE

on the fall of 4 brake shoes and their keys from the wagon no.31817853504-7, being the 14th one within the freight train no.70926, these parts leading to the derailment of both axles of the first bogie (in the running direction)

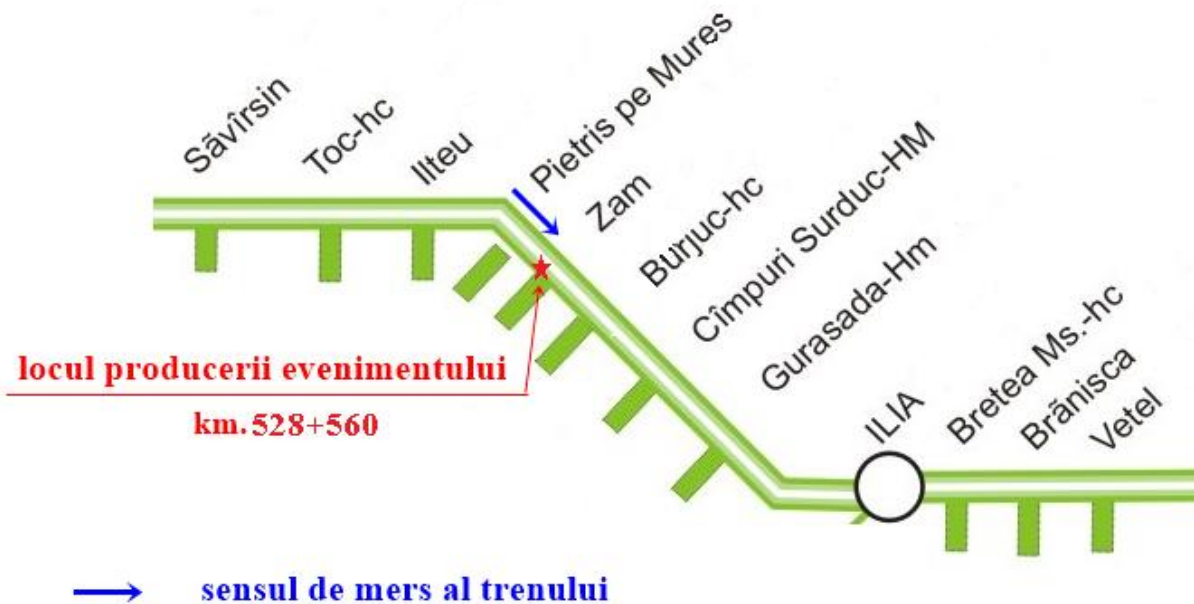
Drawing no.1 – incident site

On the **11th November 2018**, at about 11:10 o'clock, in the **railway county Timișoara**, interoperable track section Deva - Radna, electrified double-track line, on the track II, between the railway stations Ilteu and Zam, km 528+560 (*drawing no.1*), in the running of the freight train no.70926, got by the railway undertaking MMV Rail România, the first bogie, in the train running direction, (axles 3 and 4) from the wagon no.31817853504-7 derailed, following the fall of 4 brake shoe and their keys.

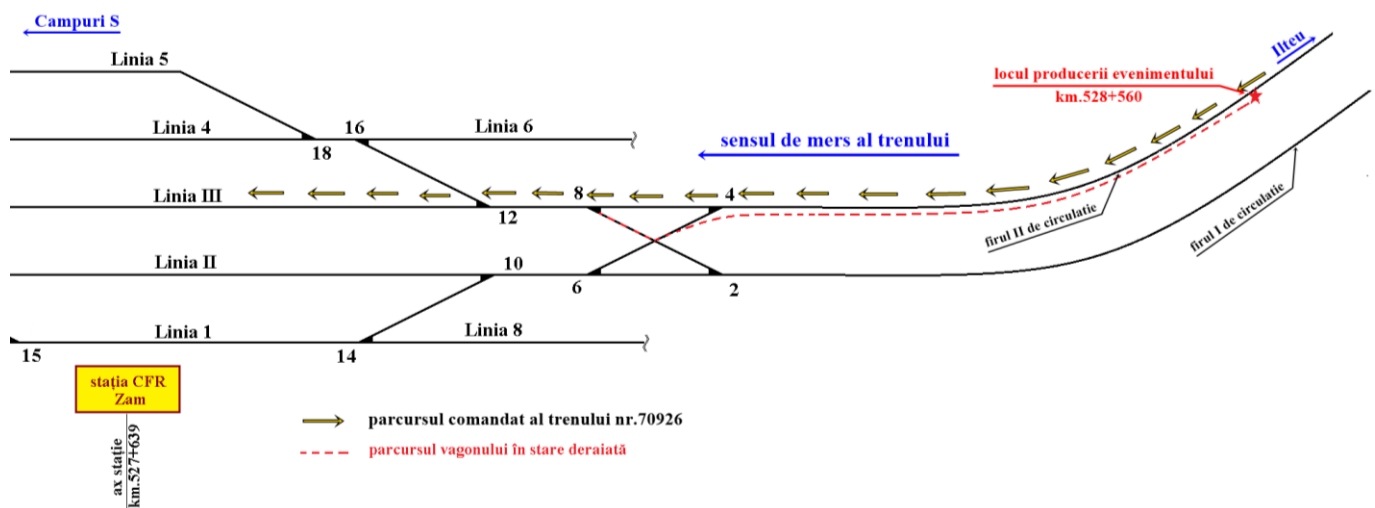
Drawing no.2 – route of the derailed train

The findings at the train showed that the axles from the first bogie in the train running direction (axles 3 and 4) from the 14th wagon after the locomotive (no.31817853504-7), derailed at km.528+560, between Iteu and Zam railway stations, on a curve, with right deviation. From this point, on 660 m, one could see traces of wheel running on the track bed (*drawing no.2*).

The wagon with the first bogie derailed ran in this condition on about 660 m (*drawing no.2*), then the left wheels hit and climbed the double frog of the cross-over 2-4-6-8 (situated to the running line), running then on the track bed (on the centre of the cross-over rhomb), and at the double frog (situated to the centre of the railway station) came on the rails of the diverging track of the switch no.8. The right wheels of the derailed bogie ran on the track bed, and at the double frog they climbed on the right rail (in the running direction) of the diverging tracks of the switch no.8. The wagon with the first bogie derailed stopped with the first axle at 2,5 m from the point rail tip of the switch no.8. Following the derailment dynamic, the switch no.8 has changed the position by the derailed axles.

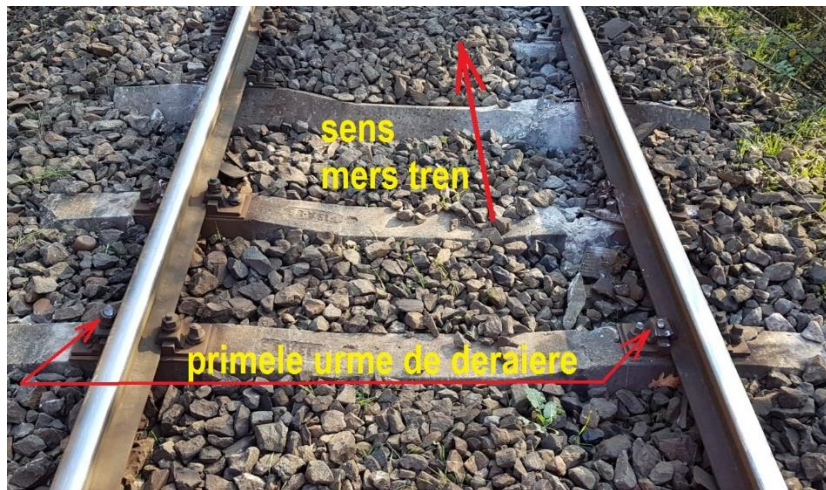
Photo no.1

Analysing the traces left by the derailed wheels, one can state that the both axles of the bogie derailed on the same cross track section (*photo no.1*), falling with the wheels on the vertical screws of the system for the fastening of the rails on sleepers. The left wheels, having like reference the train running direction, (that ran on the exterior rail of the curve), fell outside the track, and the right wheels inside the track. There were not identified traces of rail climbing, only traces of left wheel coming down on the field face of the left rail, in the train running direction (on 10 cm), and (on the same track section), traces of the right wheel coming down on the field side of the right rail, in the train running direction.

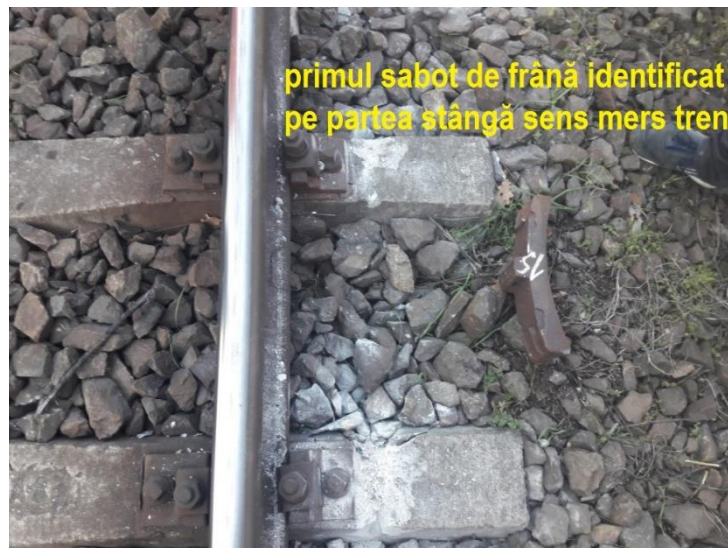
Foto nr.2

During the checking on site, on the area affected by the derailment, one found four brake shoes and their keys. Two of them were found at 8,5m (on the same track section) against the derailment point (one outside the left rail - *photo no.2* – and another one outside the right rail), and their keys at 10,3 m, respectively 14,10 m from them. The 3rd brake shoe was found at 15,60 m against the first two brake shoes fallen, and its key at 7,70 m from the brake shoe. The 4th brake shoe was found at 352 m against the derailment point, and its key at 1 m from it.

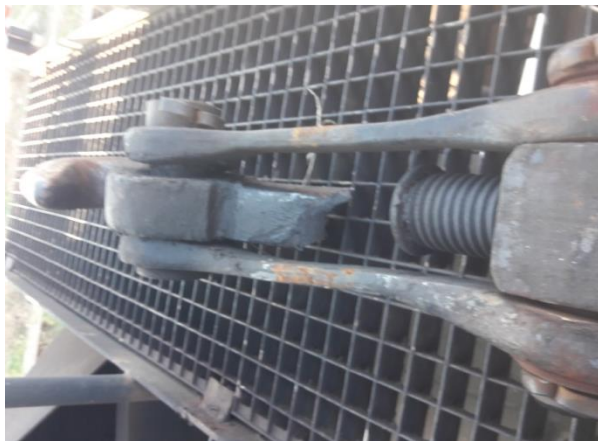
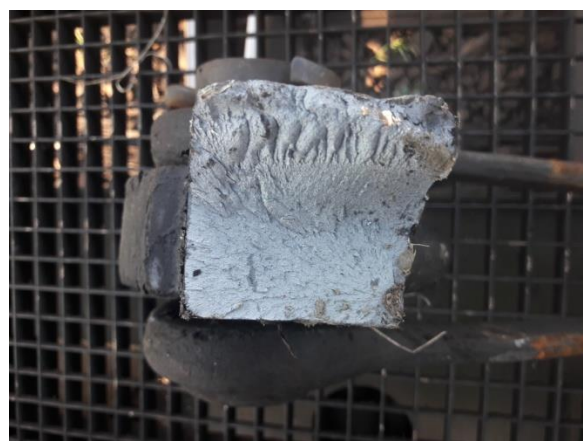
The 13th wagon after the locomotive, no.33607855466-8, at the end to the 14th wagon, had the bar of the draw hook broken (new breakage, with irregular forms) at about 20 mm from the hook (*photos no.3 and 4*), and the left buffer in the running direction with the screws for fastening in the headstock pulled, with up position.

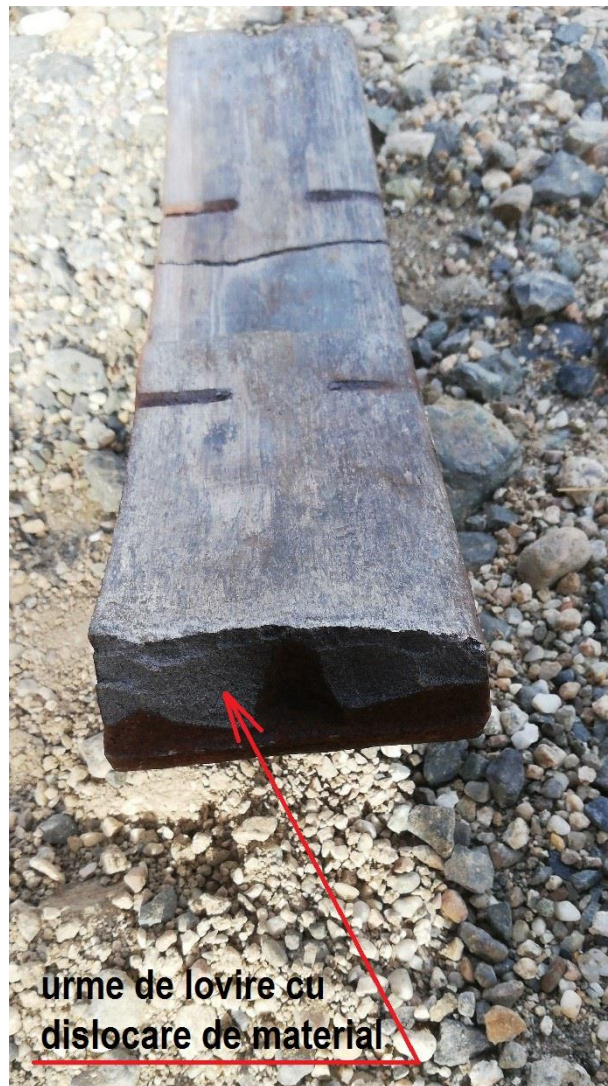
Photo no.5

One checked the left brake shoe, running direction (*photo no.5*), first brake shoe found after the derailment site, finding traces of mechanic hit on the brake shoe width, at one of its front parts, having material recently removed, from the working area of the brake shoe and two cross cracks (possible following the interposition of the brake shoe between the wheel and the running surface). Those three parts of the brake shoe (generated through breakage) were kept by the steel armature of the brake shoe.

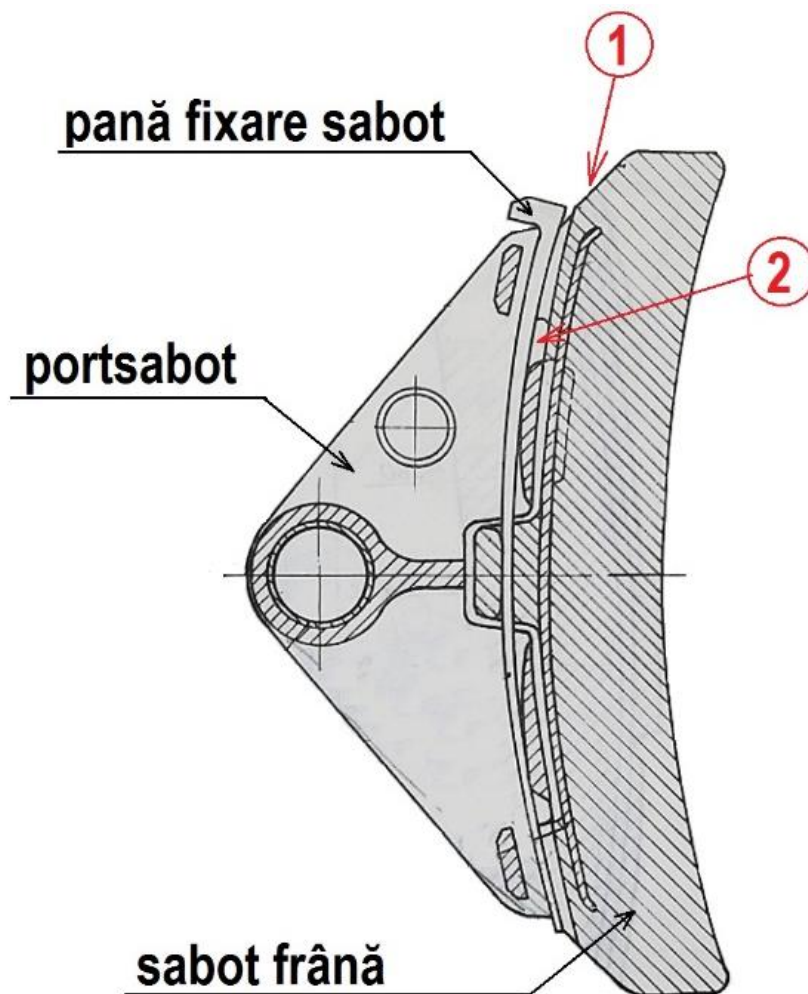
Drawing no.3 Remarks: points 1 and 2 – place for the introduction of the key for the dislocation of the brake shoe from the brake block holder.

- the key introduced in the brake block holder (without the brake shoe) could not fall following the size of its nose;
- taking into account that, after the site of brake shoe identification, fallen on site, one identified also their keys, one did many simulations for the establishment of the way of this fall, close to those two parts, was possible (brake shoe – key). Following these simulations one concluded that the only position that could lead to the simultaneous fall was that with the key introduced about 1/3 between the brake shoe and the brake block holder (*drawing no.3*). The explanation that the key could reach this position was just following the intervention of some persons nonidentified that, for their removal and the theft of the brake shoes, they took out the keys from normal position and tried their use like lever for the removal of the brake shoes from their heads. The try to remove the brake shoes, using this method, with success, supposed that the automatic brake be not applied, it being done short time before the train departure from the railway station, in this case, before the train start from the railway station Milova (last stop of the freight train no.70926, before the derailment of the train wagon no.33817853504-7).

Taking into account these mentioned, the investigation commission concludes that the derailment of the wagon no.33817853504-7 was generated by the fall of a brake shoe from the wagon, that falling interposed between the running surface of the wheel and the rail head. The fall of the brake shoe followed by the fall of its key happened through the intervention of some nonidentified persons, that during the stop of the freight train no.70926 in the railway station Milova, having the intention of stealing the brake shoes, they removed the keys, trying to use them for the dislocation of the brake shoes from their heads. The operation could not be ended because the automatic brake of the train during the stop is applied. This external intervention generated, after the release of the automatic brake of the train and the departure of the train from the railway station, in its running, the possibility of the fall of the brake shoes non-ensured, and implicitly of their keys, left between the brake shoes and their holders.
