## NOTE

*on the fall of 4 brake shoes and their keys from the wagon no.33530823236-2, the 20th wagon of the freight train no.30626-1, these parts generated the derailment of the second axle from the first bogie (in the running direction)*

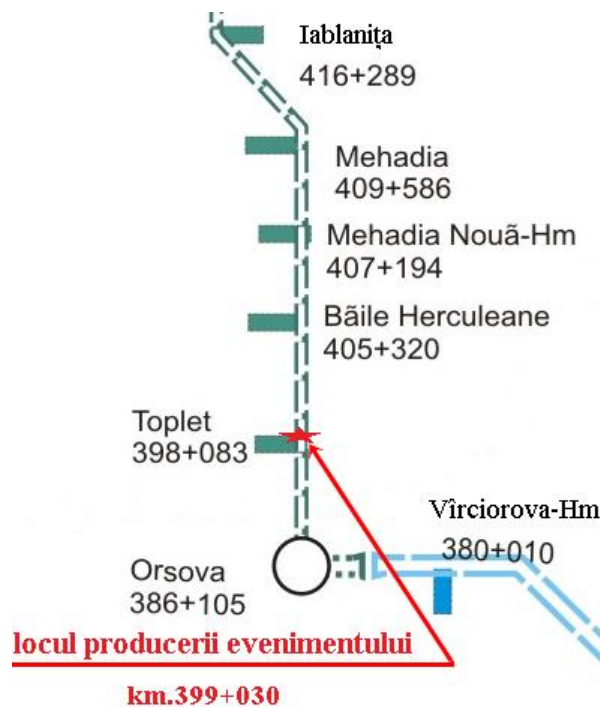
Picture no.1 – incident site

On the 25th October 2018, at about 11:30 o'clock, during the track inspection made in Topleț railway station, the ganger found hits on the ends of the vertical screws from the fastening system of the rails on the sleepers, starting with km 399+030, area of the connection rails on the switch no.2 and up to the level crossing from km 400+190, hits specific to the running of the derailed rolling stock (outside the left rail and between the rails, close to the right rail having as reference the km increase direction). Also,

close to the first derailment mark, one found at 0,8 m, respectively 3,5 m, a key of a brake shoe and a brake shoe from a wagon, on the left side of the line.

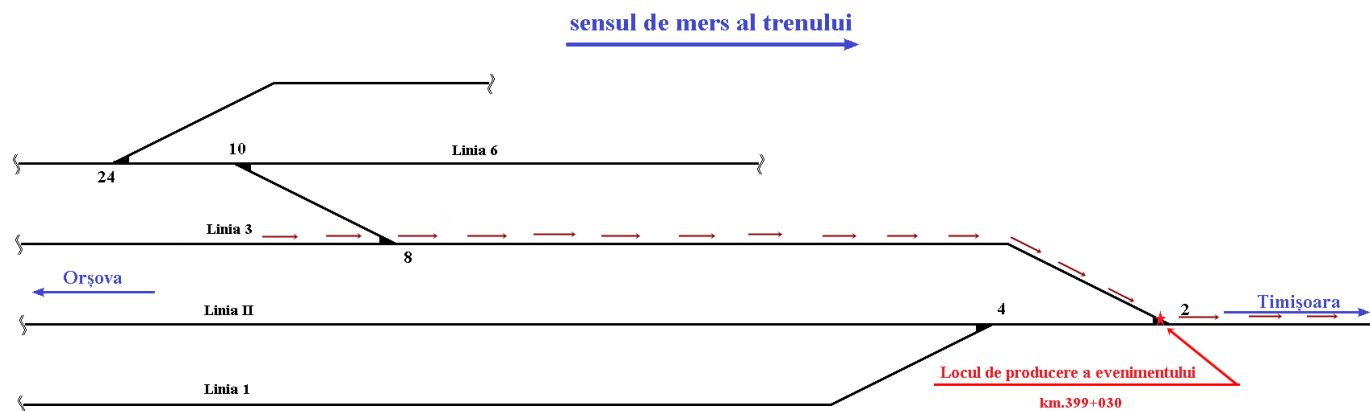
*Drawing no.2 – route of the freight train no.30626-1 in the railway station Topleț*

At 02:05 o'clock, the freight train no.30626-1 was dispatched from the line 3, railway station Topleț, having assured the exit route on the running line „deflecting one”, on the switch no.2, passed on trailing.

The first derailment mark was found at km.399+030, on the connection rails, on the deflecting section of the switch no.2, at 15 m from the tip joint of the switch. The derailment happened following the simultaneous fall of the wheels of the second axle, of the first bogie, in the running direction, from the 20th wagon of the train. The left wheel of the derailed axle fell outside the line and the right one inside the line. One did not identify marks of overclimbing of the rails, being visible only a mark left wheel running down on field side of the left rail, in the train running direction (on 9 cm), then one noticed (in the same track section), hits on the ends of the vertical screws of the fastening system of the rails on the sleepers, following the wheel fall.

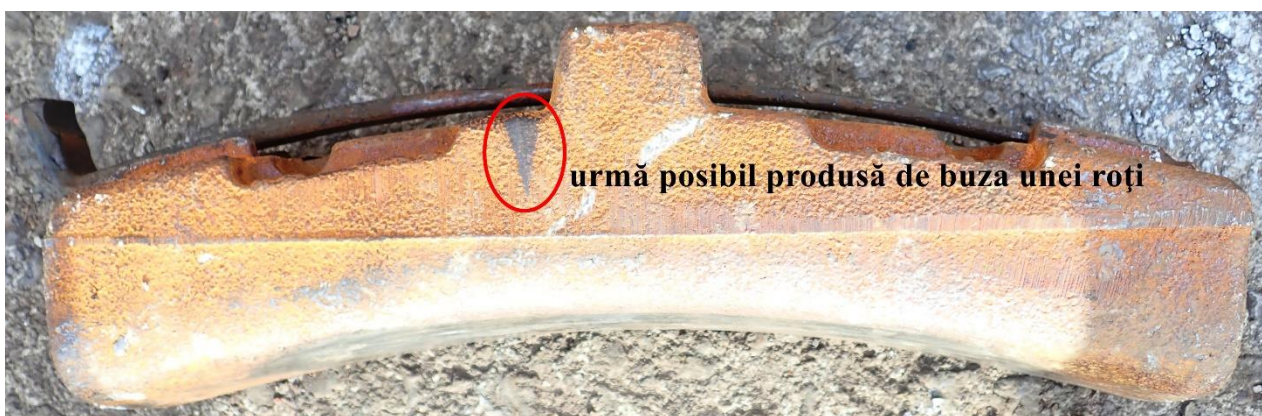
One checked the brake shoe found at the first derailment mark , being identified a series of new marks (metallic luster), as follows:

- on one of the lateral sides, starting from the edge up to close the central area, a mark possible generated by the flange of wheel;

*Picture no.1* – the brake shoe found at the first derailment mark

- on the site opposite the first presented mark, on one of the lateral edge, one identified a circular mark generated by hit;

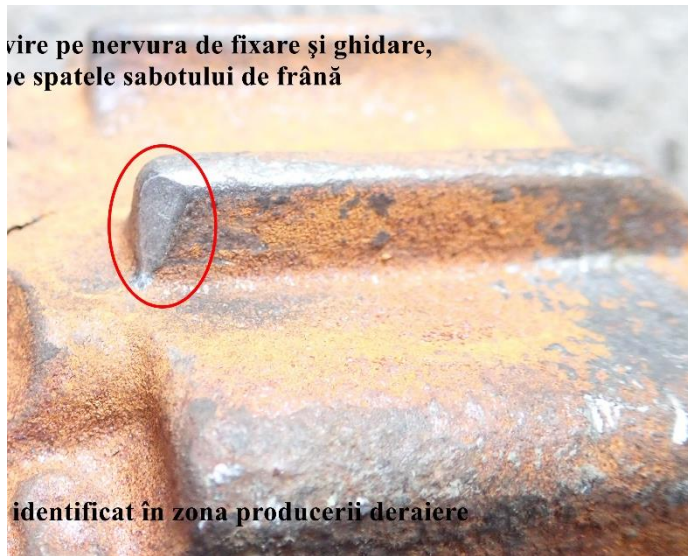
- at the lower part of one from the pins for the fastening and guiding of the key, from the back of the brake shoe, a mark of metallic luster, this mark having correspondence on the brake shoe holder of the wheel no.7 front (left side in the running direction).

Picture no.2 – mark of hit on the pin for fastening and guiding of the brake shoe identified at the derailment site

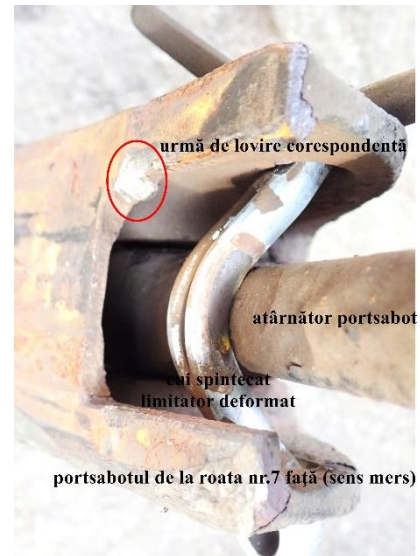
Foto nr.3 – hit mark on the brake shoe holder of the corresponding wheel nr. 7

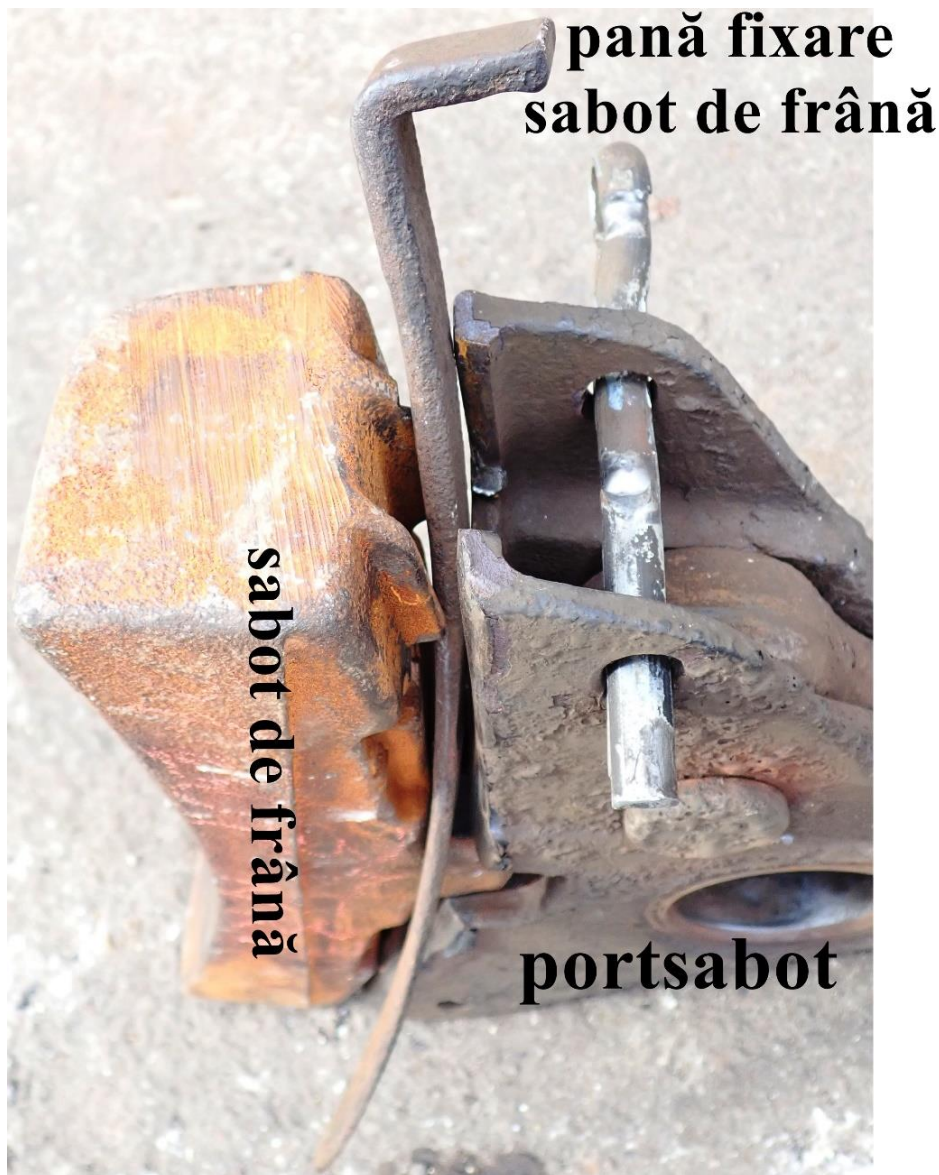
Taking into account that those three brake shoes identified on the field had close to them the keys, more simulations were made in order to identify the way this simultaneous fall was possible. Following these simulations, one concluded that the single possibility that could generate a simultaneous fall was that with the key put in the brake shoe and its holder, it helping the easier removal of the brake shoe from its holder, favouring the fall of the brake shoe.

The keys of the brake shoe holders could reach a such position only following the intervention of some non-identified persons which, for their removal, maybe for the theft of those brake shoes, they took out the keys from the normal position, trying their use like lever through their introduction between the brake shoe and their holder, in order to remove the brake shoes from their holders and the brake shoe dislocation. During these operations, when the train was stopped, the automatic brake was applied, the brake shoes being pressed between the running surfaces of the wheels and the brake shoe holders, so the brake shoes could not be removed, it being possible only after the release of the train automatic brake, this operation being performed before the train start from Topleț railway station .

*Picture no.4 – ensemble brake shoe – brake shoe holder  
having the key put between those two elements*
