MINISTRY OF TRANSPORTS AND INFRASTRUCTURE
ROMANIAN RAILWAY AUTHORITY - AFER

INVESTIGATING REPORT

of the serious railway accident

occurred on the 16th of October 2013, in the activity of the Branch of the CREIR Cluj, between the railway stations Monor Gledin and Rapa de Jos

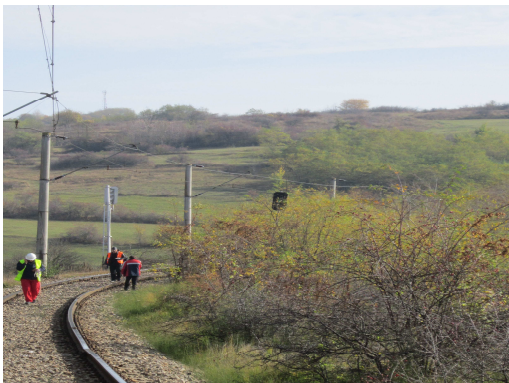
- in the area of the accident occurrence (km 33+003) the track is in curve with a radius of R=345 m;
- abundant vegetation on the track embankment, especially on the right side in the running direction, hindering the visibility of the signals;

The profile in length where the accident occurred is on an area with a declivity of 2‰ (ramp in the running direction of the train).

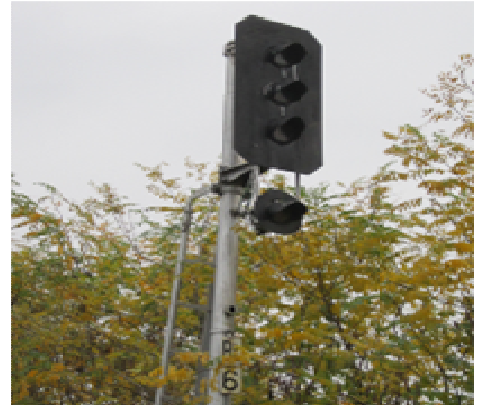
- BL6 signal was off;
- the bulbs red and back-up red were burned;
- the red fire was fed with 11 V tension;
- the yellow bulb was broken;
- the green bulb was intact;
- after the accident occurrence were no damages recorded at the SCB installations.

After the performed investigations immediately after the accident occurrence were found a series of irregularities at signal BL6, as follows:

- the BL 6 signal was off;
- the bulbs red and back-up red were blown;
- the yellow bulb was broken;
- after the derailment occurrence were none damages at the SCB installations.

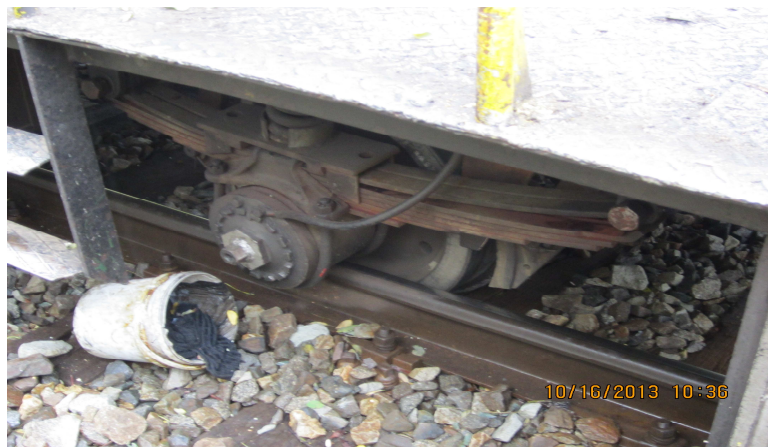
Photo no. 5: The derailed tower wagon DP 58

- the front left buffer was fallen;
- the front right buffer gear was damaged;
- the headstock was damaged;
- the front bogie solebar was deformed;
- the front protection hand rail was deformed;
- the front headlamp was broken;
- pantograph was moved and broken from welding;
- the suspension spring from the back had the main leaf broken;
- the diesel engine was moved;
- the driving belts from the compressor and ventilator were broken;
- the front windows were broken;
- journal cross from the gear box to the gearing-down device was torn from coupling;
- the rollers which assured the rotation of the platform were damaged;
- two guiding rollers from the tower were broken;
- the protection net of the tower was dislocated;
- the fastening system of the working bench from the back platform had the screws broken;
- the banks from the rear platform were broken from the fastening system.

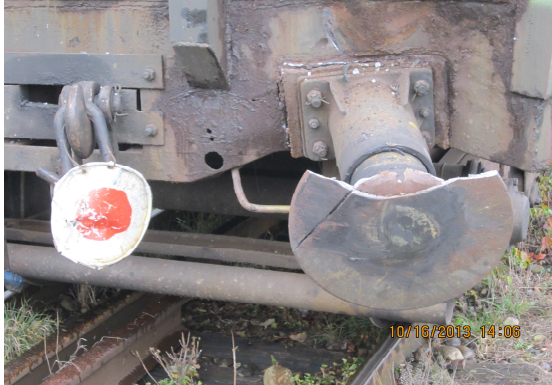
Damages at wagon no. 3535304679-0, the last from the freight train no.50473-2:

- the headstock was deformed in the buffers fixing area;
- approximatively a third from the buffer of the right side in the running direction was broken, the rupture being new.

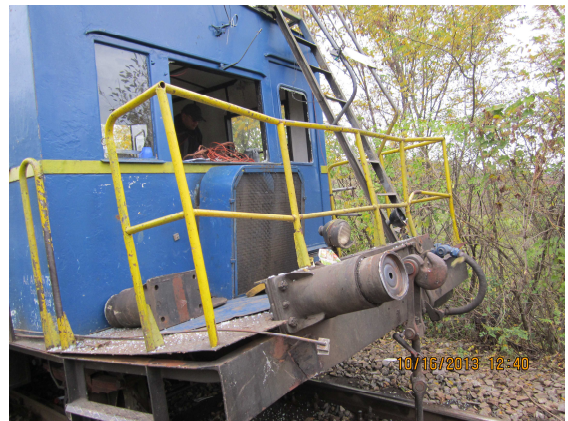
Damages at the tower wagon DP 58
