Final report RJ 2015:02e

Incident for collision between train 44660 and train 1859 in Bjuv, Skåne county, on 22 July 2014

File no. J-33/14

2015-06-30

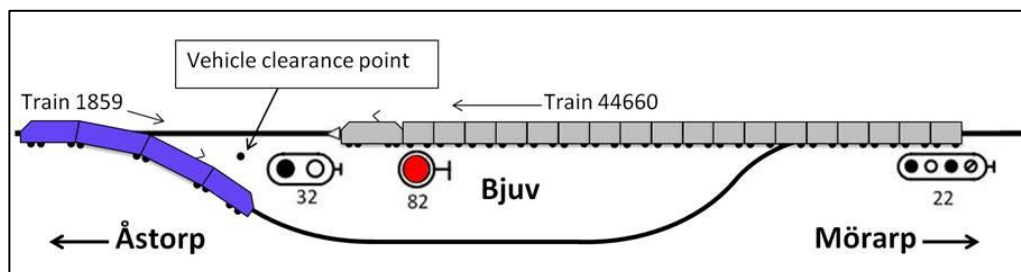
The train stopped with the engine approximately 40 metres beyond the route stop lantern 82, but without passing section signal, Bjuv 32. Shortly after the train had stopped, passenger train 1859 arrived at Bjuv and stopped at the platform to drop off and pick up passengers. The driver of the passenger train did not experience anything abnormal when entering Bjuv but thought, however, that the freight train was standing unusually far ahead when he passed the home signal. The total braking distance for train 44660 was approximately 2,000 metres, and if the freight train had continued for another 80 metres before stopping, it would have compromised the route for train 1895, and in unfavourable conditions a collision might have occurred between the two trains involved.

Figure 1. Schematic drawing of the approximate position of train 44660 when it came to stop after passing route stop lantern 82. Shortly thereafter train 1859 arrived to the platform at Bjuv station.

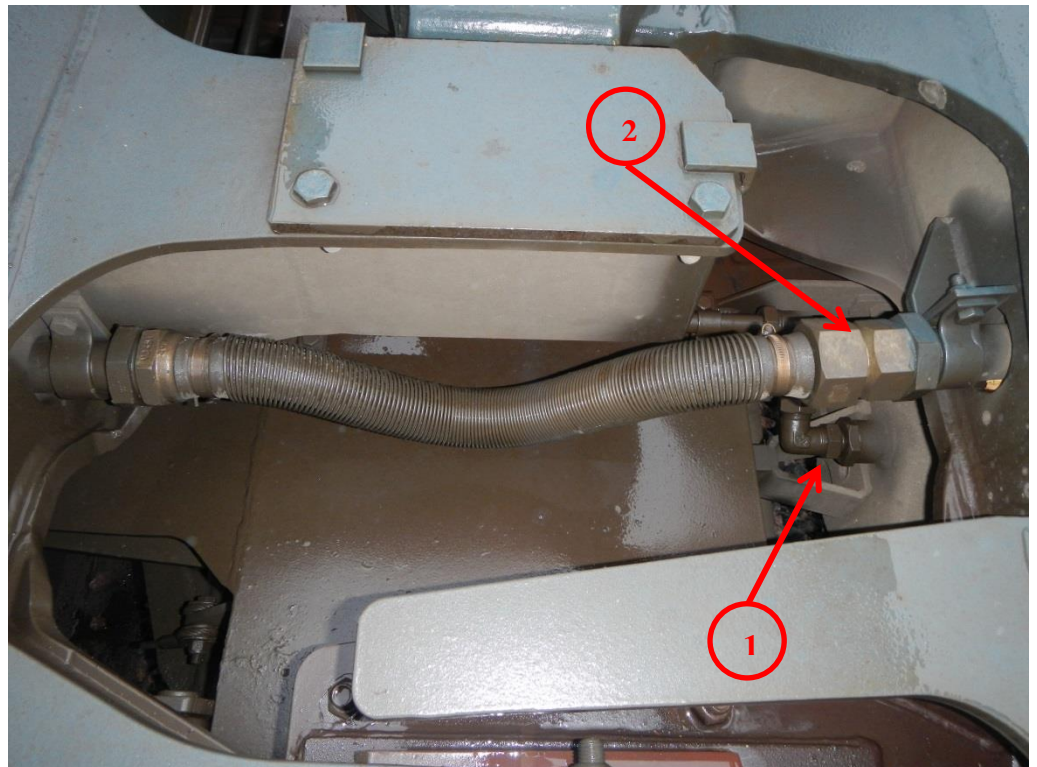
The mechanic connected air to the wagon to perform fault isolation and localised the leak to a coupling in the line to the middle bogie brake cylinder (arrow 1 in Figure 2). To obtain access in order to repair this, it was necessary to remove the hose (arrow 2 in Figure 2) that transfers the air between the two parts of the articulated wagon. As can be seen from Figure 2, it is otherwise difficult to access the coupling.

Figure 2. The wagon's middle bogie. (Not the actual wagon involved in the incident). In order to access the mounting at the brake cylinder (1), the mechanic had to take off the main line for the brake system (2).

The hose was removed in order to gain access to the pressure tube for the brake cylinder in the middle bogie in order to rectify an air leak in a pipe coupling. As can be seen from Figure 2, it is otherwise difficult to access the mounting. It is therefore understandable that the hose was removed. There were no specific instructions in NetRail's maintenance documentation regarding how the hose should be handled in this type of repair work.

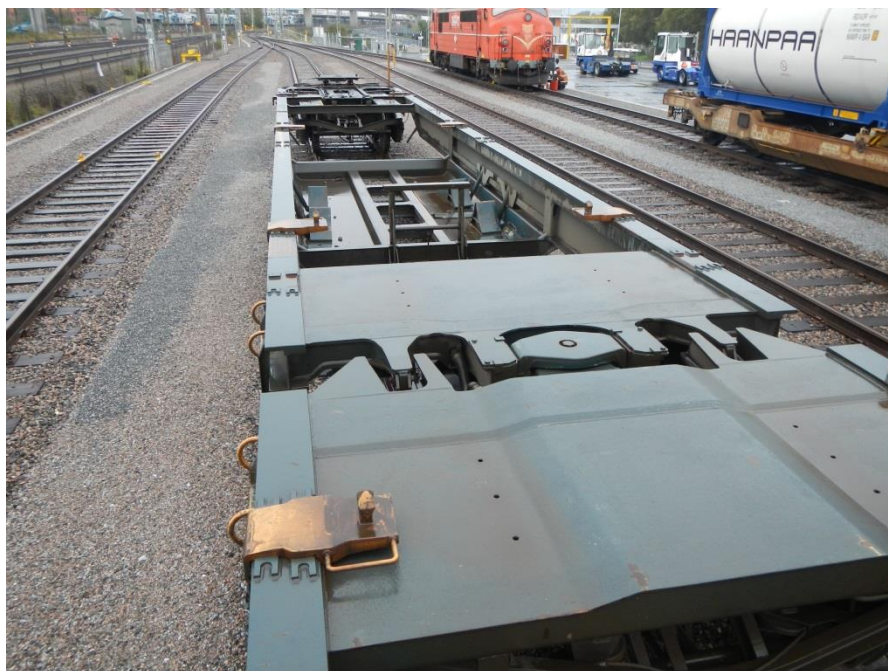
Figure 3. Sdggmrs wagon. The picture is taken from the wagon's middle bogie.

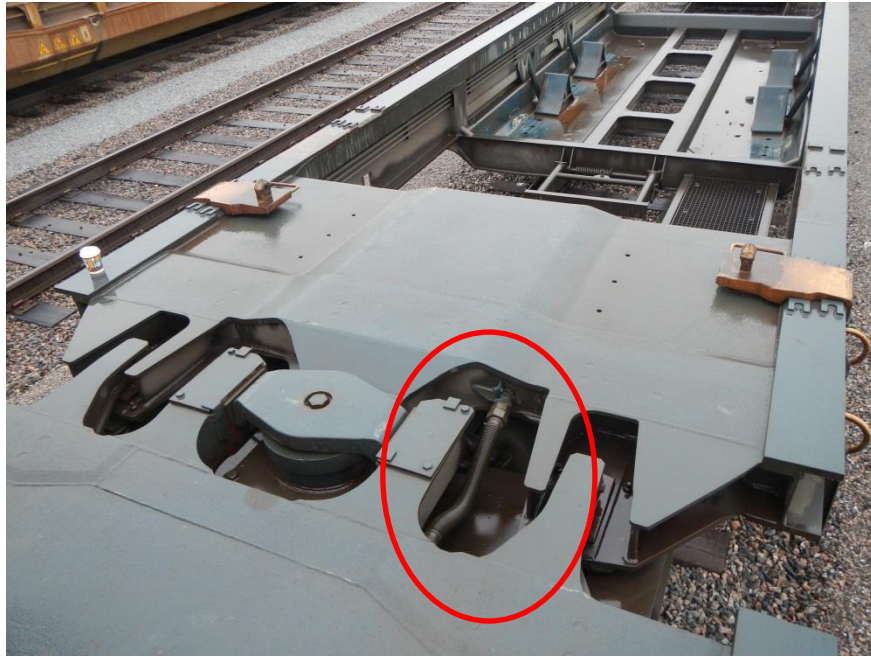
Figure 4. The red circle in the picture shows the hose in question over the middle bogie.

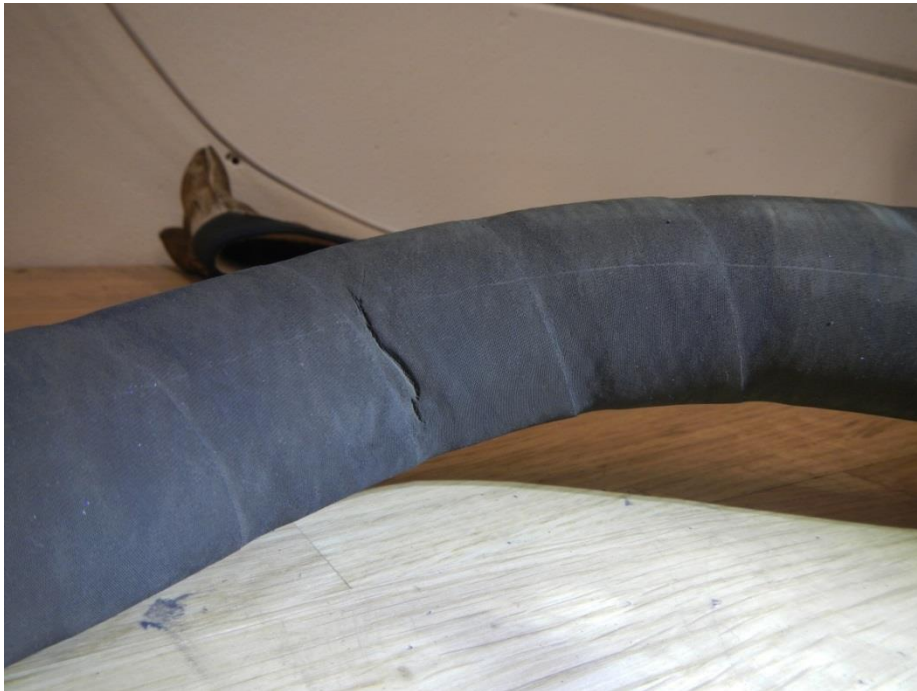
There is a crease on the surface of the hose material, at about the middle of the hose, which implies that at some point it has been folded there. See Figure 5. SHK's own tests show that if the hose is sufficiently twisted, it causes a kink, or a fold, at the area where the crease is, and in conjunction with this the flow area is reduced drastically, i.e. a constriction arises. The appearance and direction of the crease in relation to the hose is consistent with a kink that would be expected to occur if the hose was excessively twisted when fitted, which could happen as a result of, for example, after-tightening of the fixed coupling to the wagon after tightening the clamp coupling at the other end of the hose, or the hose not remaining straight when the clamp coupling is tightened, which could happen as a result of excessive friction between the collar nut and the clamp coupling flange.

Figure 5. The examined hose material has a crease on the surface.

After examination of the hose, SHK makes the assessment that the present constriction of the hose cannot arise spontaneously, nor will this condition be significantly affected by the movements of the wagon if the hose is not already twisted from the outset. The conclusion is thus that the hose was twisted when it was refitted and was not appreciably affected by the vehicle's motion. It has not been possible to establish with certainty exactly how much the hose had been twisted and how limited the air flow has been.

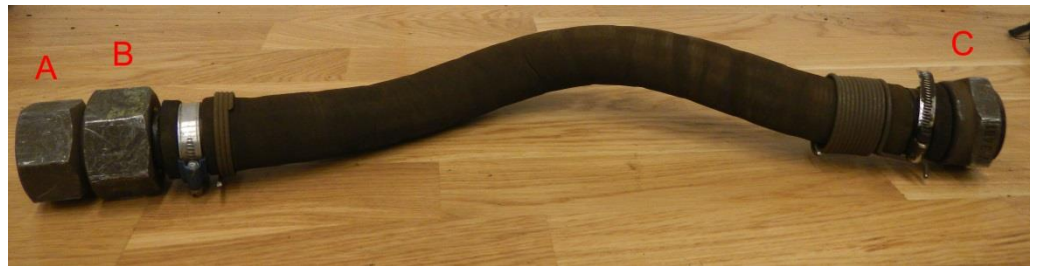
When fitting the hose, the manner of tightening the nuts is important in order to avoid twisting the hose. Nut "B" (see Figure 6) is used to seal the line with a clamp coupling. Once nut "B" starts to pull the clamp coupling together, there is a risk of the hose twisting as the nut is turned. If any of the nuts are retightened, there is also a risk of twisting the hose. The flow area is drastically reduced in the hose already after half a turn of the hose. Almost complete constriction seems to be the result after some 270° of twist. If the friction of the clamp coupling is too high, there is a risk of the hose following along with the collar nut before the coupling is sealed tight, thereby introducing a twist in the hose. The only way to prevent the hose from twisting in that situation, is to hold the hose still, using a pipe wrench

or similar tool. There is however no really suitable place to apply such a tool on the hose.

Figure 6. Examined hose. A, B and C mark the nuts.

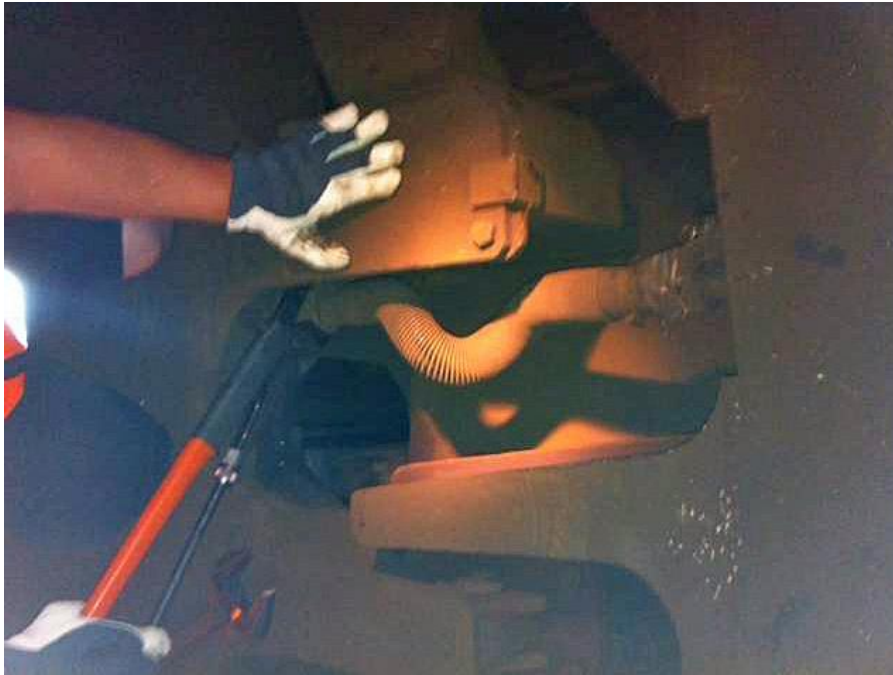
The investigation has not been able to determine how much the hose was twisted at the time of the incident. The hose was restored by TX Logistik AB personnel before SHK had opportunity to examine it. The data available is information from the mechanic and photographs taken by TX Logistik AB, which show the hose before it was restored and the twist was completely released.

Figure 7. Image of the hose directly after the event, before it was restored by TX Logistik AB. Photo: TX Logistik AB.

The constriction occurred because a fixed hose coupling in the main line had been refitted in a way that introduced a twist in the hose which caused it to twist. During assembly, the hose became twisted in a way that affected the flow area. The constriction was not identified by the technical post-inspections, nor by the subsequent brake tests.

AAE has resumed discussions with the manufacturer of the hose to see whether a better design solution can be found (such as having the steel spring support on the inside instead of on the outside). AAE is also working on a modification of the maintenance documentation, TSO module 22, in order to clarify the necessary tasks when separating and coupling the two halves of the wagon.
