Safety Investigation Report

Drifting of 2 empty railcars
followed by a lateral collision with a technical train
between the Brussels-North and Schaerbeek stations
24 April 2018

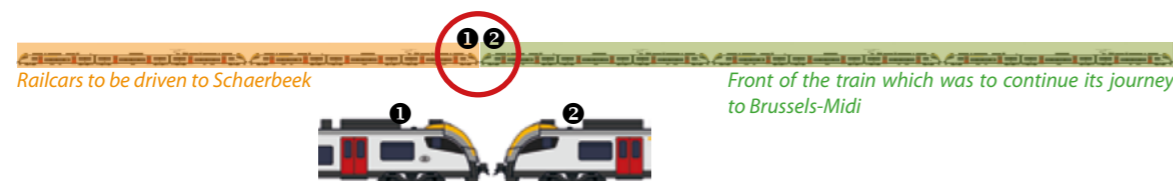
When the driver started the decoupling from the driver's cab ②, the railcars that were to be driven to Schaerbeek came loose and drifted in the Brussels-North set of tracks towards Schaerbeek.

The fact that the parking brake was not engaged on these two railcars was the direct cause of the uncoupling and drifting.

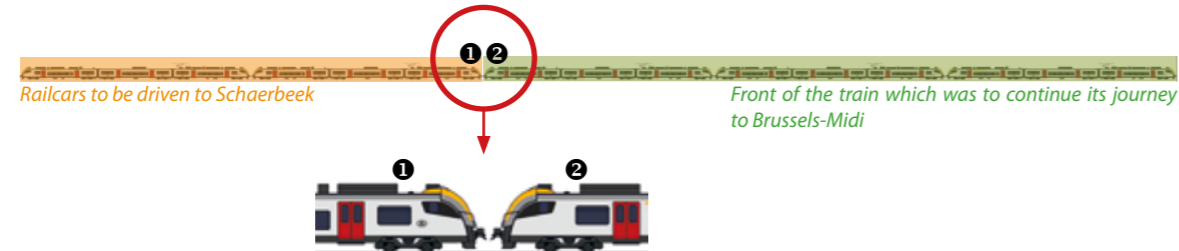
To perform the decoupling, the driver sent to Brussels-North tried to board the first of the towed railcars (❶): he pressed the door button, but as there was no power supply on these railcars, the doors did not open.

He did not notice either that the parking brake indicators on the side of the railcar were green: the parking brakes were not applied.

The driver then went to the last door of the last railcar (❷) of the towing train, and entered the driver's cab.

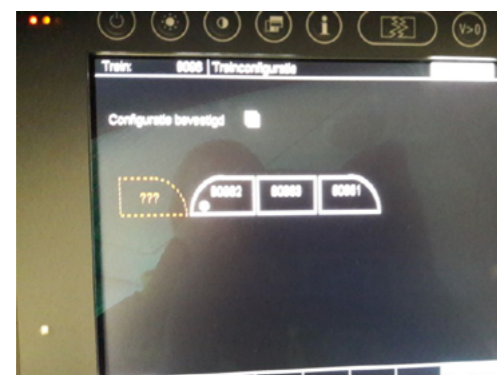
Image from a reconstruction.

- the white area represents the railcar in which the driver is located (❷ on the previous diagram);
- the dotted lines indicate that one or more railcars are coupled in "vehicle" mode.

This characteristic display did not sufficiently draw the driver's attention to the fact that the 2 towed railcars were in "vehicle" mode.

On the control panel, a parking brake indicator light was on, but as there were no electrical connections between the towing railcars and the towed railcars, this indicator only provided information on the status of the parking brakes of the 3 towing railcars (❷ on the diagram and shown in white on the TDD screen).
