Summary
Safety Investigation Report
Collision between a passenger train and
the rear of a freight train
Hermalle-sous-Huy - 5 June 2016

SUMMARY

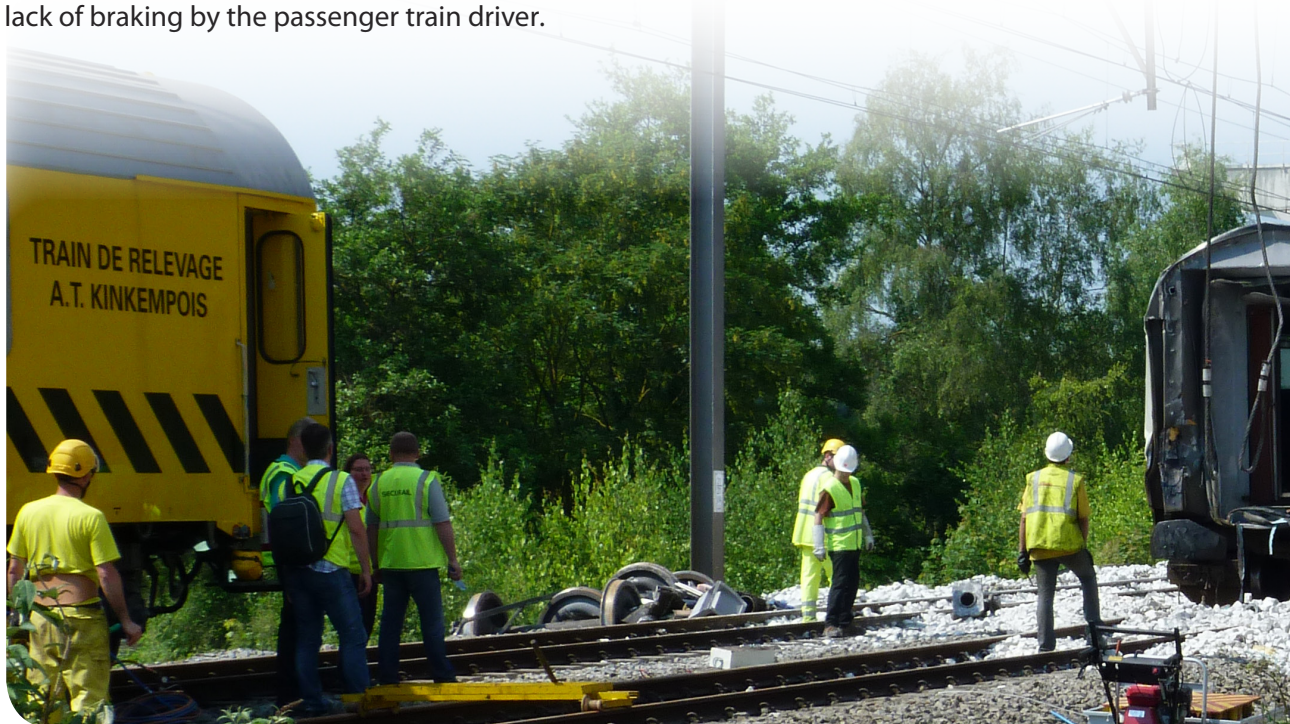
The train E3820 arrived at signal B222 at a speed of 112 km/h. As provided in the operation of the signals, and in accordance with the closed aspect of signal B222, the crocodile associated with the signal did not emit an electrical current: the E3820 train passed the closed B222 signal without the driver being warned by the equipment aboard the train. The train continued to move.

By the time the E3820 driver probably saw the tail signal of the freight train, he began an emergency braking while the train was travelling at about 118 km/h. The E3820 train travelled a distance of approximately 178 meters before colliding with the rear of train E48535 at a speed of approximately 88 km/h.

The catch-up collision was due to having passed a signal that showed a closed aspect after the lack of braking by the passenger train driver.
